University of Maryland, College Park  
National Pollutant Discharge Elimination  
System MS4 Phase II  
FY2019 Annual Report  
General Discharge Permit #13-SF-5501

## **Stormwater Treatment Final Report & Recommendations**

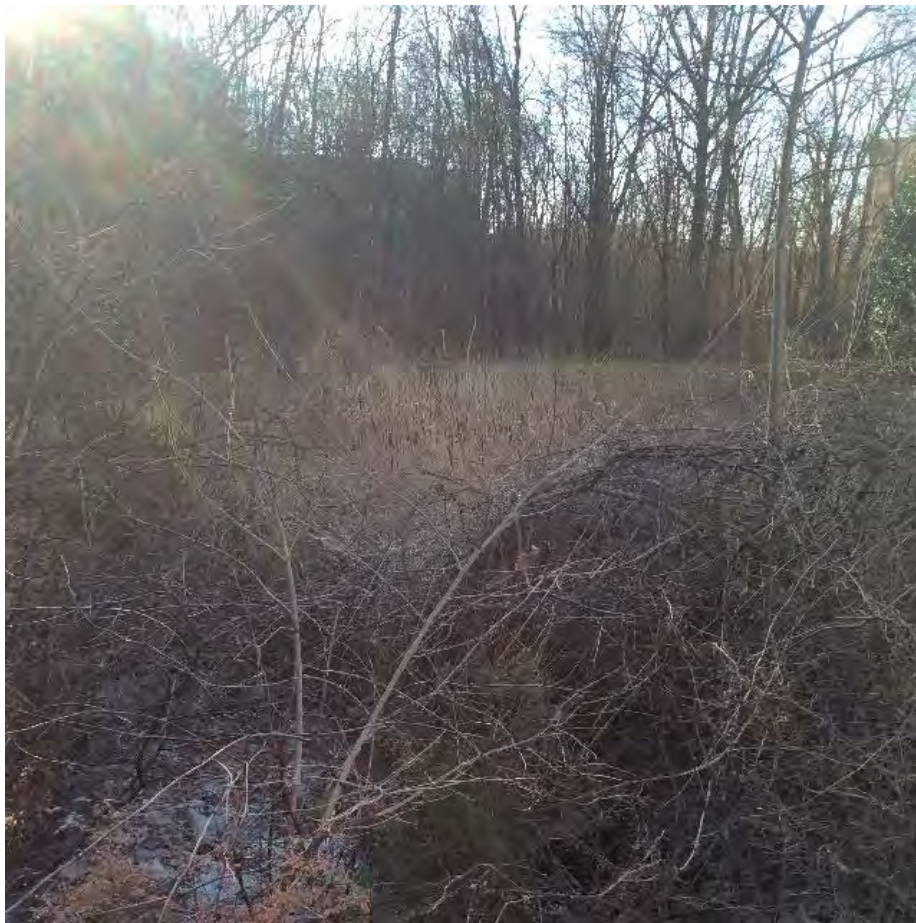
- **BMP Access** - Good
- **Debris & Sediment** - Fair
- **Vegetation** - Poor
  - Overgrown Vegetation, invasive species present, cattail growth reducing treatment capacity
- **BMP Contamination** - Good
- **Inflow Condition** - Fair
- **Forebay** - Not Rated
  - Not Part of Design
- **Conveyance Stability** - Fair
- **Downstream Condition** - Good

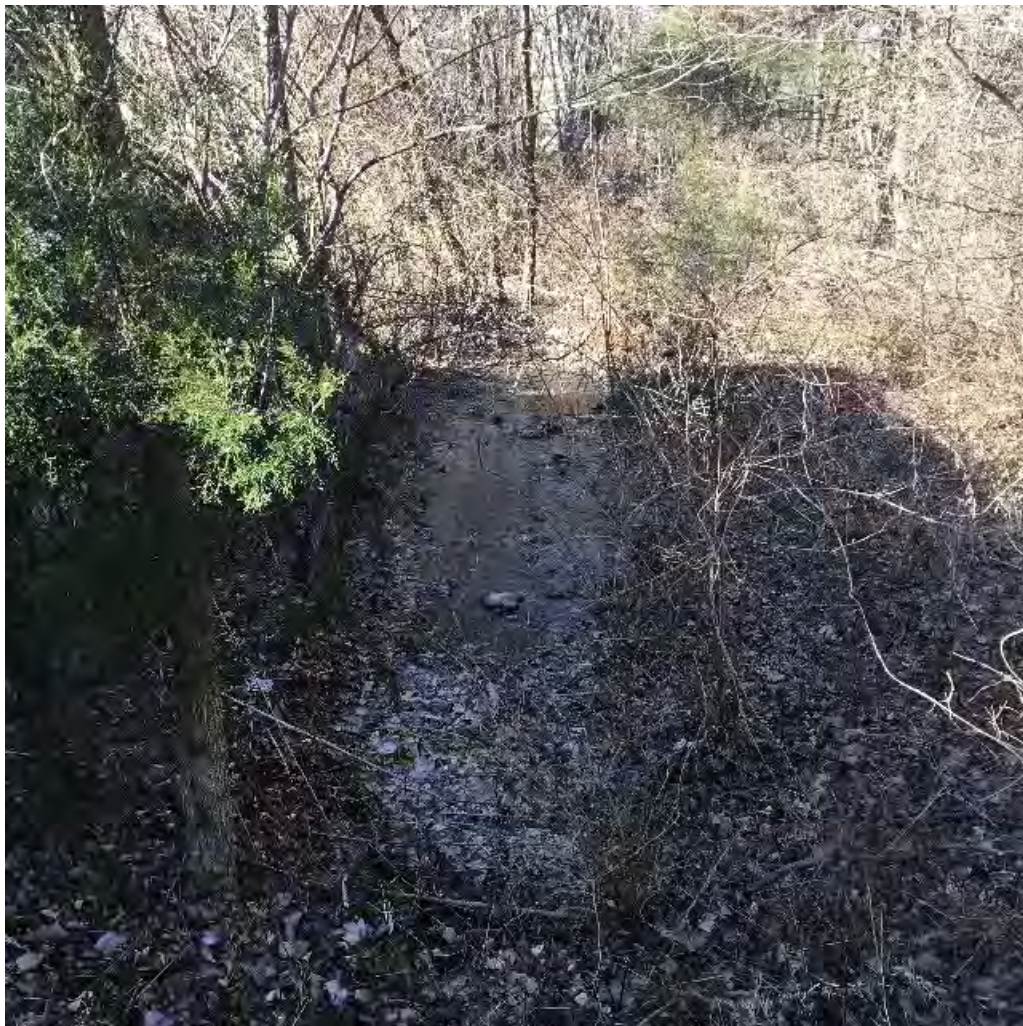
- **BMP Access** - Good
- **Debris & Sediment** - Poor
- **Vegetation** - Poor
  - Trees growing in BMP
- **BMP Contamination** - Good
- **Inflow Condition** - Good
- **Forebay** - Not Rated
  - Not Part of Design
- **Conveyance Stability** - Poor
  - Infiltration trench is ponding past the dewatering period and not infiltrating as designed
- **Downstream Condition** - Poor
  - Overgrown vegetation at downstream end of BMP; erosion downstream from BMP overflow

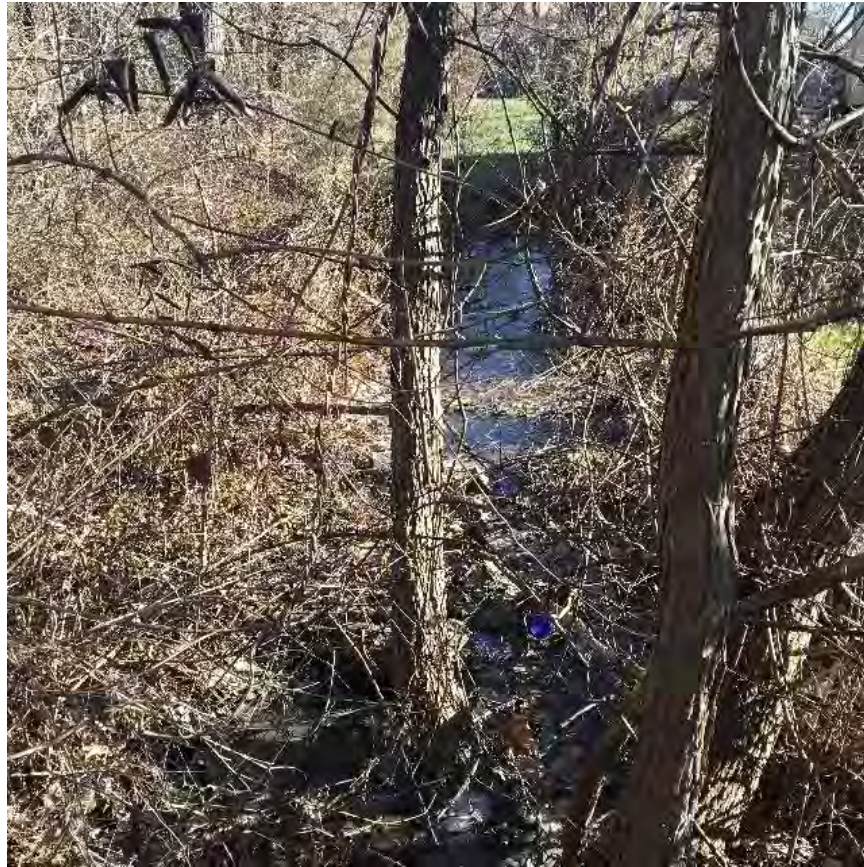
Tree growth within BMP

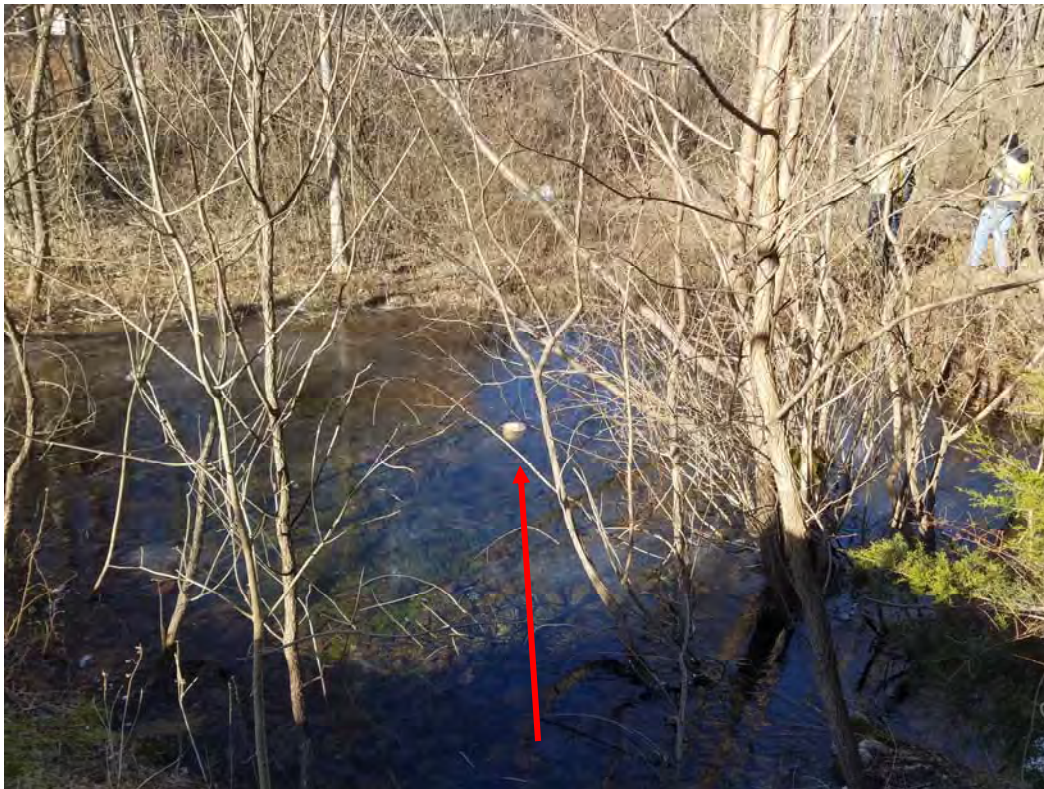
- **BMP Access** - Good
- **Debris & Sediment** - Poor
- **Vegetation** - Poor
  - Tree growth around infiltration trench
- **BMP Contamination** - Good
- **Inflow Condition** - Fair
- **Forebay** - Not Rated
  - Not Part of Design
- **Conveyance Stability** - Poor
  - BMP is ponding and not infiltrating
- **Downstream Condition** - Good

Ponding within BMP, Observation Well submerged, minor reseeding at inflow - sheetflow.

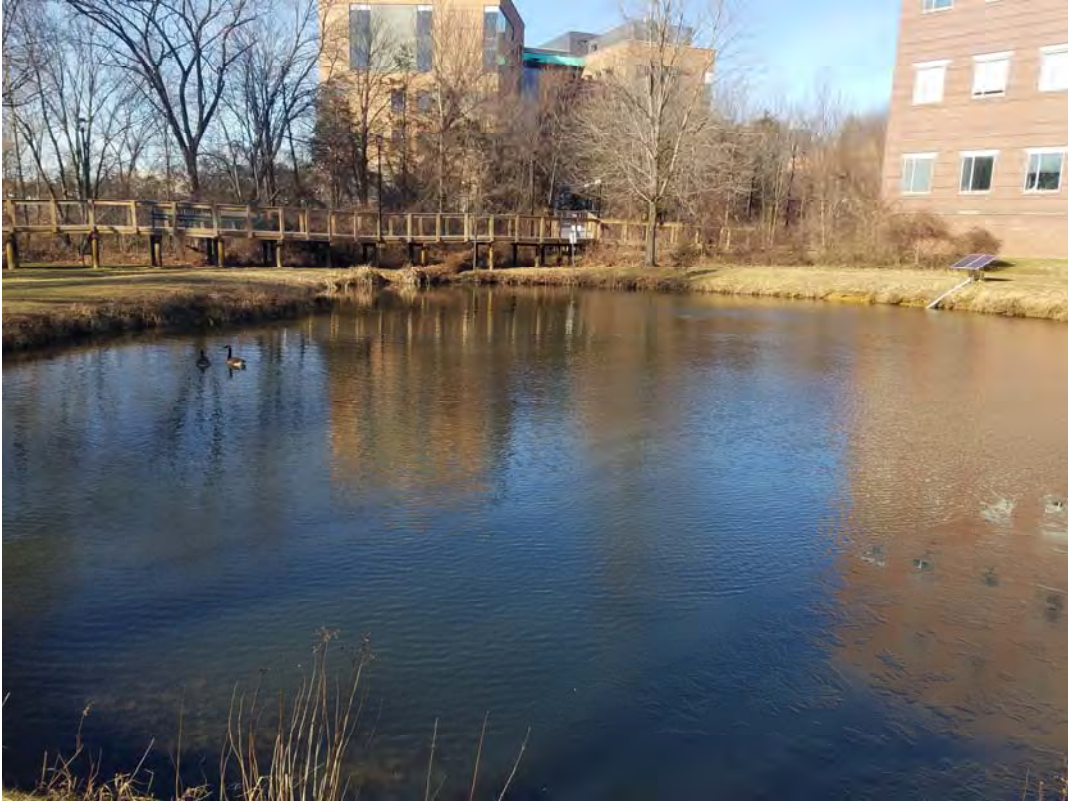
Upstream embankment, minor erosion

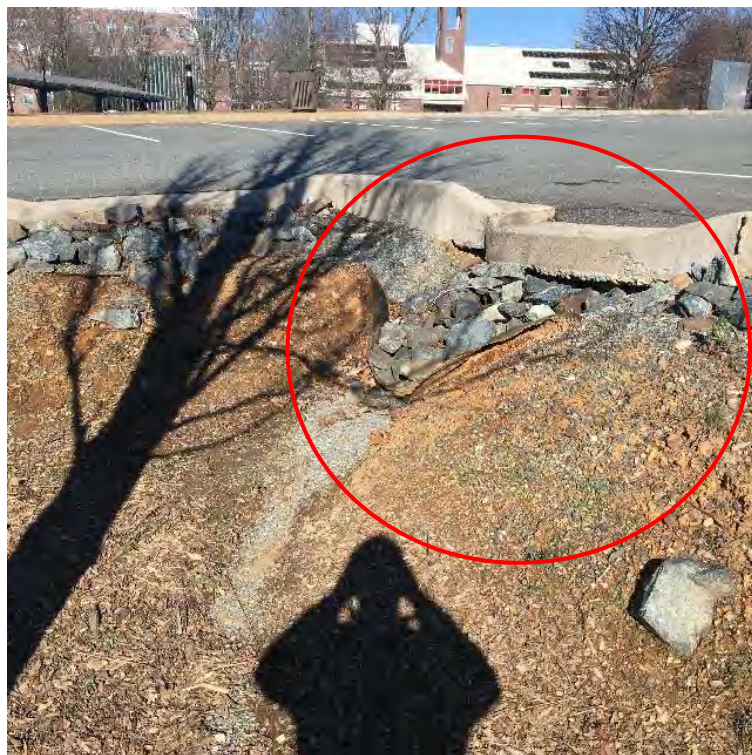
Inflow - Curb Cut, Facing West, Curb Damaged and Undermined

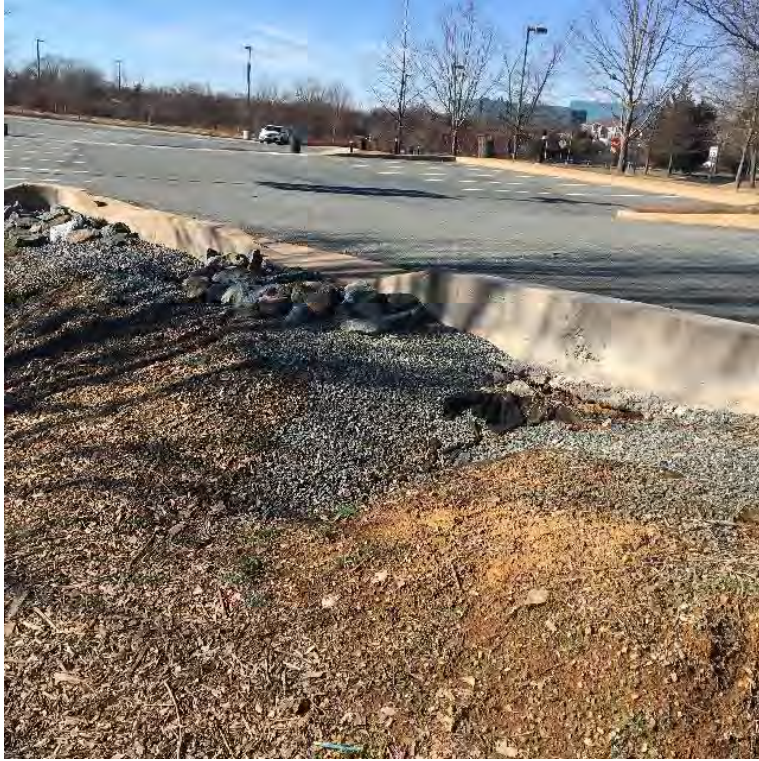
Gravel Curtain Drain Clogged

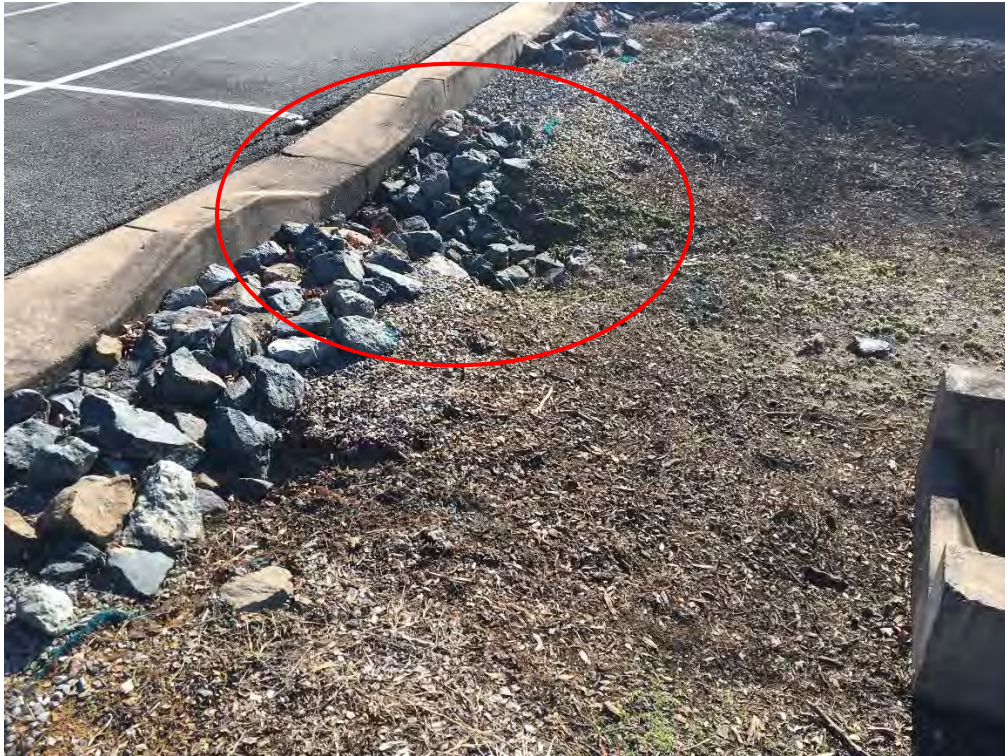
Erosion at inflow, water flows under curbing

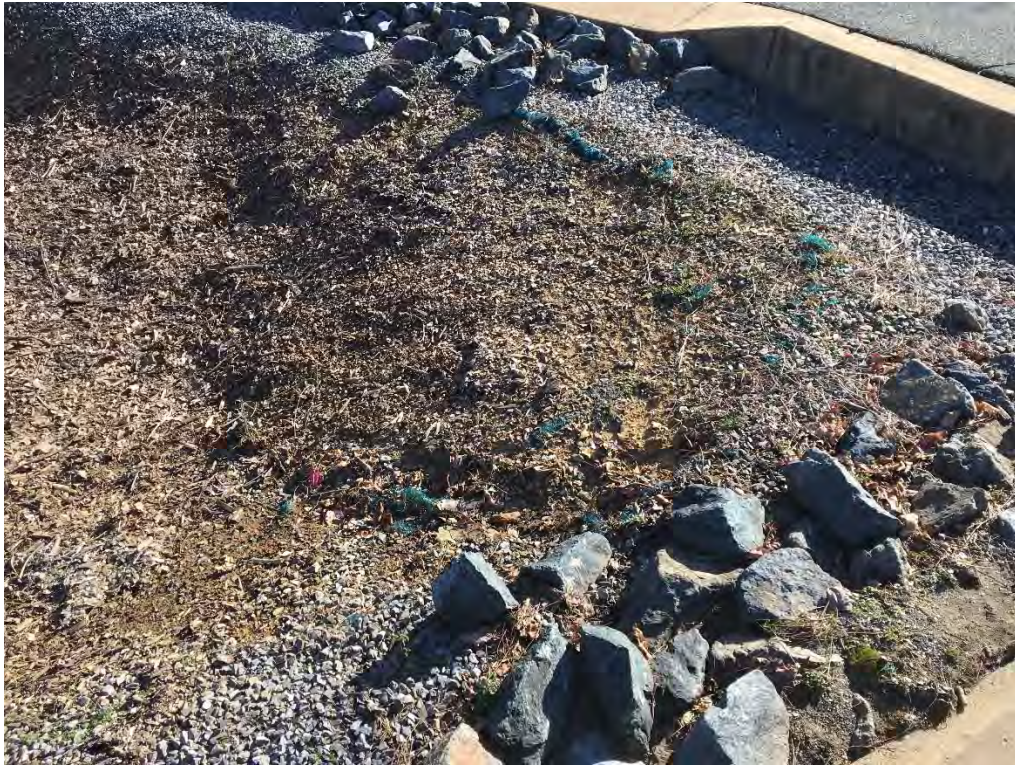
Sediment within Curtain Drain, Erosion at Curb Cut

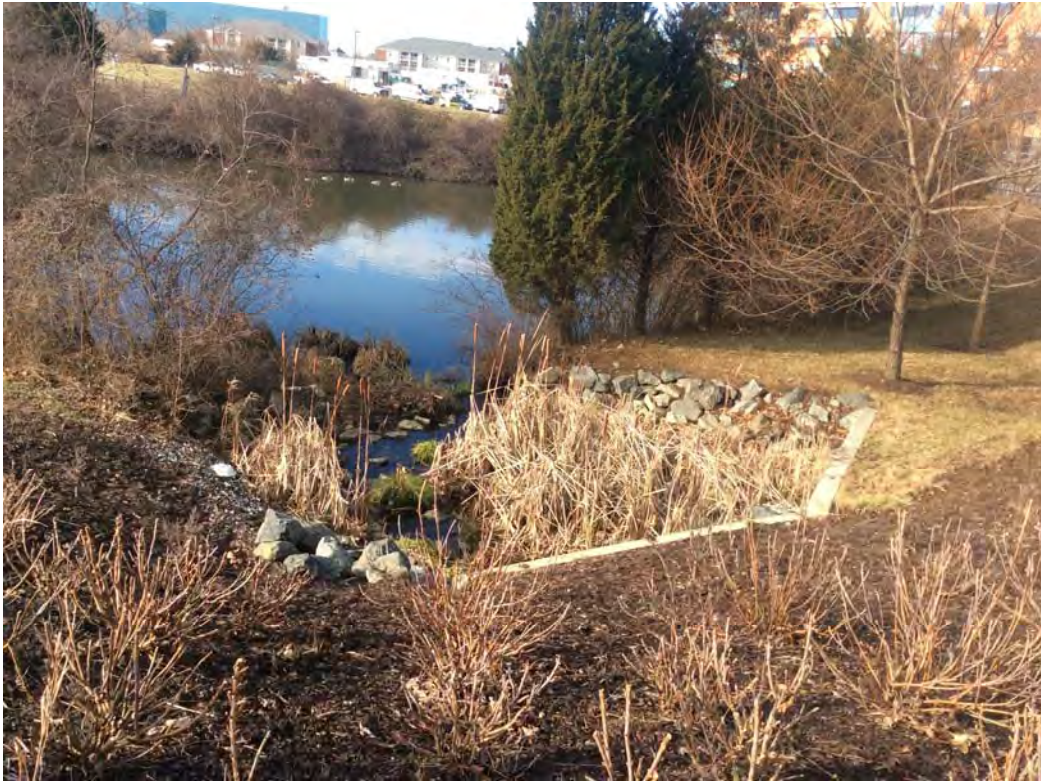
Forebay, Cattail Growth

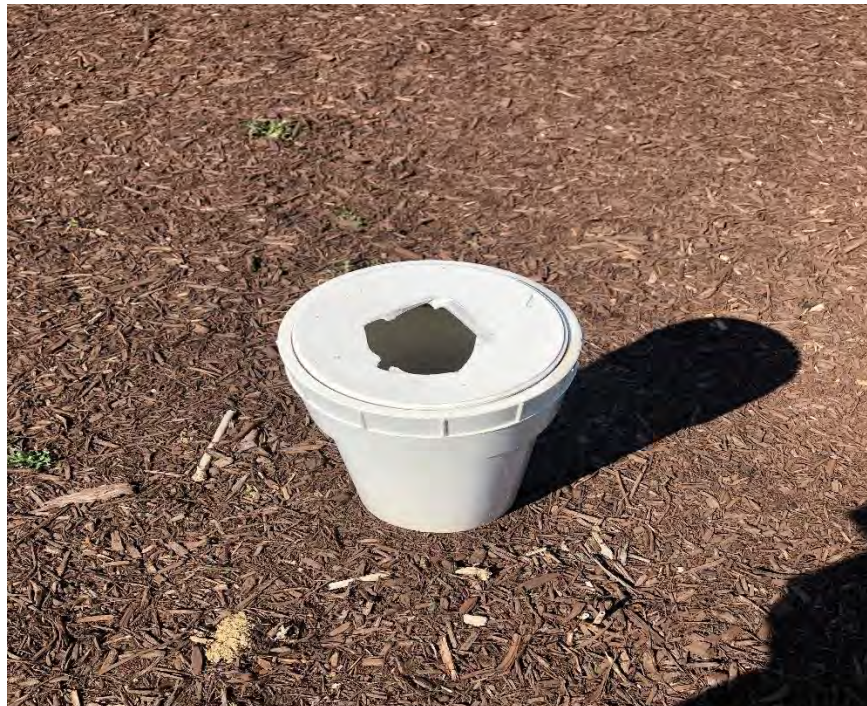
Photo #2: Broken cleanout inside the facility.

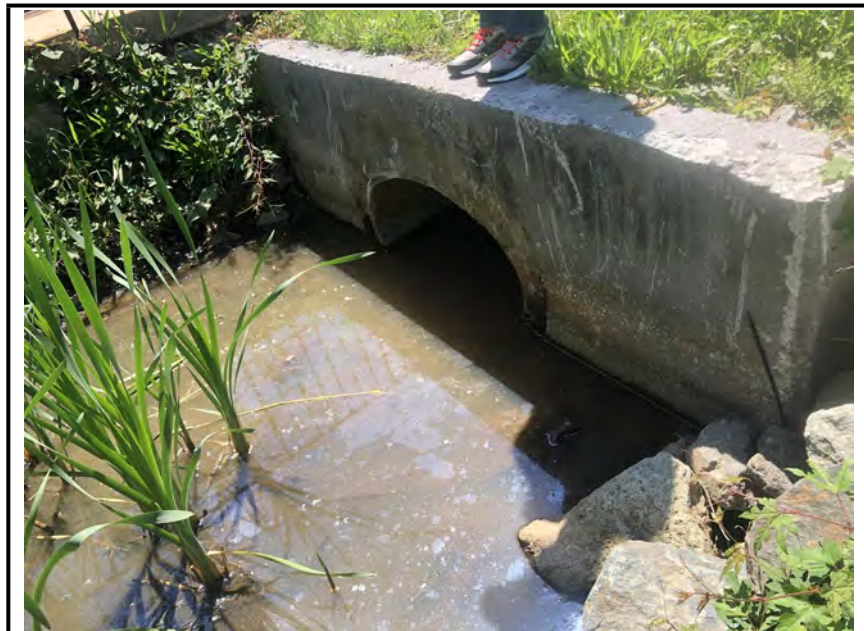
**Photo #8:** The inflow pipe with standing water.

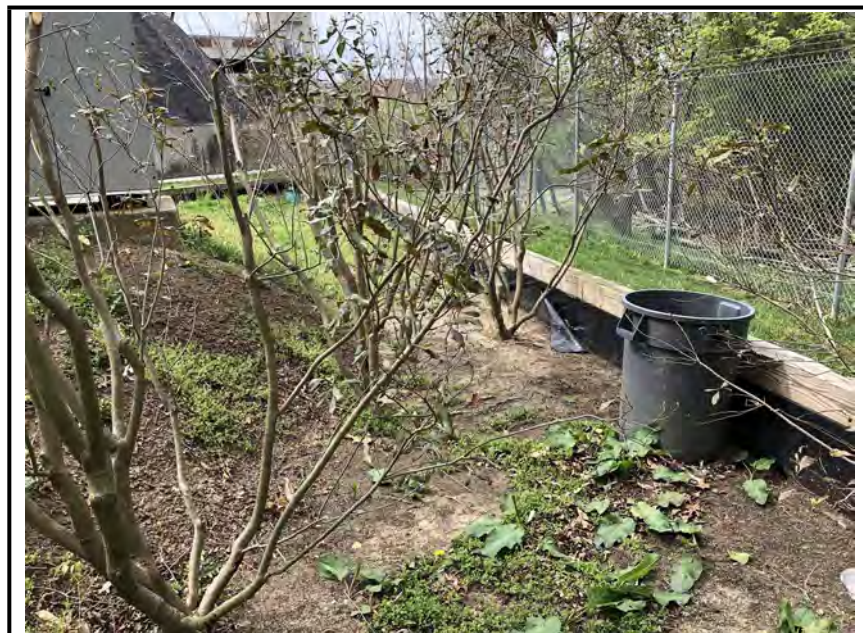
Photo #2: View into the facility, with trashcan in the filter bed.

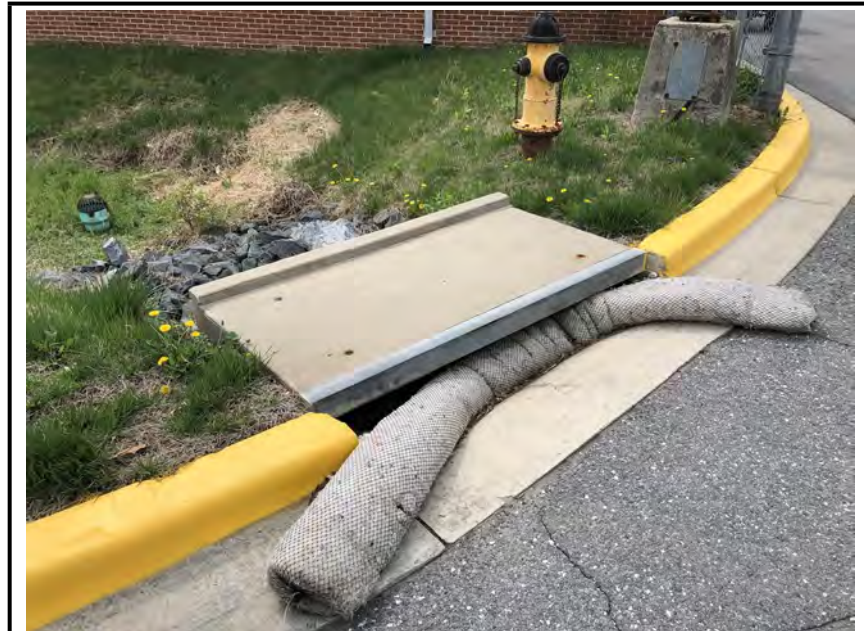
Photo #1: Filter log stuck inside of the inlet.

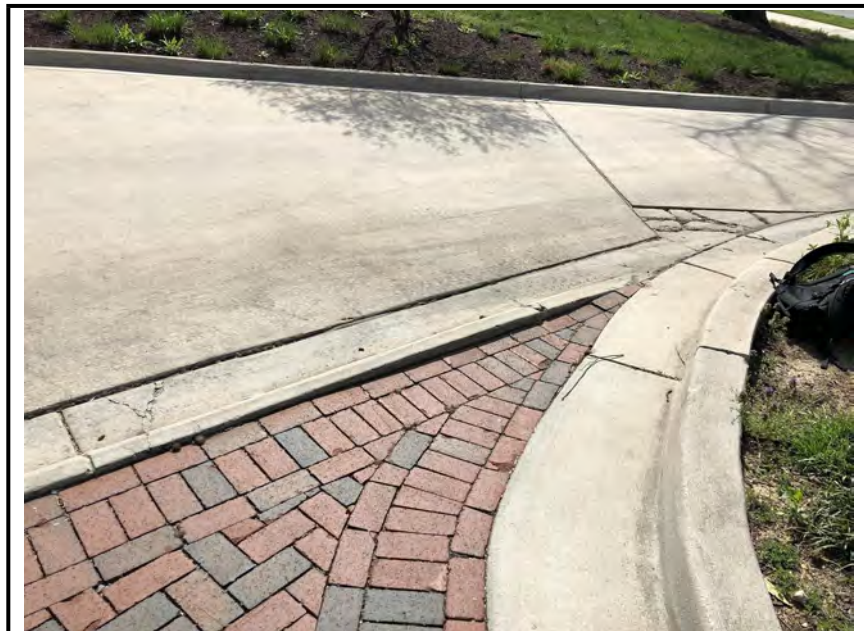
**Photo #2:** Curb is not flush to the pavers.

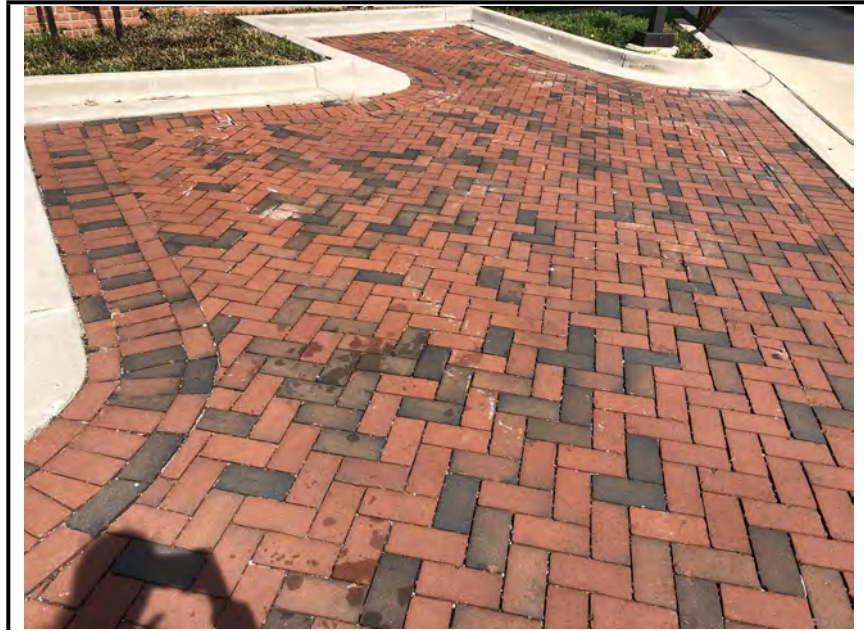
**Photo #3:** Stains on the pavers.

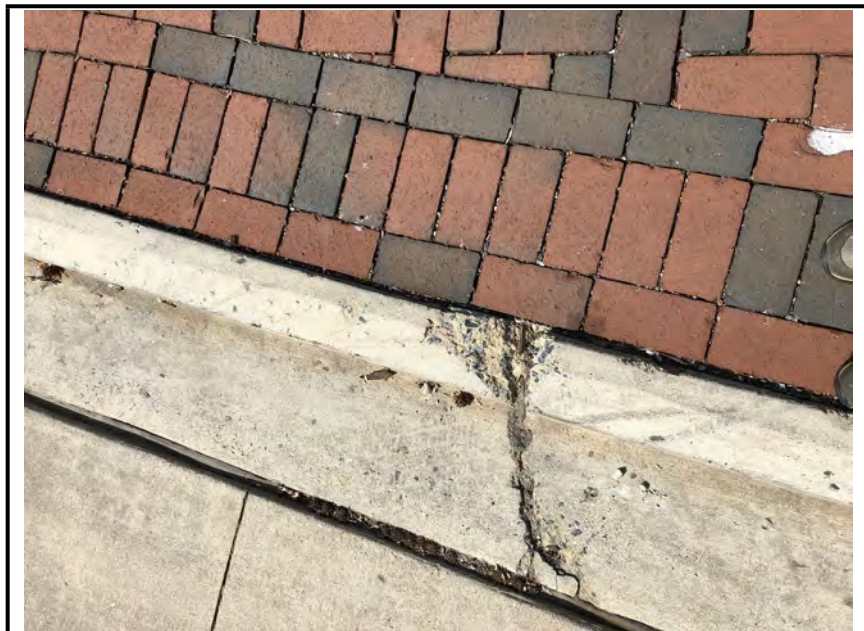
**Photo #4:** Curb is chipping and cracking in some places.

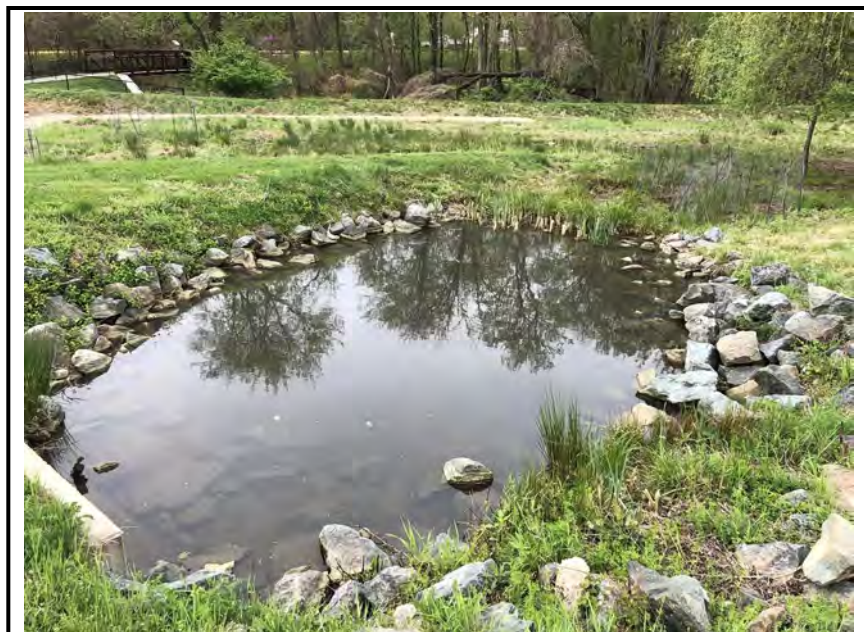
Photo #6: Stagnant water in the forebay.
