University of Maryland, College Park  
National Pollutant Discharge Elimination  
System MS4 Phase II  
FY2019 Annual Report  
General Discharge Permit #13-SF-5501

## **Stormwater Treatment Final Report & Recommendations**

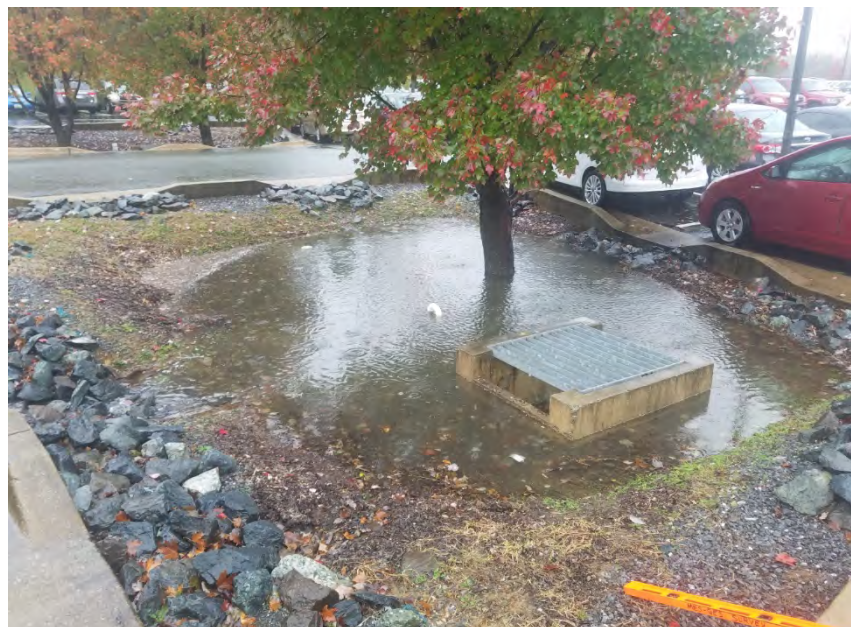
Figure 3 - Bioretention facility during rain event

All four facilities have overly deep ponding areas. MDE's guidance requires 12" or less of ponding at microbioretention and bioretention facilities. The facilities currently have 14"-20" of ponding depth. This depth is measured from the inlet's weir to the bottom of the basin. The original design plans called for 6" of ponding.

In order to lessen the ponding, 3" of mulch should be added

to the facilities with ID#s ending in 19 and 21 (the two facilities located on the northern side of the parking lot) to bring the facilities to 12” of ponding depth. The ponding is even deeper in the two facilities with ID#s ending in 20 and 22 (the two facilities located on the southern side of the parking lot) and thus these facilities should first have 4-5” of bioretention media added (media shall adhere to SHA Std. 920.01.05) and then 3” of mulch should be placed on top of the bioretention media. This will provide 12” or less of ponding at all four facilities (see Table 6 below).

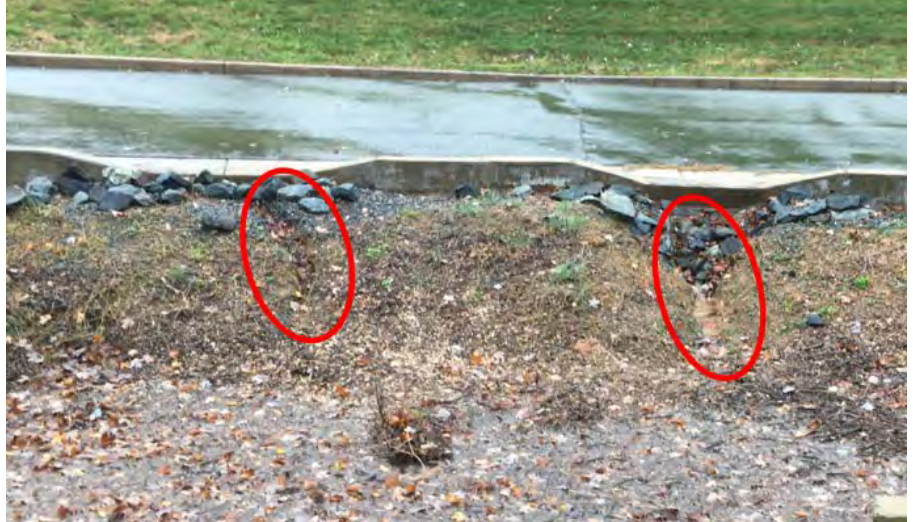
Figure 4 - Existing erosion at side slopes

There is erosion at many of the inflows due to large amounts of rainfall with inadequate slope protection. All side slopes should be re-graded at a 3:1 slope and should tie into the top of the back-side of the curb. Currently, the grading ties into the bottom of the curb, which is not providing enough structural stability for the curb, as shown in Figure 4.

Once the basin's new elevation has been established with the mulch (and bioretention media where needed), then the side slopes should be graded at a slope of 3:1 (3' horizontal for every 1' of vertical grade change), ultimately tying into the top of the back side of the curb, as shown in Figure 5.

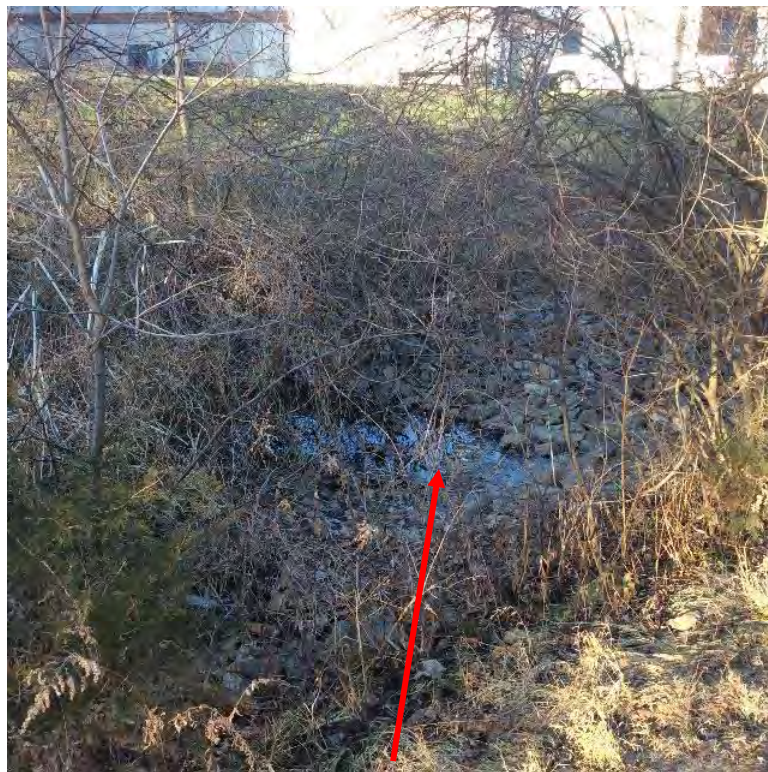
Inflow, Pipe Submerged

The sand filter is considered failing and requires major maintenance to restore to functioning condition. Maintenance recommendations to restore the sand filter to functioning condition include: Removal of debris, unplanned and woody vegetation within a 10' buffer around the facility. Daylight 8" PVC inflow and repair and reset riprap at inflow. Removal of sediment and vegetation within the facility and dispose at an approved location. Excavation and reinstallation of the sand filter. Regrade the embankment to original design. If ENAKMAT 4010 device is compromised, reconstruct as designed. Removal of debris, unplanned and woody vegetation within a 15' from the downstream and upstream toe of the embankment and control structure. Recommend installing an underdrain and forebay to bring to approved MDE design standards. Facility may not be feasible in current location due to low grade and adjacent wetland. Site is located on type C soils.

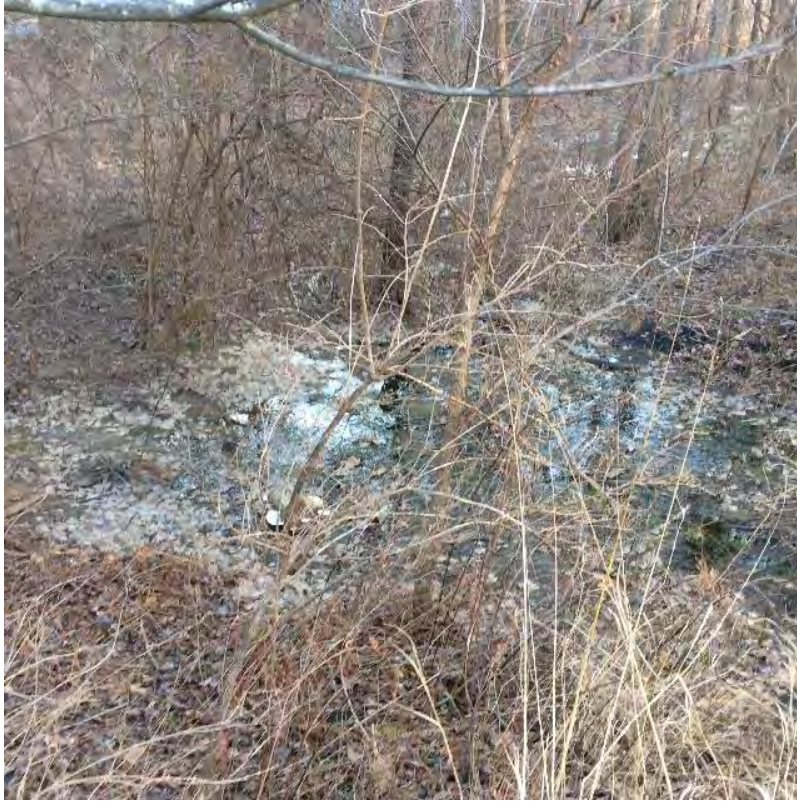
Tree Growth on Embankment

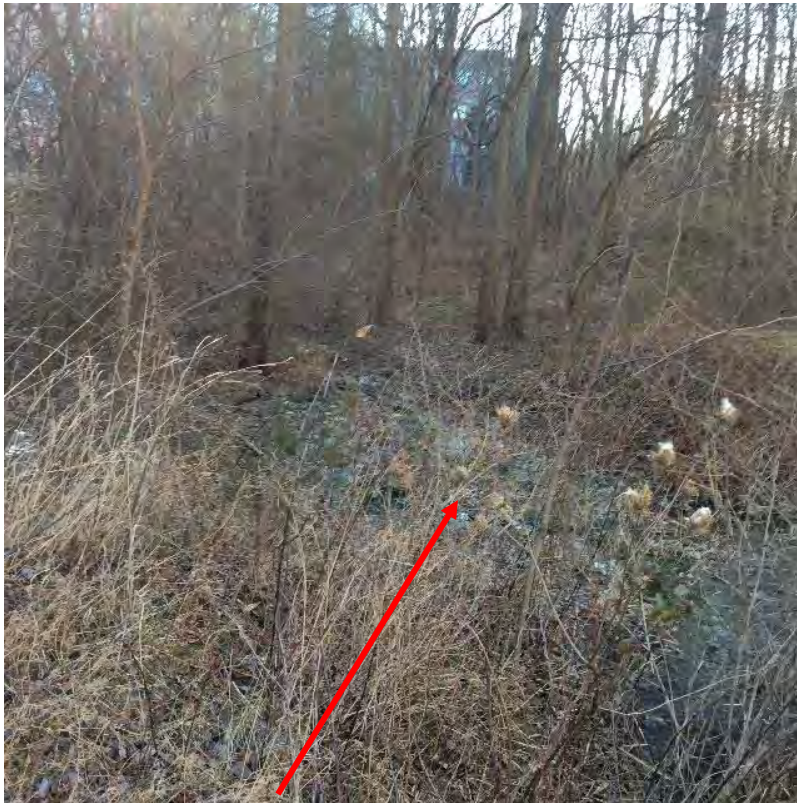
Embankment Blown Out at Control Structure

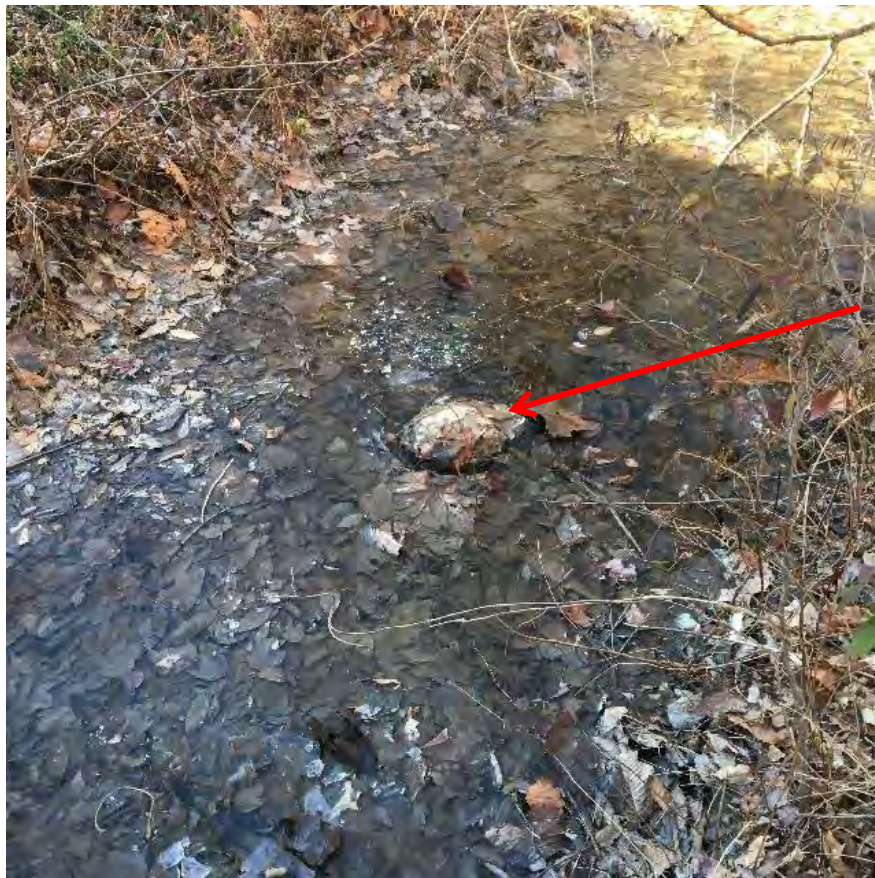
Ponding on BMP surface and observation well

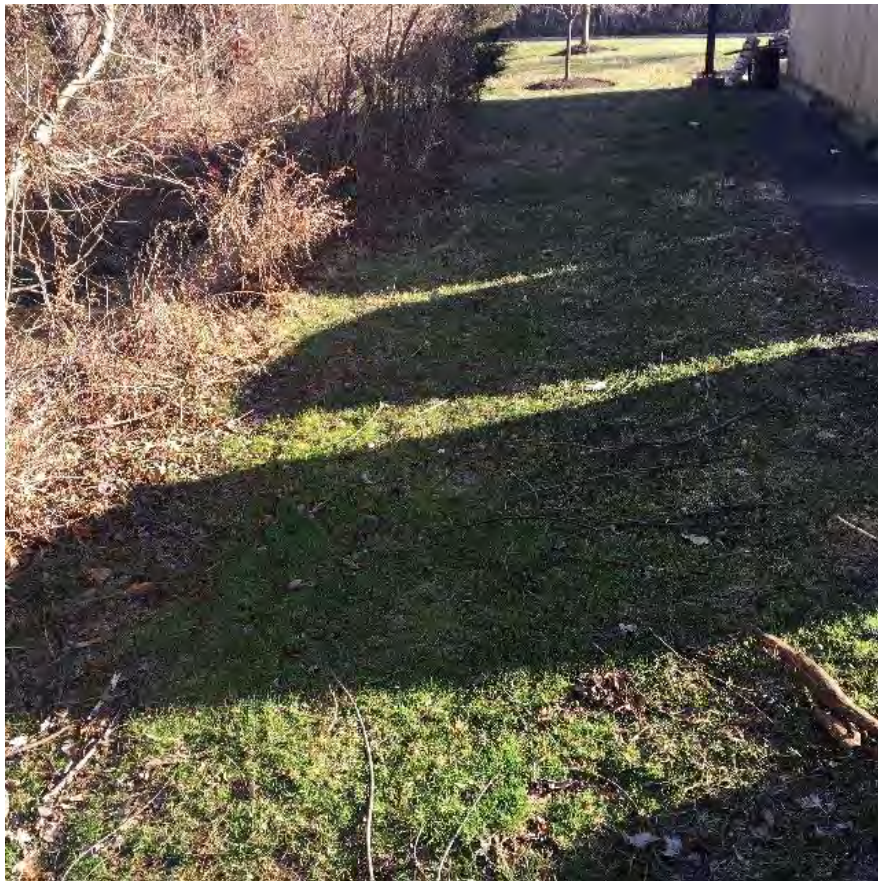
Inflow to BMP – sheetflow

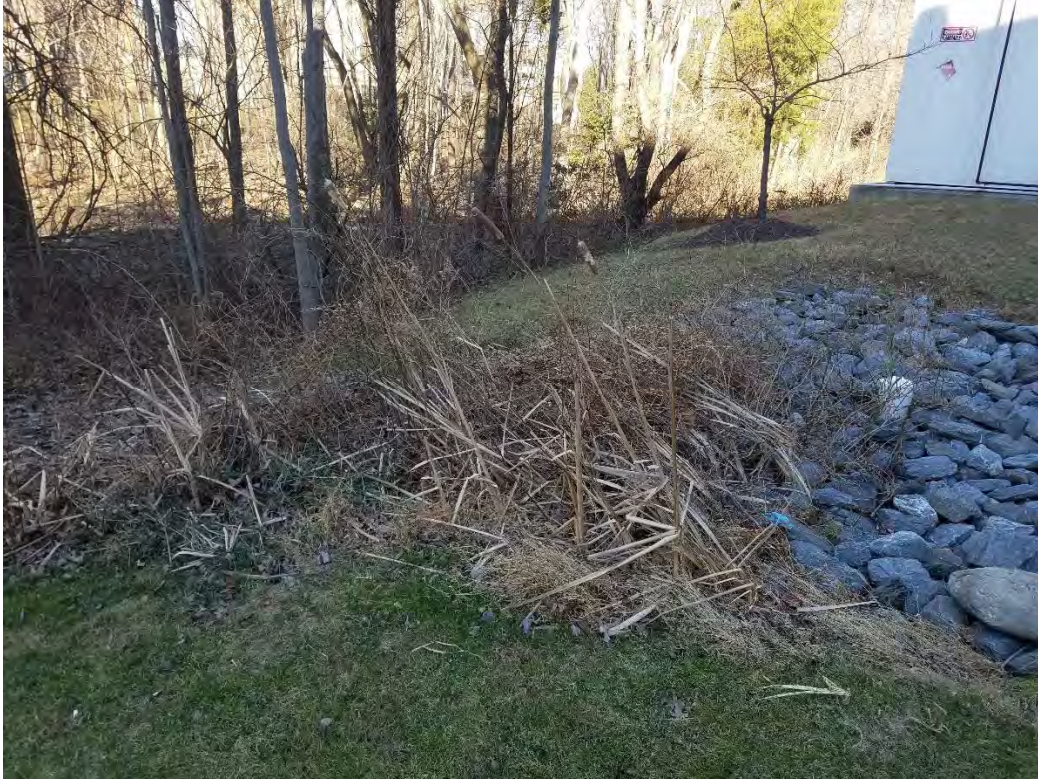
Overflow and overgrown vegetation

No remedial action necessary as the infiltration trench is in good functioning condition. Routine maintenance recommendations include: Removal of debris, sediment, and unplanned vegetation at the overflow and within a 10' buffer around the facility.

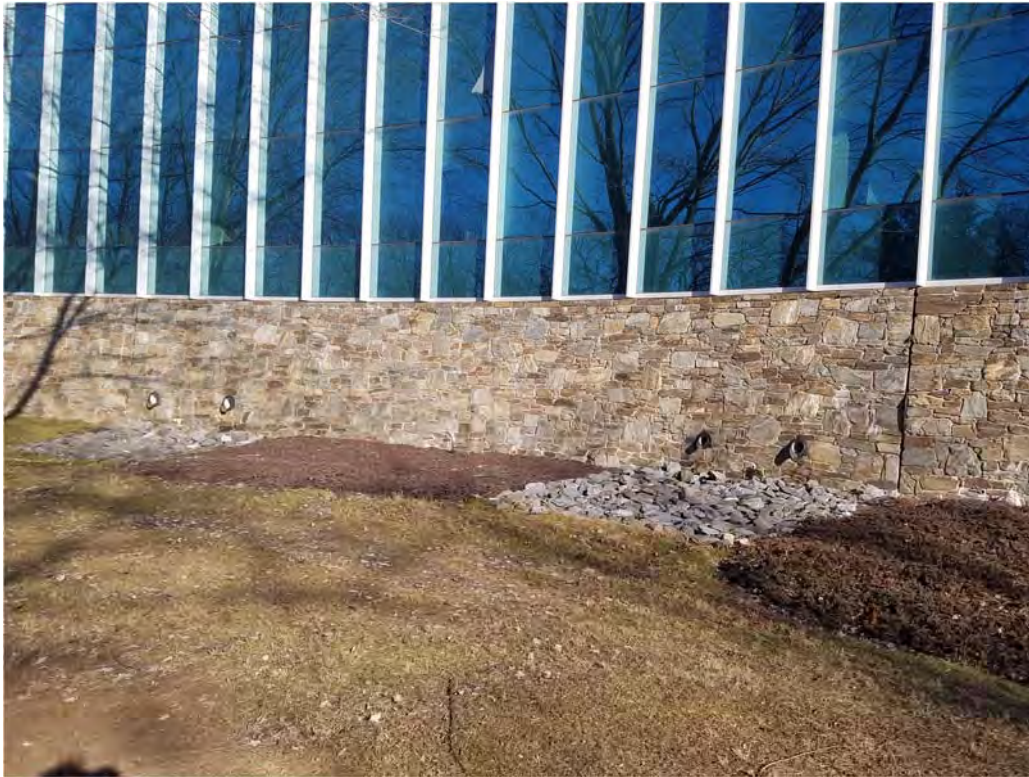
Inflow from roofdrain

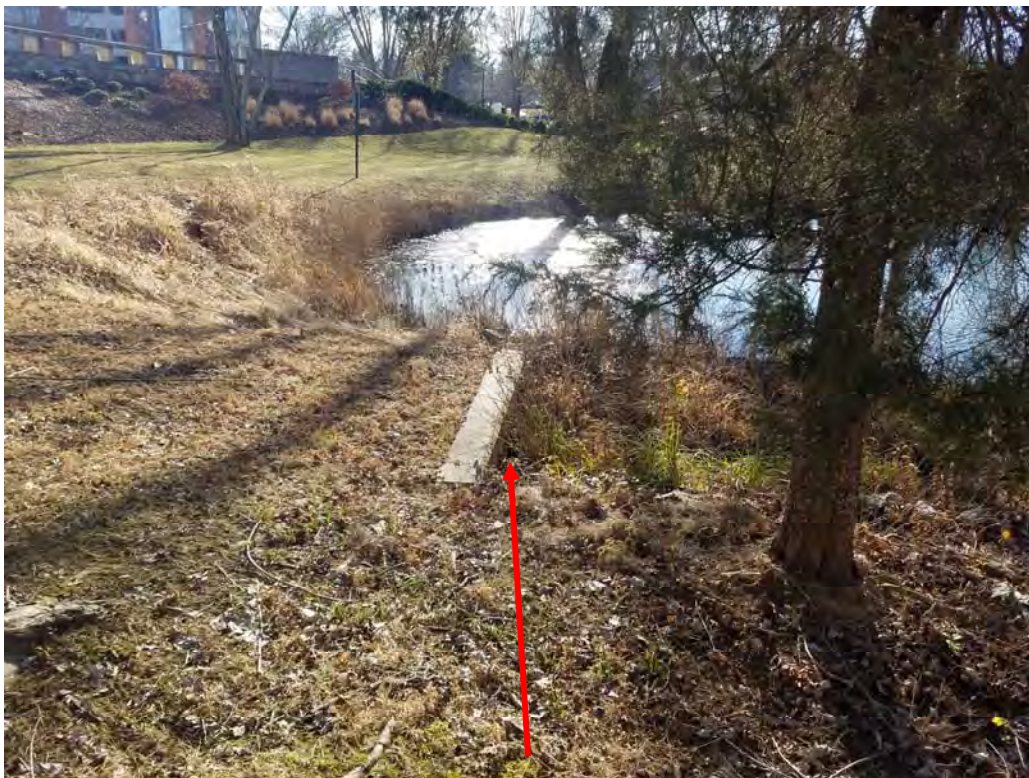
<b>Date of Inspection:</b>	01/11/2019 12:16 PM	<b>Inspector Initials</b>	SAL,JK,CAB
<b>BMP ID</b>	USG19BMP00007	<b>Inspection Firm</b>	MES
<b>BMP Type:</b>	Retention Pond (Wet Pond)	<b>Underground BMP?</b>	No
<b>Rating:</b>	B - Functioning, needs minor maintenance	<b>Overall Inspection Comment</b>	BMP may require sediment removal to return to full capacity, erosion at upstream embankment toe, riprap weir needs minor repair, inflow pipe requires minor sediment removal. BMP functioning as designed.

Inflow from pipe, partially buried

The wet pond is considered functioning but could use minor and routine maintenance. Maintenance recommendations include: Removal of debris, sediment, and unplanned vegetation around the facility and at the inflow. Removal of sediment, debris, woody and unplanned vegetation at the rock weir and 15' downstream from the control structure. Removal of riprap at inflow and outfall and reset riprap to original design. If possible, wash and replace stone. Repair and stabilization of eroded sections of the pond perimeter. Refer to MDE for woody vegetation removal along the embankment.

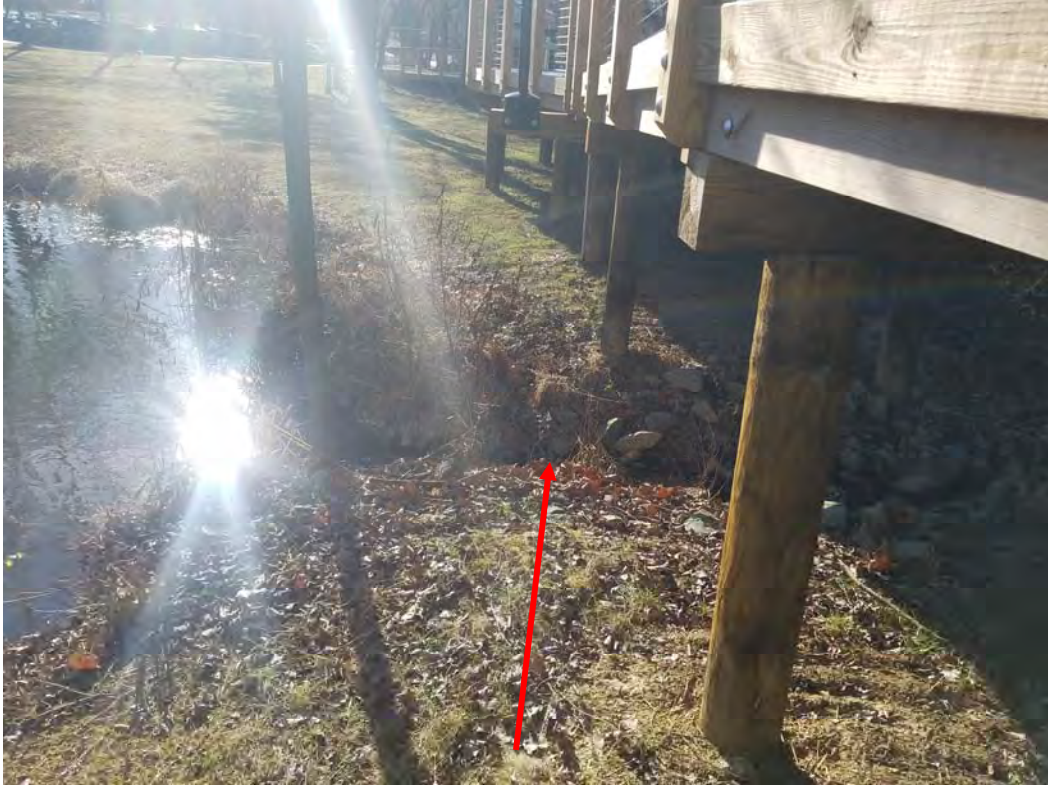
Control structure, riprap weir

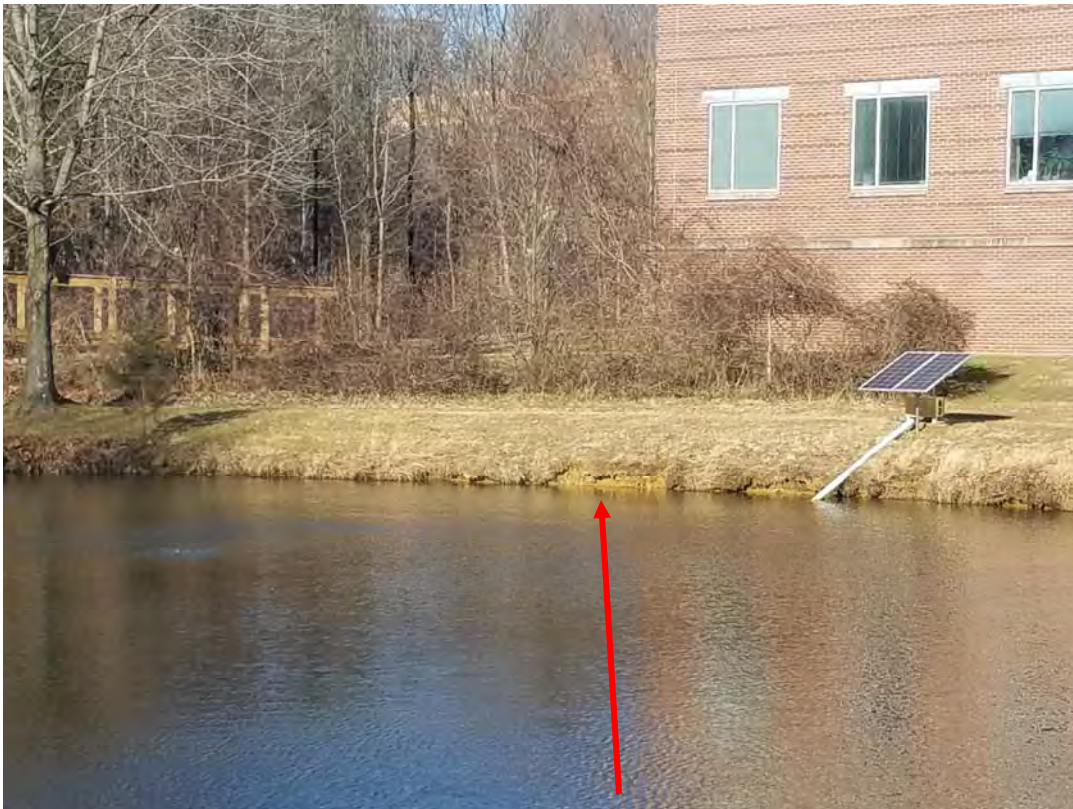
Erosion at embankment toe

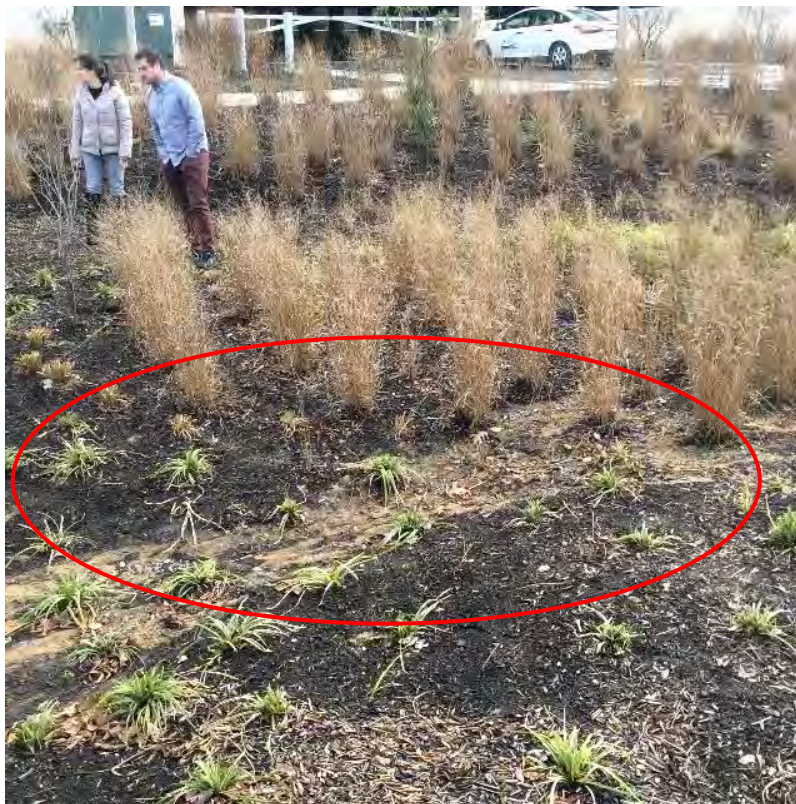
- **BMP Access** - Good
- **Debris & Sediment** - Good
- **Vegetation** - Not Rated
  - Outside Growing Season
- **BMP Contamination** - Good
- **Inflow Condition** - Good
- **Forebay** - Not Rated
  - Not Part of Design
- **Conveyance Stability** - Poor
  - Erosive flow within BMP, low point
- **Downstream Condition** - Not Rated
  - Site outfalls to existing stormwater network

Erosive flow within BMP conveyance

The micro-bioretention is considered functioning but could use minor and routine maintenance. Maintenance recommendations include: Repair and stabilization of eroded areas within facility. Restore the facility to design grade. Replanting of any disturbed bioretention plants. Removal of any debris, sediment, and unplanned vegetation within BMP and at the inflows.

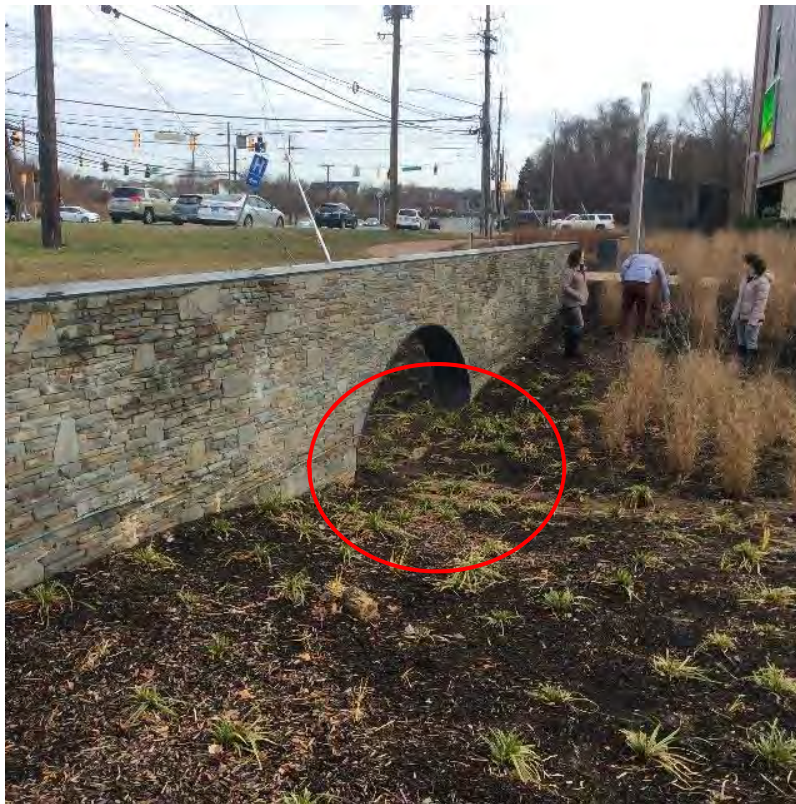
Arch located within BMP, BMP low point

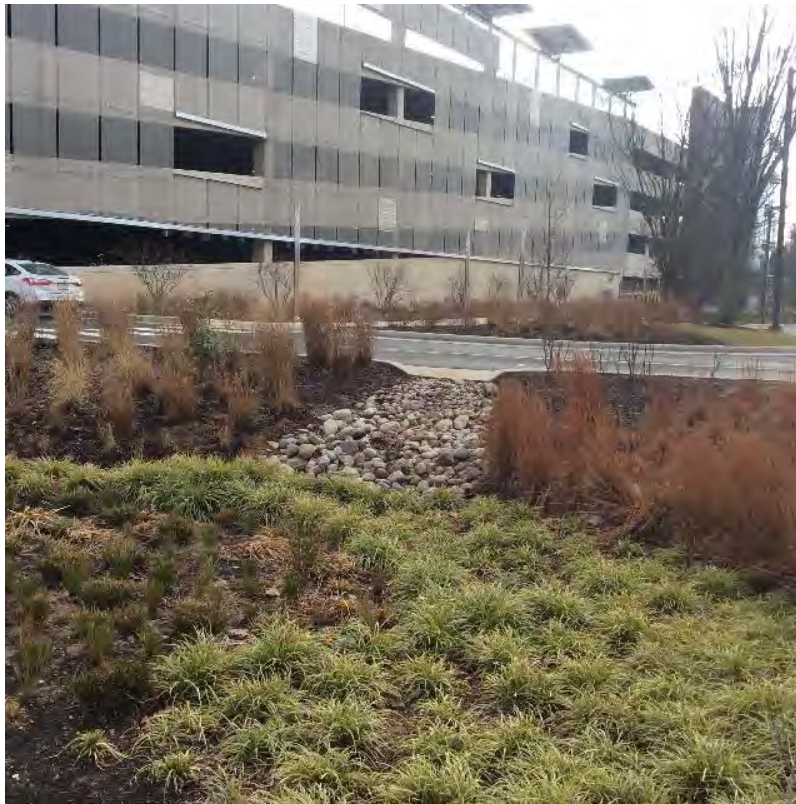
Inflow - Curb Cut and unknown pipe

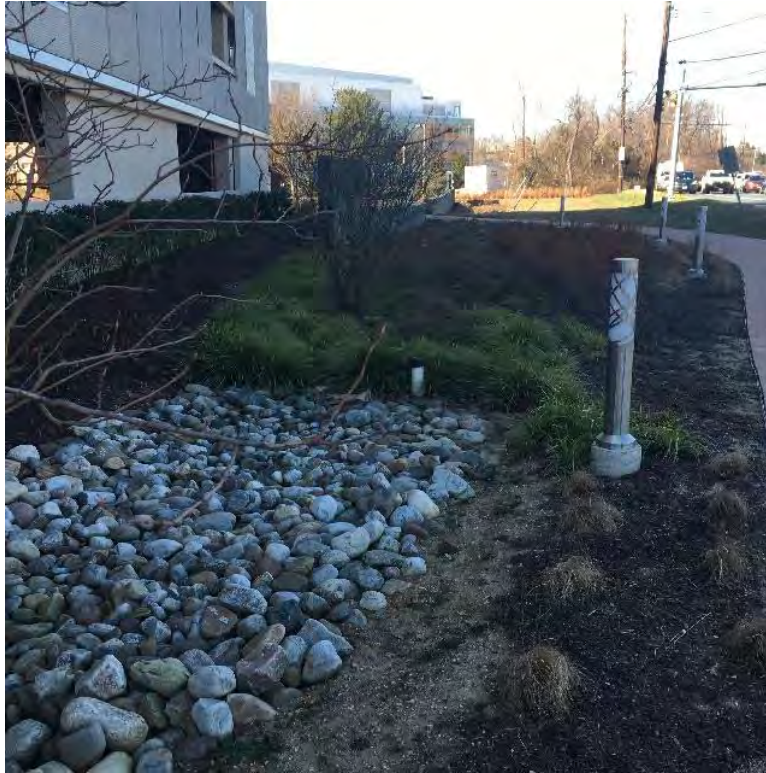
Overall - Facing North, Minor Erosion at Riprap

No remedial action needed as the micro-bioretenion is in good function condition. Routine maintenance recommendations include: Repair any eroded areas at the inflow within the BMP. Removal of any unplanned and invasive vegetation inside the facility.

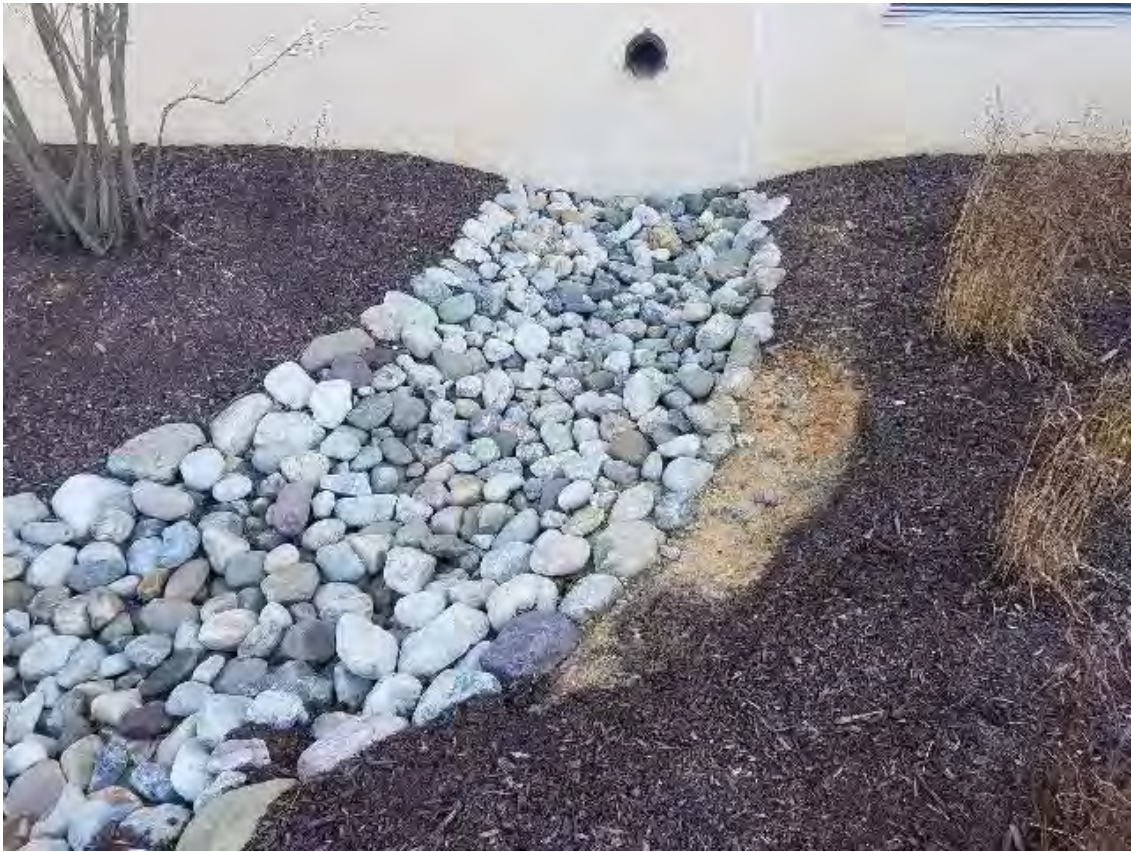
<b>Date of Inspection:</b>	01/11/2019 9:59 AM	<b>Inspector Initials</b>	SAL,JK,CAB
<b>BMP ID</b>	USG19BMP00014	<b>Inspection Firm</b>	MES
<b>BMP Type:</b>	Micro-Bioretentation	<b>Underground BMP?</b>	No
<b>Rating:</b>	A - Functioning, only needs routine maintenance	<b>Overall Inspection Comment</b>	Minor Erosion at Eastern Inflow. Repair erosion at inflow. BMP is in good condition and functioning as designed.

Inflow B, East - Erosion at inflow

No remedial action needed as the micro-bioretenion is in good function condition. Routine maintenance recommendations include: Repair any eroded areas at the inflow within the BMP. Removal of any unplanned and invasive vegetation inside the facility.

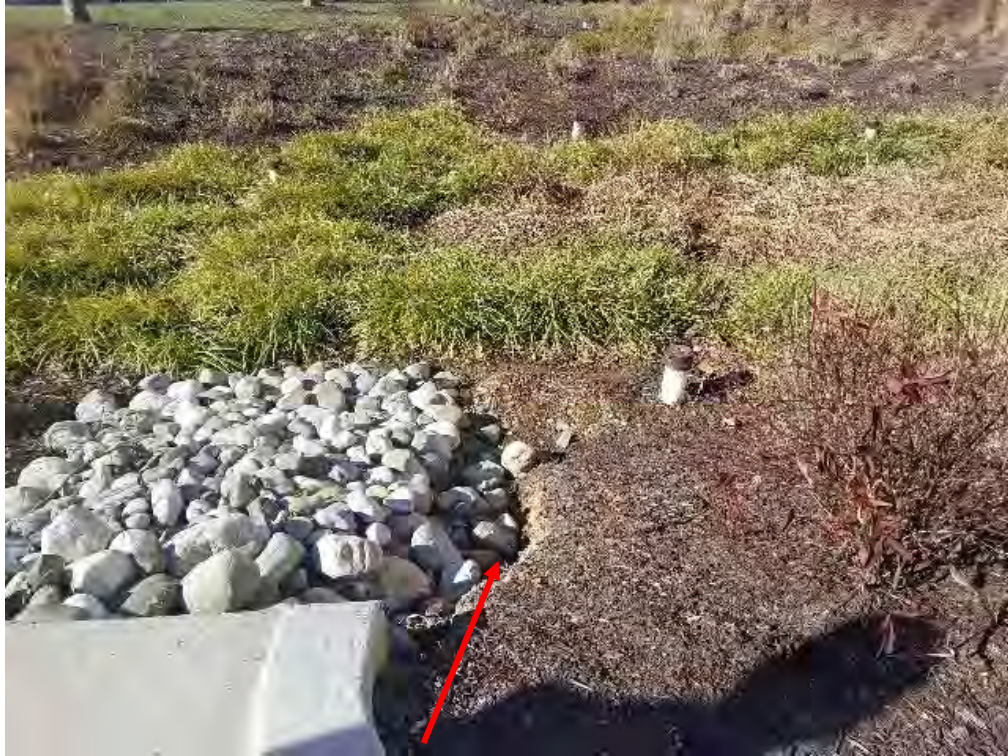
<b>Date of Inspection:</b>	01/15/2019 10:31 AM	<b>Inspector Initials</b>	SAL,JK,CAB
<b>BMP ID</b>	USG19BMP00017	<b>Inspection Firm</b>	MES
<b>BMP Type:</b>	Micro-Bioretenention	<b>Underground BMP?</b>	No
<b>Rating:</b>	B - Functioning, needs minor maintenance	<b>Overall Inspection Comment</b>	Erosion at inflow-curb cut - expand riprap apron and repair erosion, BMP in good condition and functioning as designed

Erosion at Inflow A

The micro-bioretenion is considered functioning but could use minor and routine maintenance. Maintenance recommendations include: Removal of riprap aprons and any debris at the inflows. Repair eroded areas at the inflows and reset rip rap apron using the same stone. Removal of any unplanned and invasive vegetation within the BMP.

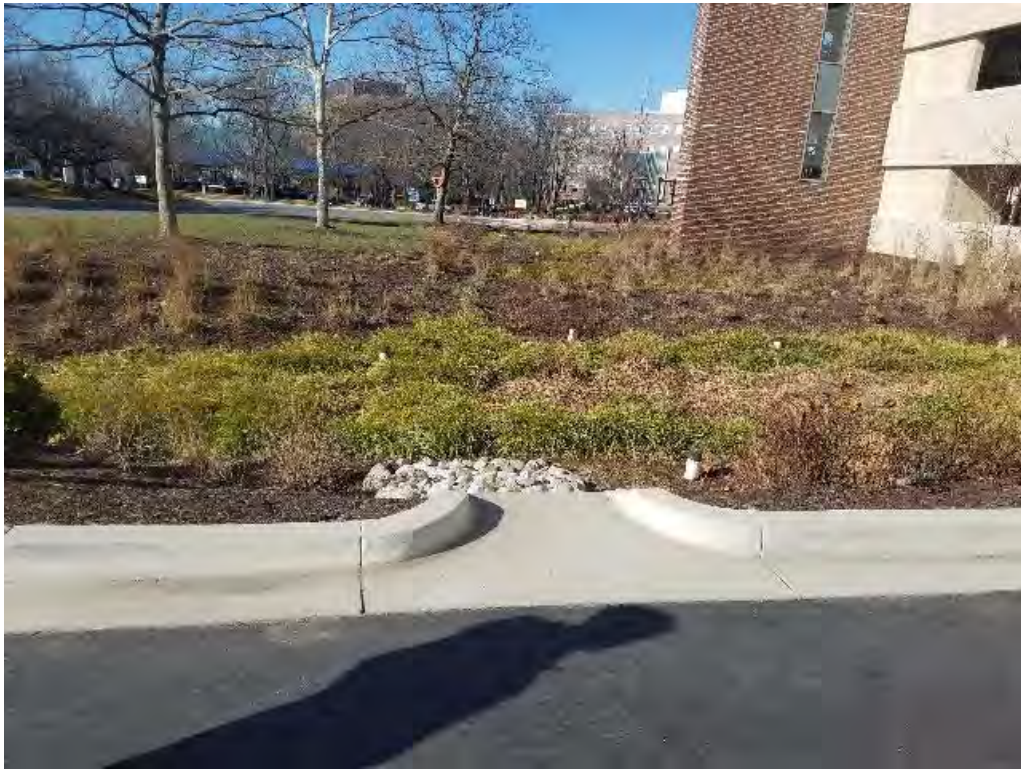
Inflow A, Curb Cut

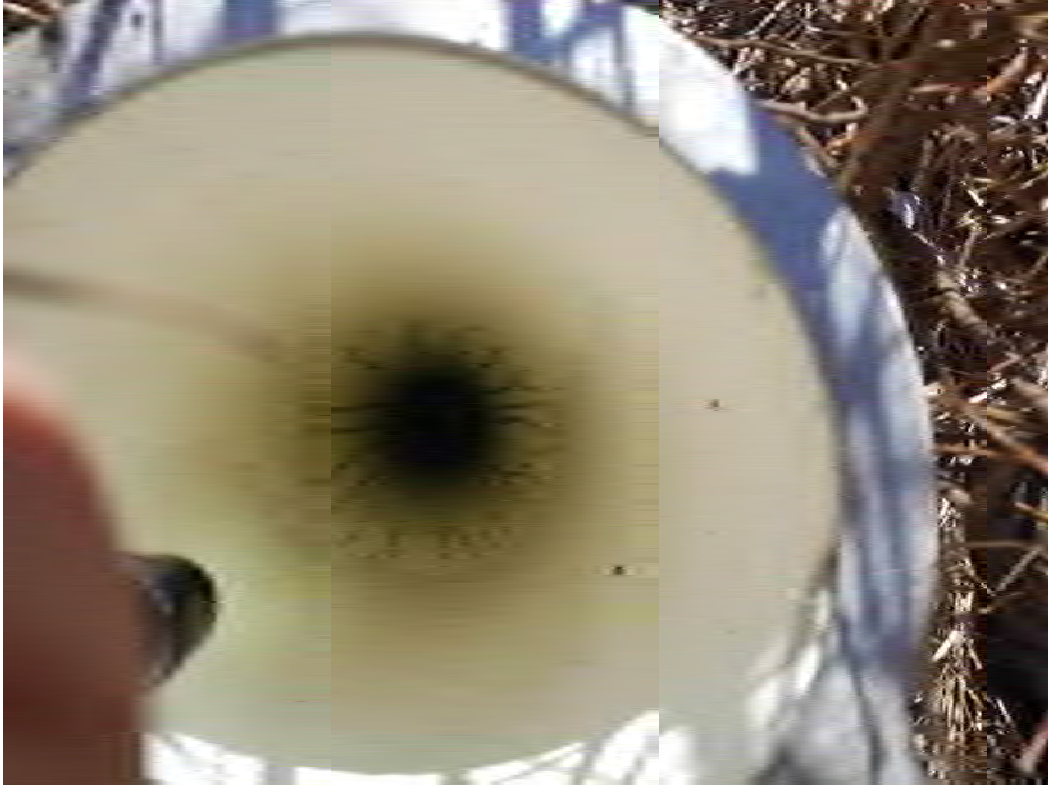
Observation Well - Interior

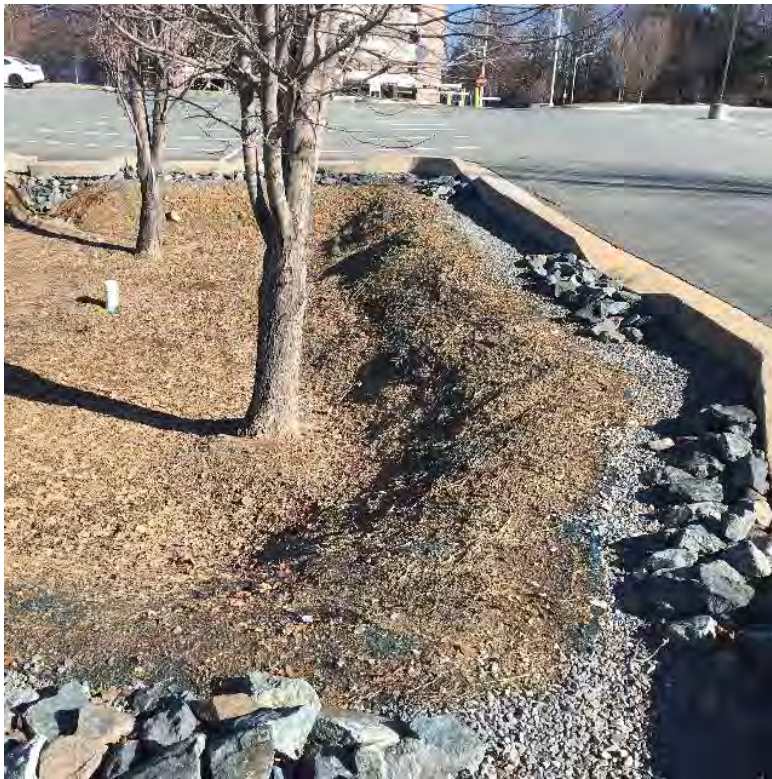
Steep Slope on BMP Embankment, Cleanout

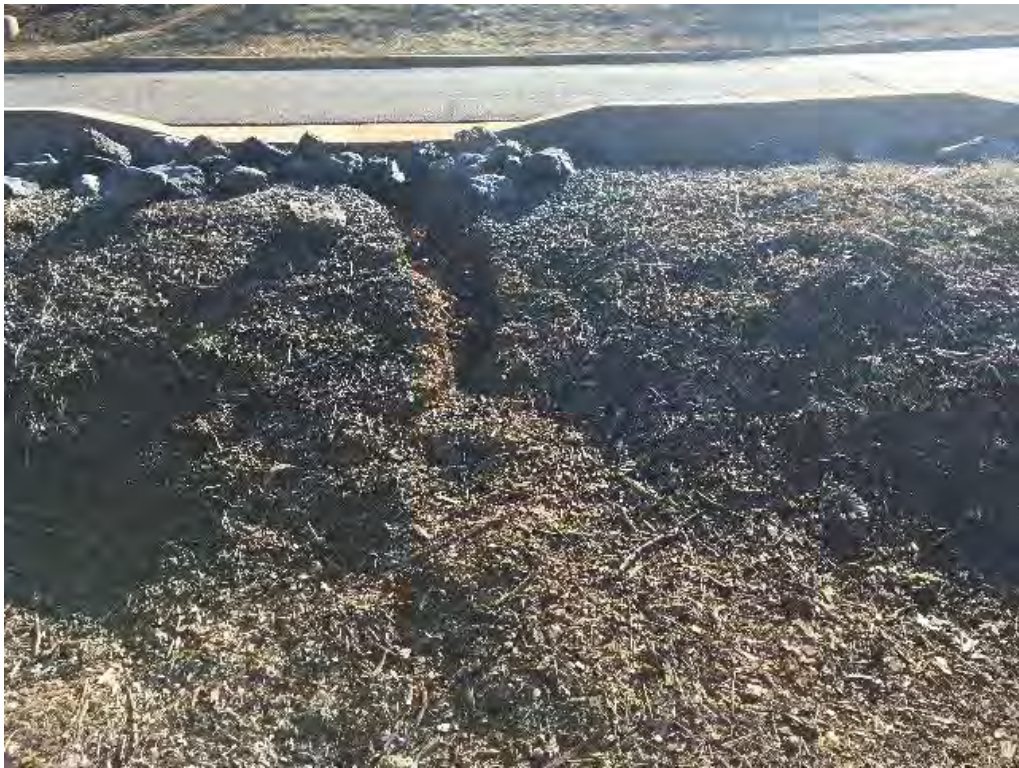
Erosion at Inflow A - Curb Cut - Facing South

The bioretention is considered failing and requires major maintenance to restore to functioning condition. Maintenance recommendations to restore the bioretention to a functioning condition include: Regrade and restore bioretention to design criteria. Replanting of MDE approved bio-wetland plants. MES recommends removing the maple tree and replace with other MDE approved bioretention plants. Restore parking lot curb along perimeter/inflows of the bioretention facility. Perform additional maintenance as directed by project engineer to restore structural integrity of the surrounding parking lot.

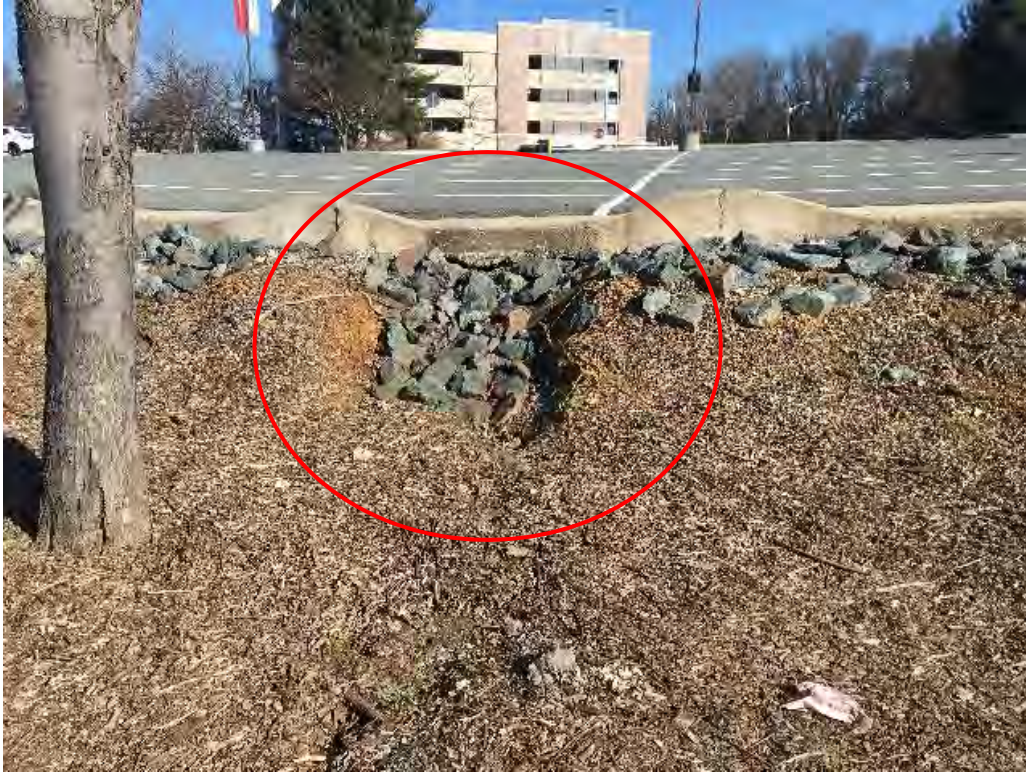
Erosion at Inflow B - Curb Cut - Facing West

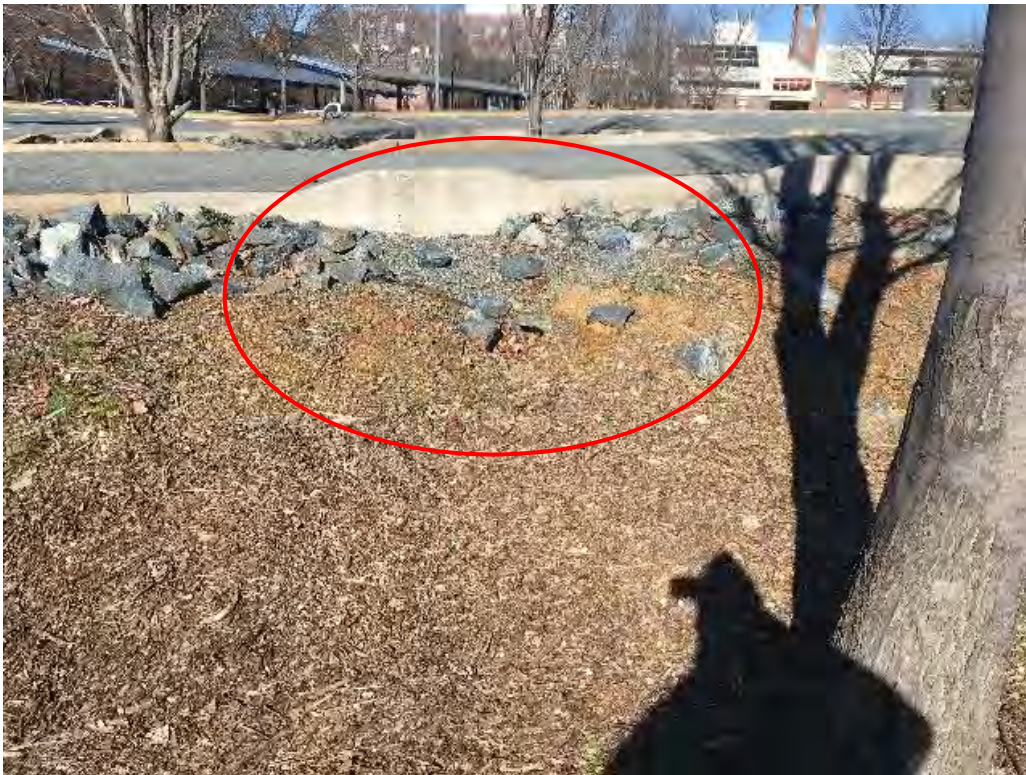
Erosion at Gravel Curtain - Facing North

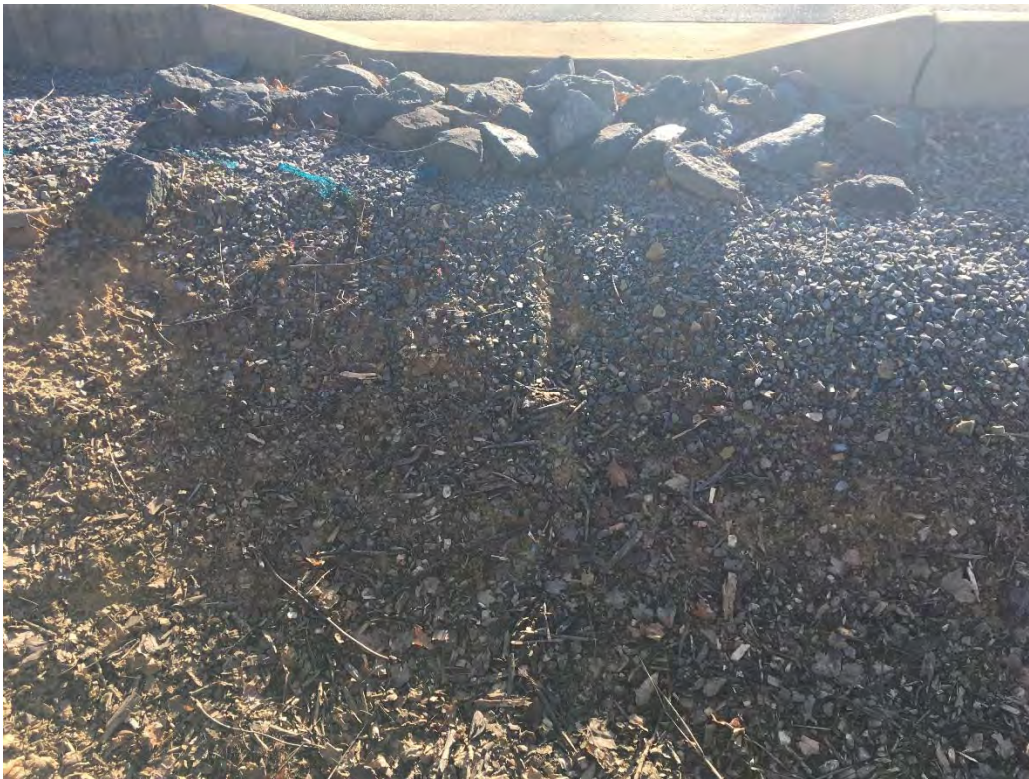
Erosion at inflow and embankment

The bioretention is considered failing and requires major maintenance to restore to functioning condition. Maintenance recommendations to restore the bioretention to a functioning condition include: Regrade and restore bioretention to design criteria. Replanting of MDE approved bio-wetland plants. MES recommends removing the maple tree and replace with other MDE approved bioretention plants. Restore parking lot curb along perimeter/inflows of the bioretention facility. Perform additional maintenance as directed by project engineer to restore structural integrity of the surrounding parking lot.

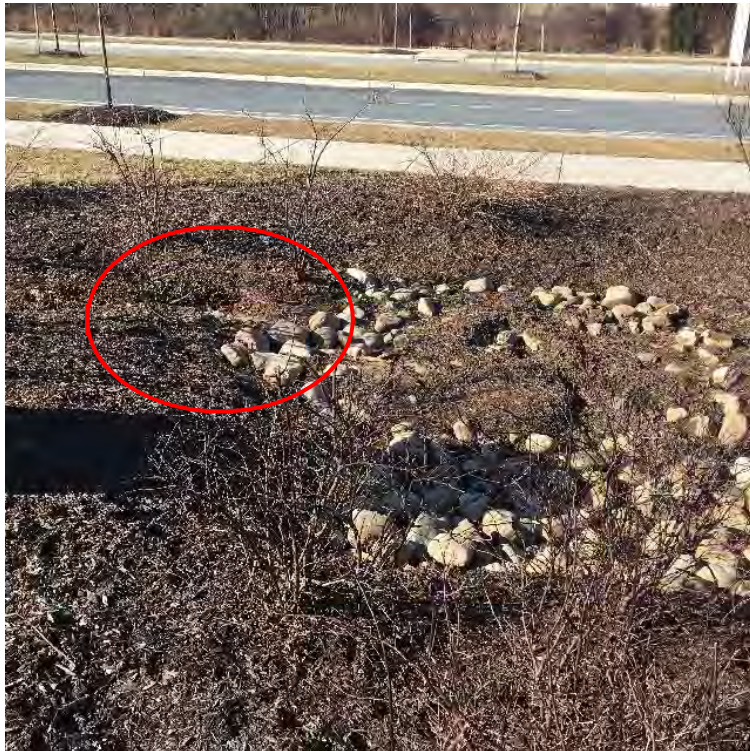
Inflow B - Flow from Sidewalk and planted area, Erosive flow into riprap

The micro-bioretenion is considered functioning but could use minor and routine maintenance. Maintenance recommendations include: Removal of debris, sediment, and unplanned vegetation around the facility and at the inflow. Removal of sediment, and debris at the overflow device. Replace bioretention plants as needed.

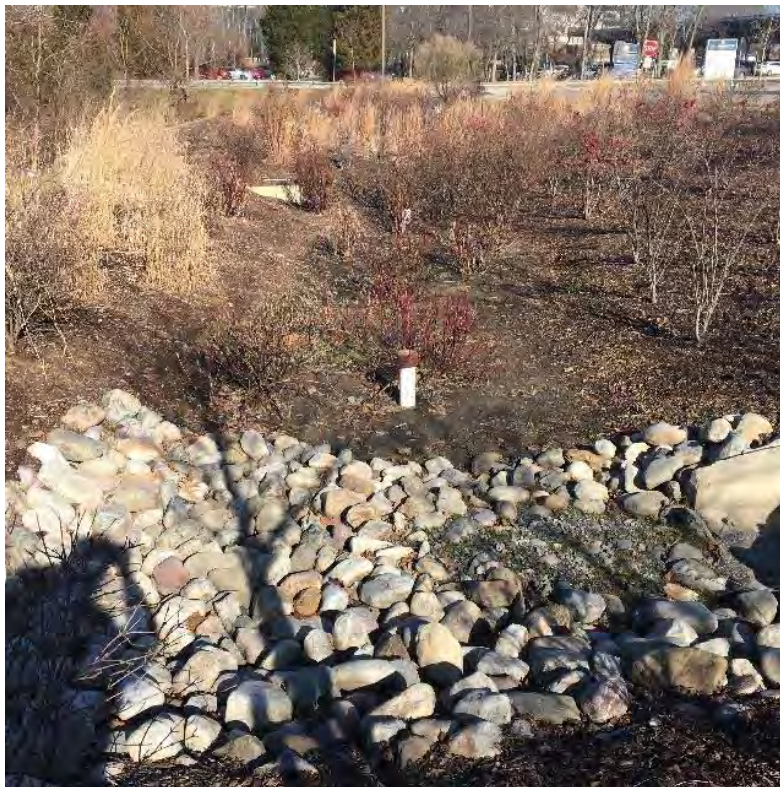
Overall - Facing North

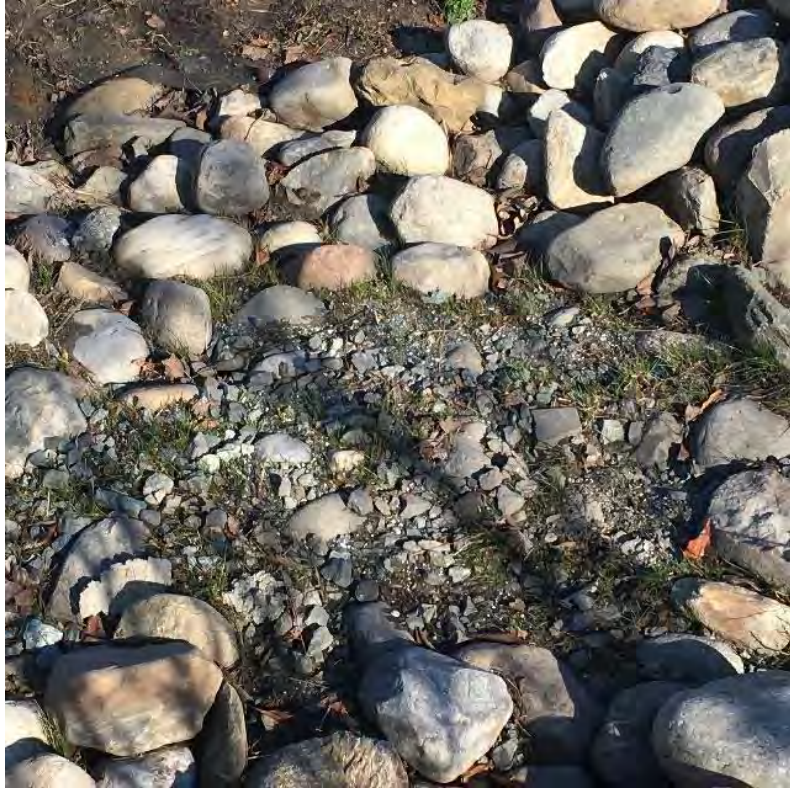
Gravel within Riprap
