University of Maryland, College Park  
National Pollutant Discharge Elimination  
System MS4 Phase II  
FY2019 Annual Report  
General Discharge Permit #13-SF-5501

## **Stormwater Treatment Final Report & Recommendations**

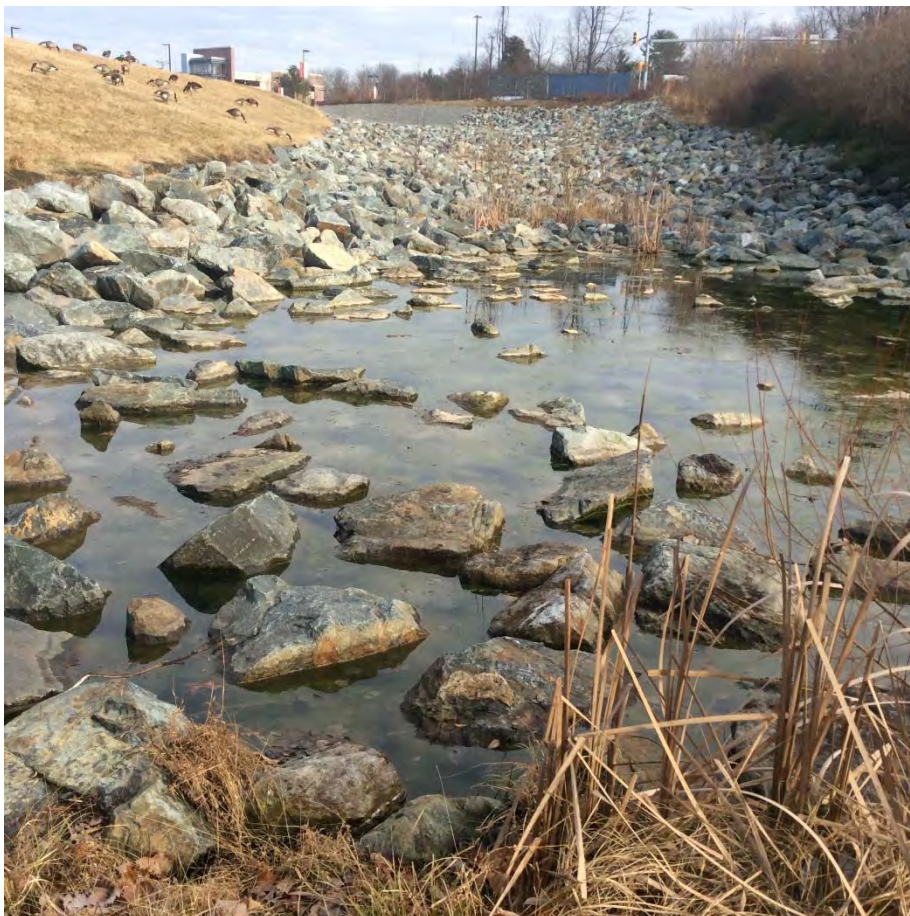
Emergency Spillway, standing water at end of spillway

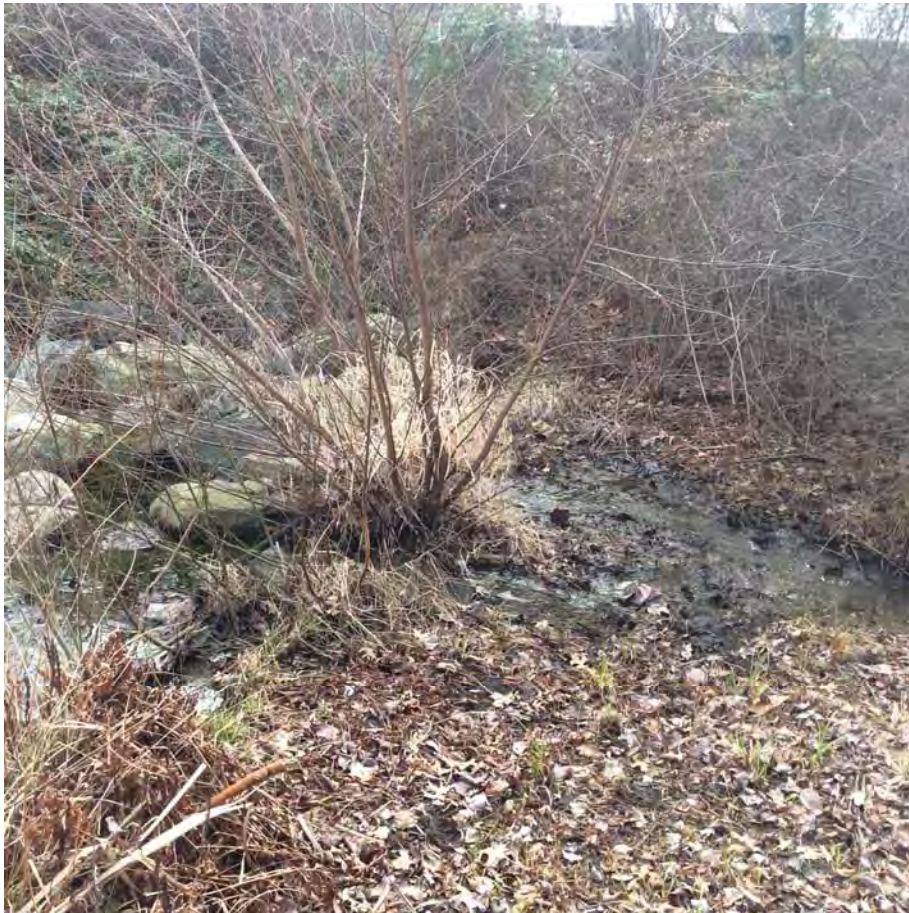
Tree Growth at Outflow of Emergency Spillway

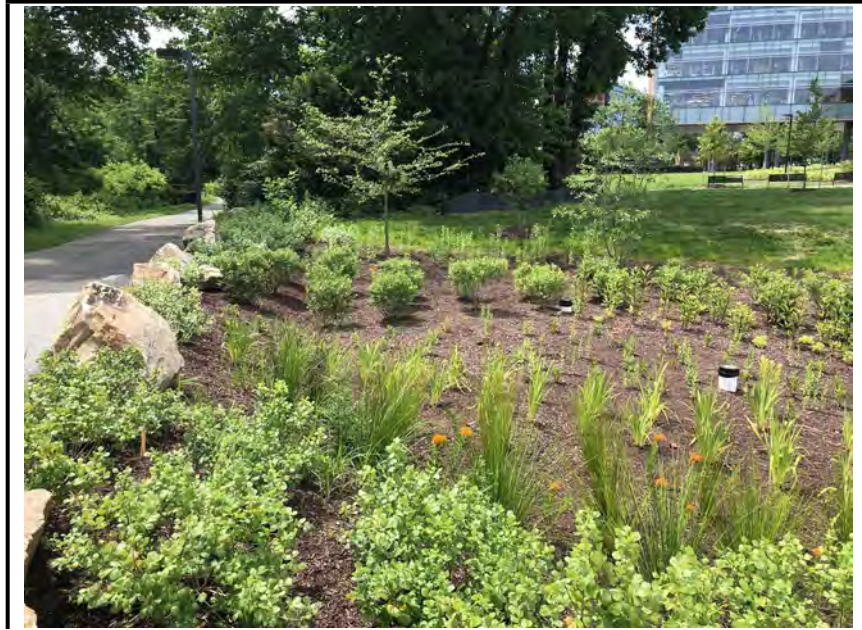
This facility is in good condition. The vegetation is well established. There are some signs of erosion visible on the side slopes of the facility. The facility appears to be functional.

**Photo #1:** View into the facility.

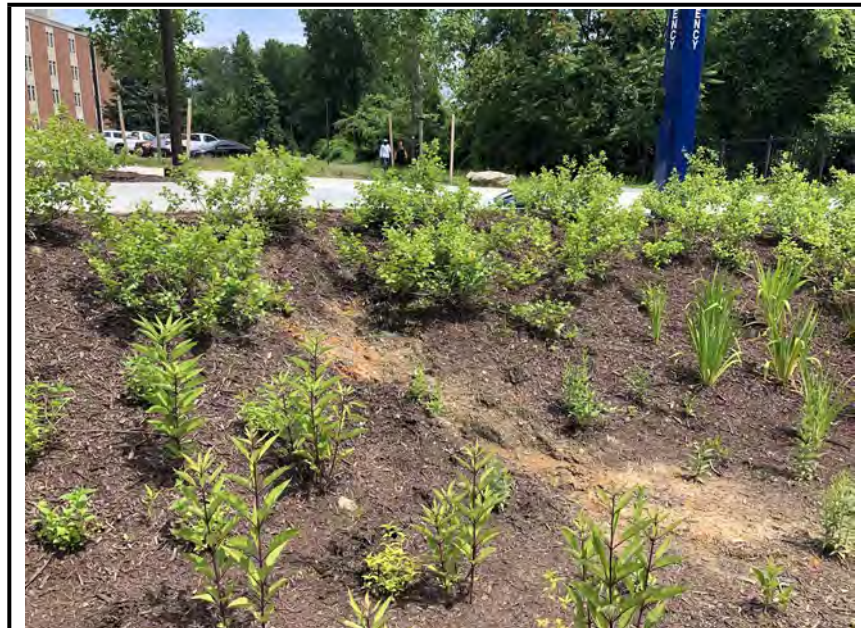
**Photo #2:** Erosion of the side slopes.

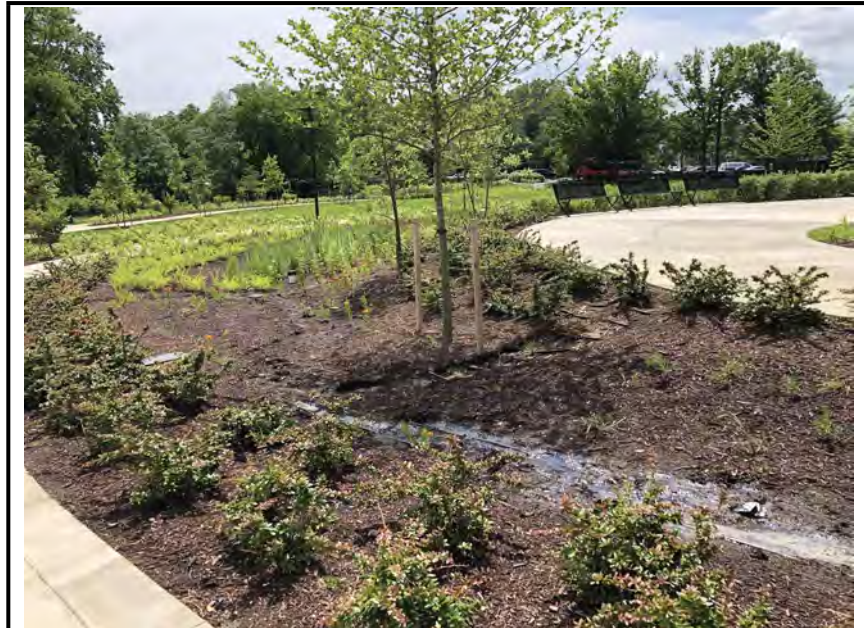
This facility is in good condition. The side slopes and inflow channels are eroded. Irrigation lines should be removed from facility as they may cause further erosion.

**Photo #1:** Erosion and standing water inside the inflow swale.

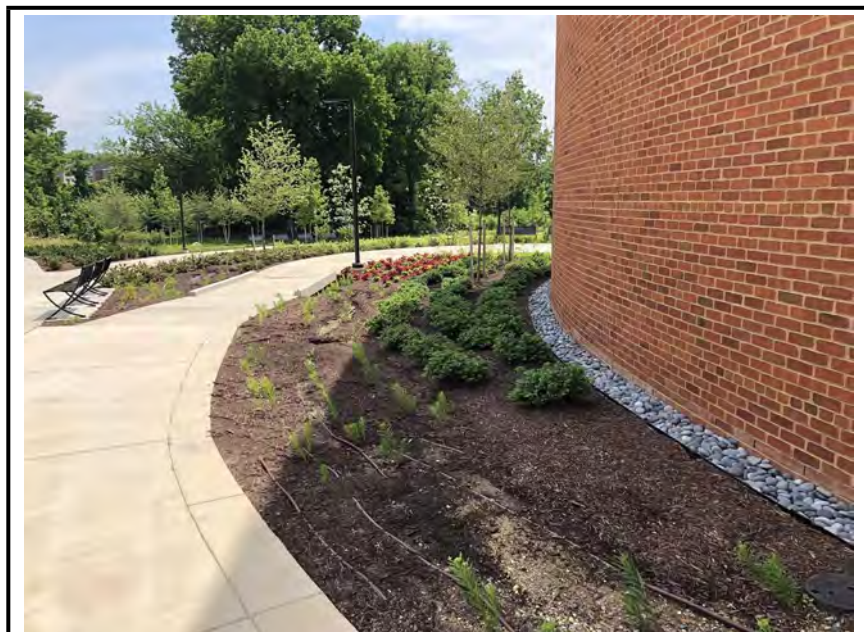
**Photo #2:** Exposed irrigation lines in the inflow swale.

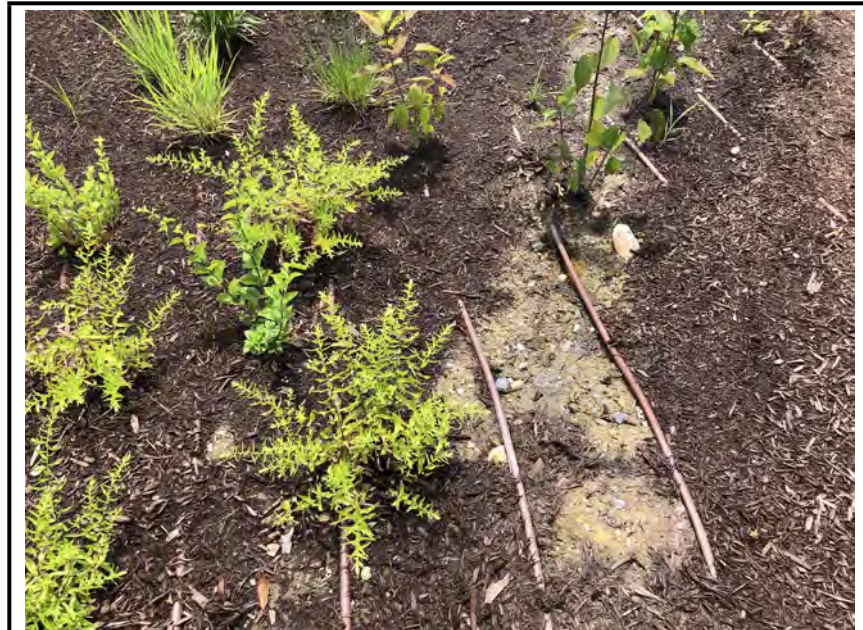
**Photo #3:** Exposed irrigation lines inside the facility.

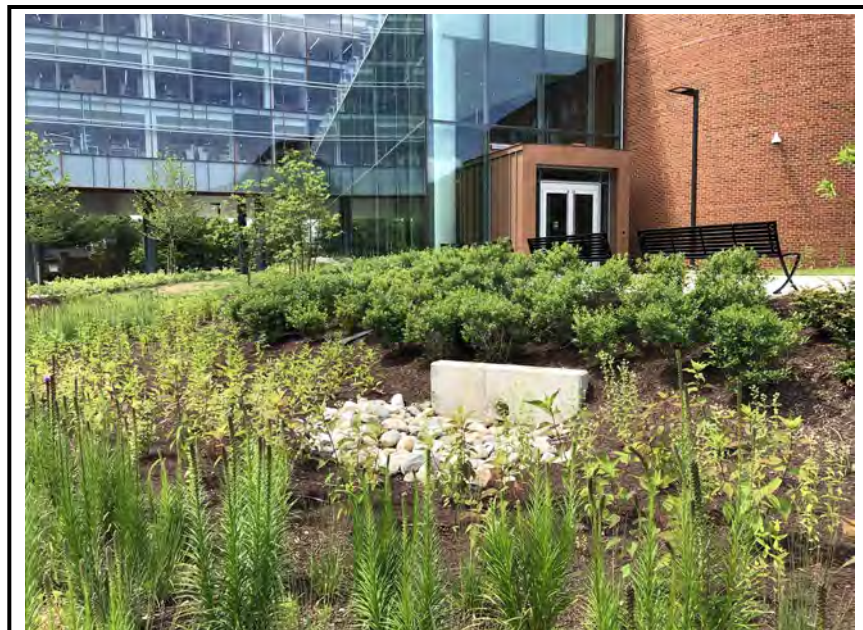
**Photo #4:** Inflow headwall that is lower than the filter bed area.

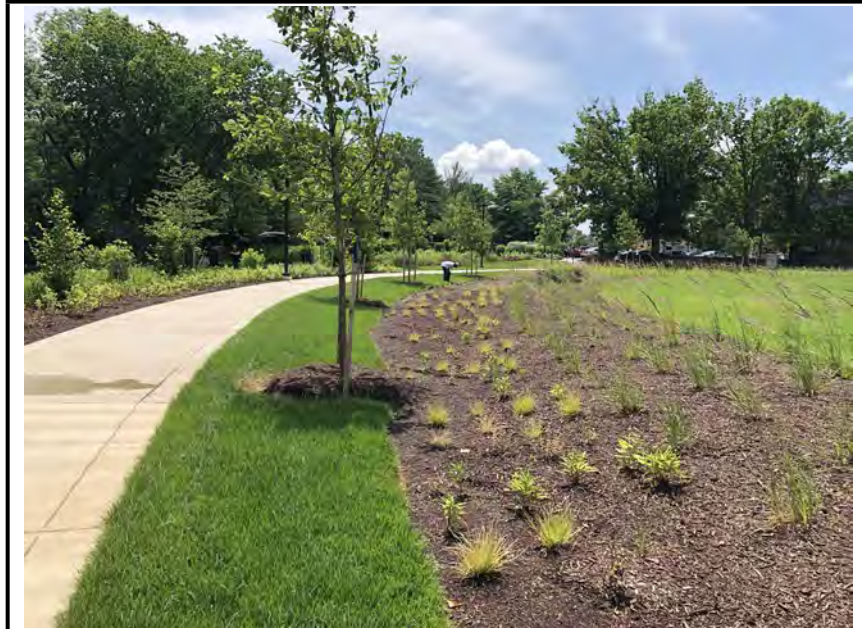
This facility is in poor condition. The waterproofing at weir walls is not secured, and the weirs do not extend fully to the edges of the swale which will allow water to bypass them. At the time of inspection, the irrigation system was backed up and causing standing water to pool in the facility. Irrigation lines are exposed throughout the facility.

Photo #1: View into the facility.

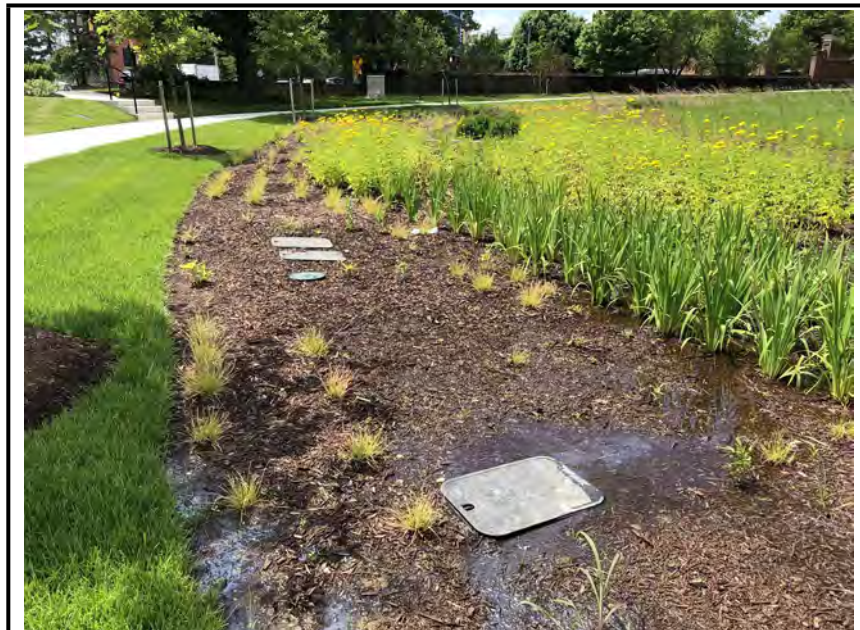
Photo #2: The effects of the backed-up irrigation system. Oil sheen is visible on water surface.

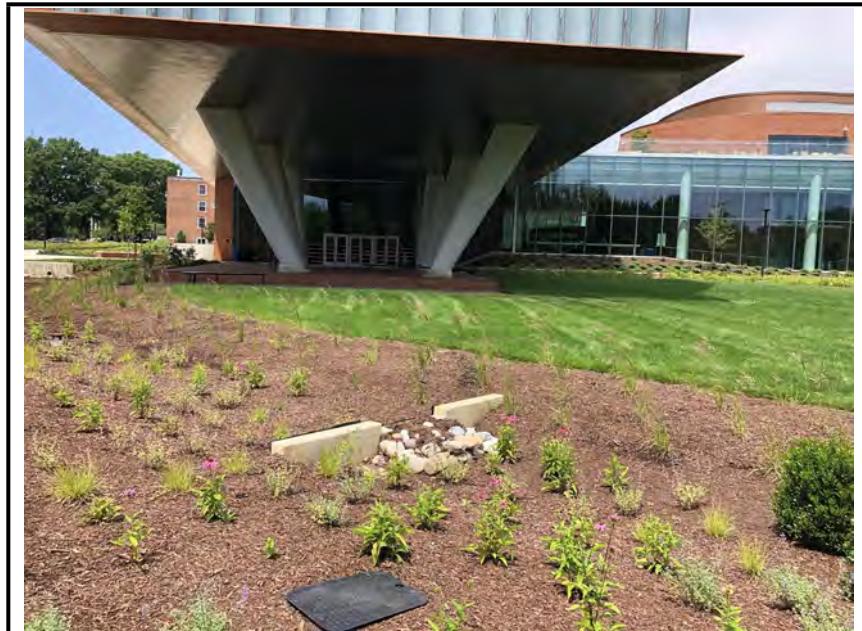
**Photo #3:** One of the weir walls. Notice the edges of the walls that do not tie not the sides of the swale.

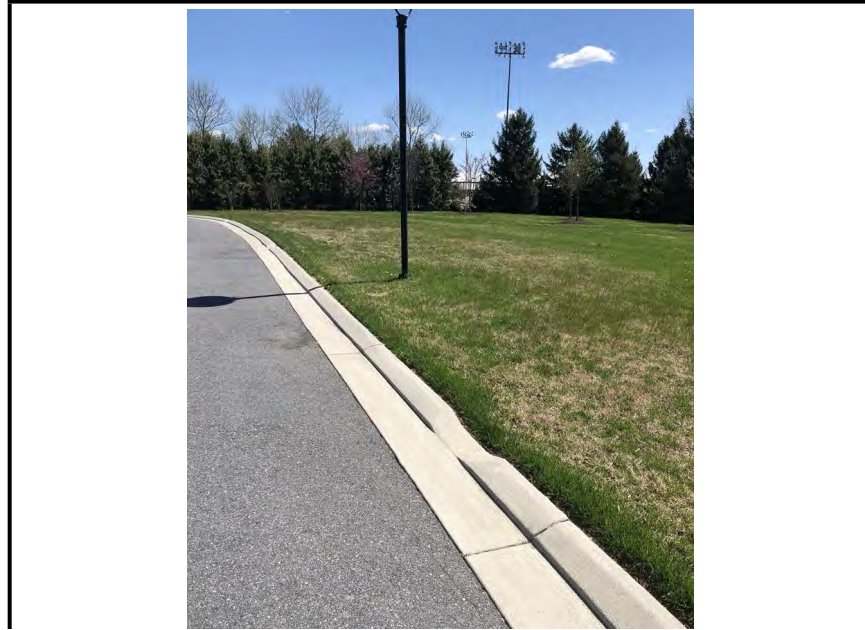
This BMP is sheet flow to a conservation area and is a non-structural practice. The grass adjacent to the parking lot is in good condition. The design and as built plans do not show the drainage areas getting to each curb cut. Curb cuts are not a normal practice for non-rooftop disconnect.

**Photo #1:** A section of the non-rooftop disconnect area.

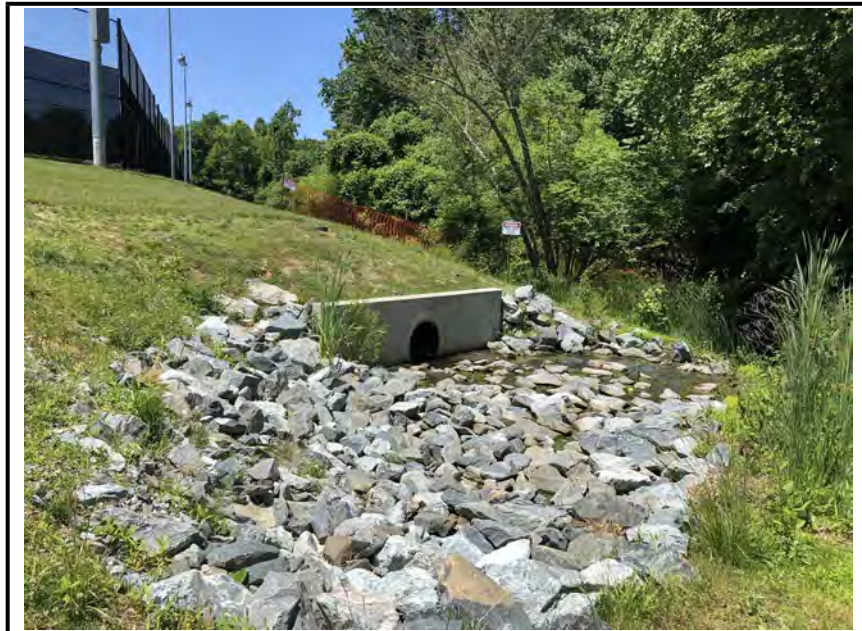
Overall, the facility is in poor condition. A combination of sedimentation and erosion has left the water in the facility stagnant. Snakes have infested the facility. The questionable color of the water in the forebay suggests compromised water quality upstream.

Photo #1: The inflow structure and pretreatment area.

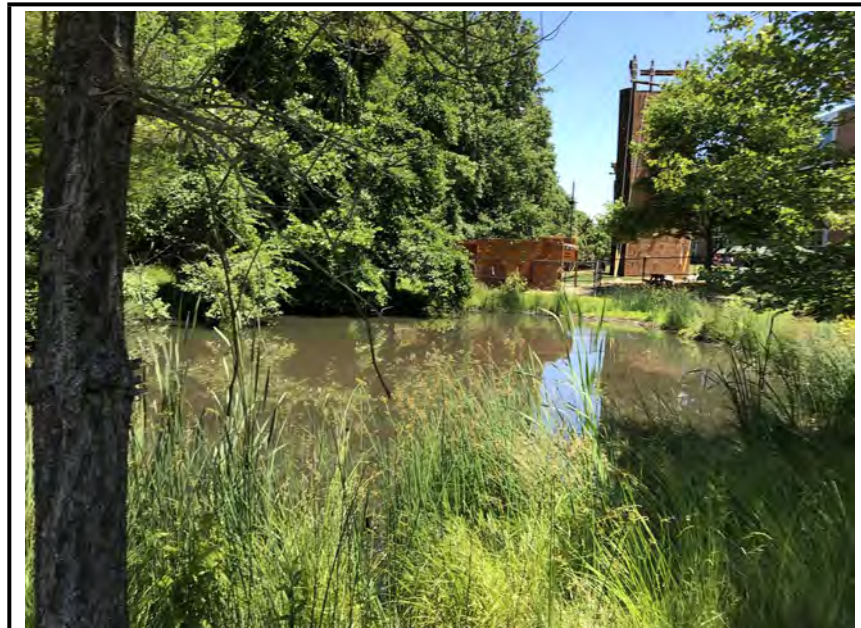
Photo #2: View into the facility.

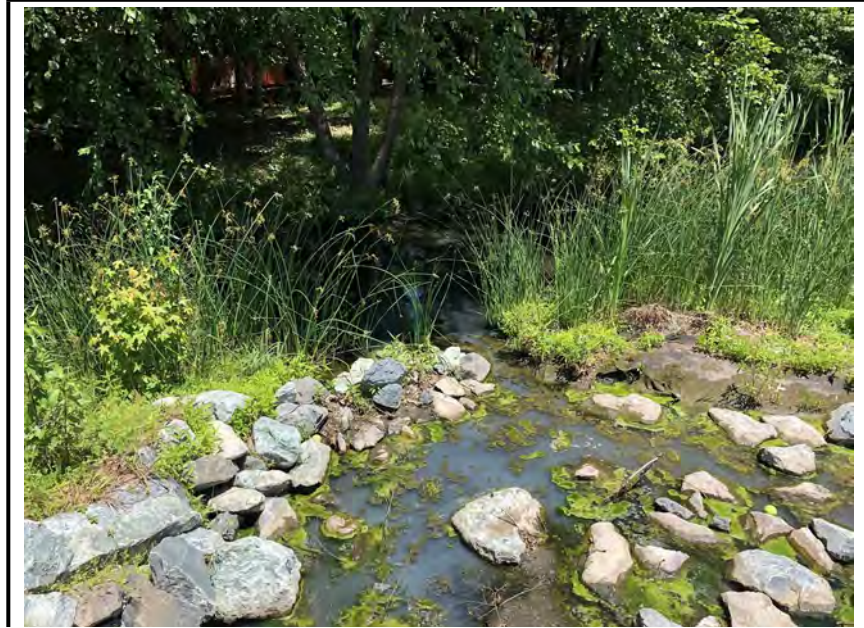
**Photo #3:** Pretreatment area with discolored water. Multiple snakes were spotted here.

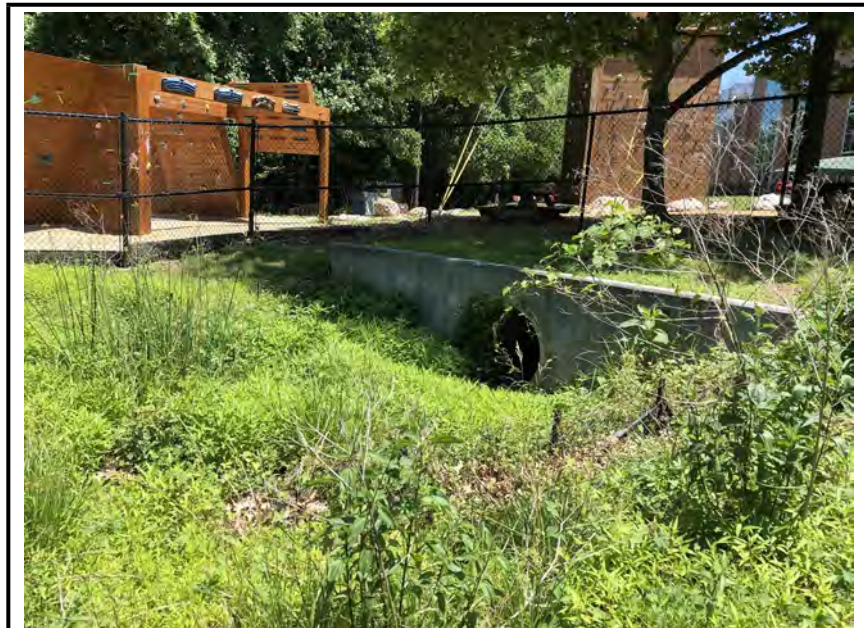
**Photo #4:** The outfall structure.

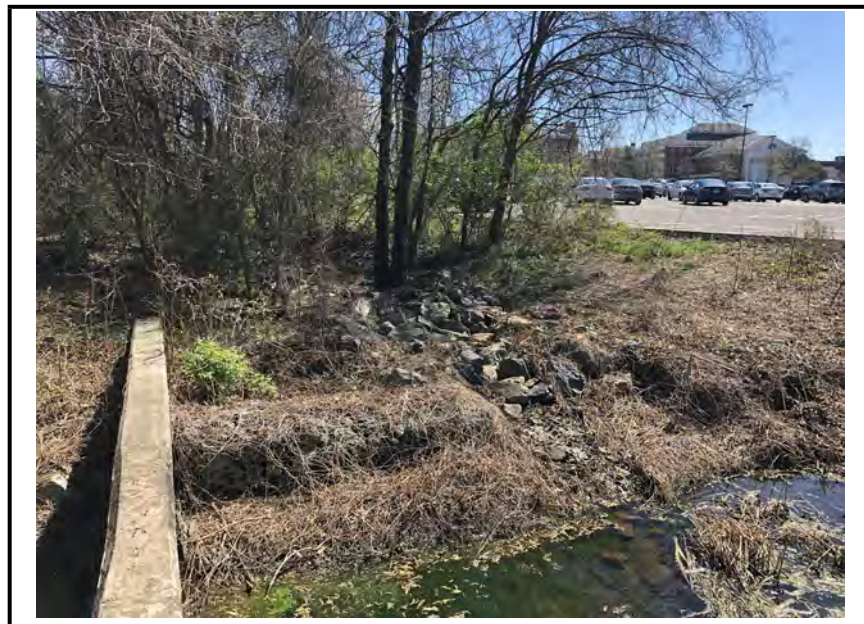
**Photo #2:** Flowsplitter, channel entering flowsplitter.

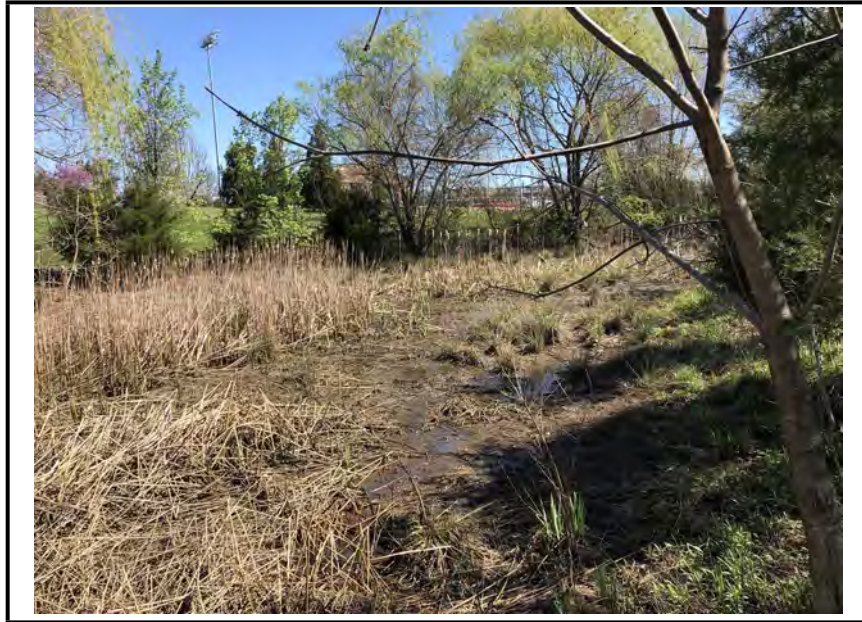
Photo #5: Pretreatment area.

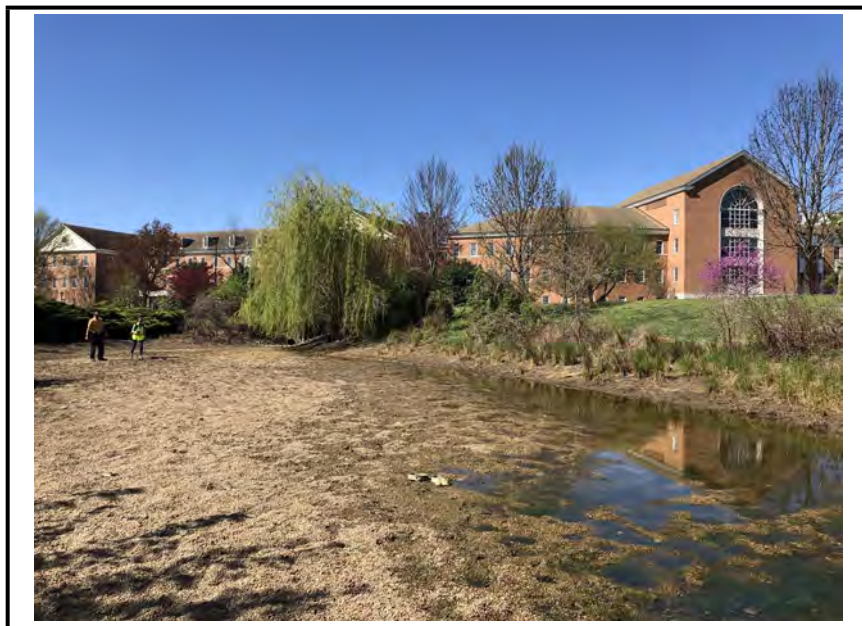
**Photo #10:** Sand filter area, ponding shown.

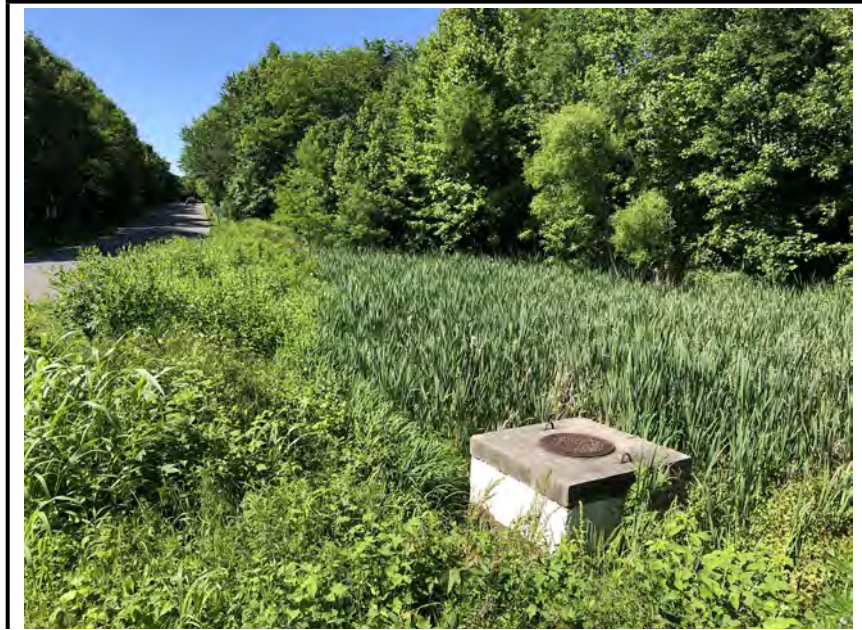
This facility is in poor condition. It is overgrown and full of cattails. The pond appears to be dry at the bottom, suggesting that the facility is not functioning properly.

**Photo #1:** View into the facility. Filter area is completely covered with cattails.

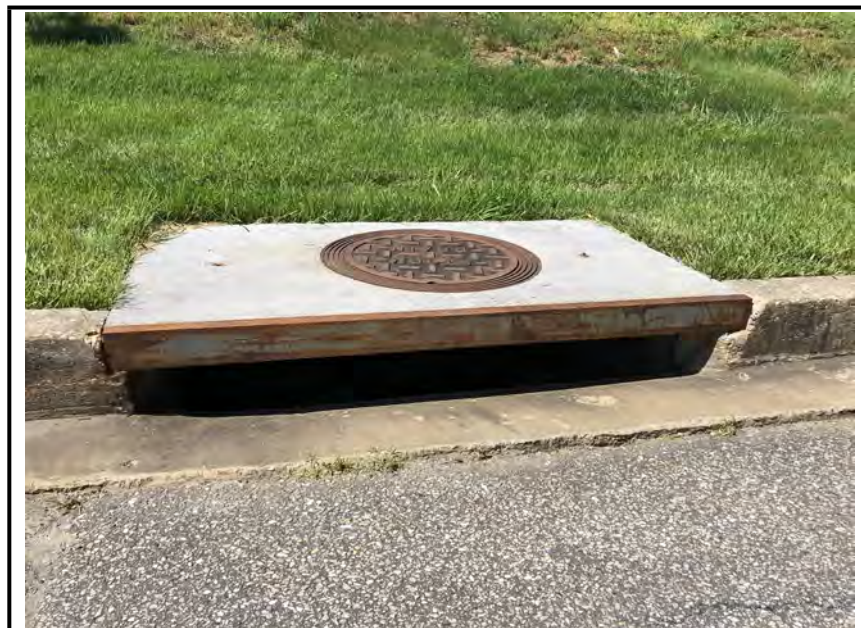
**Photo #2:** The curb inlet structure that leads into the facility.

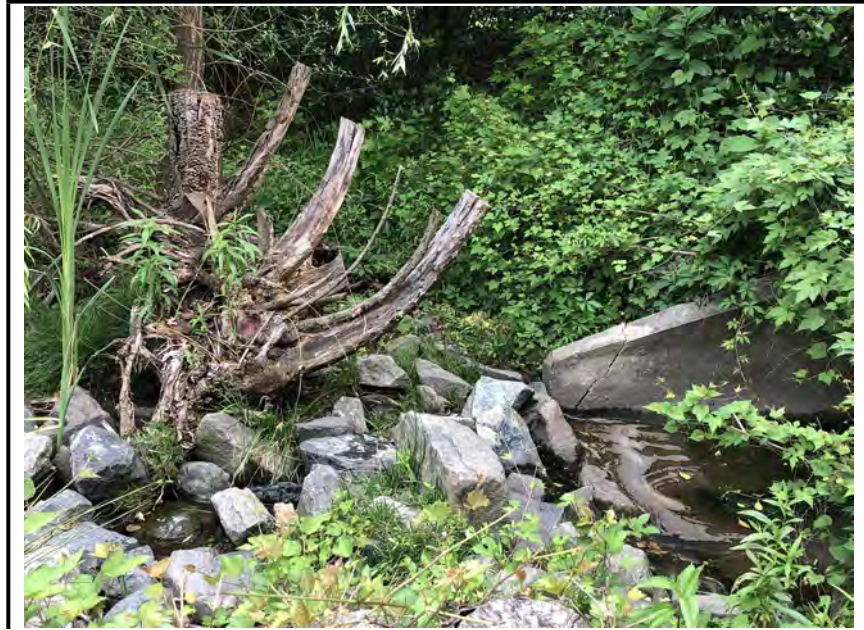
**Photo #3:** Dead tree stump in front of the culvert inflow point.

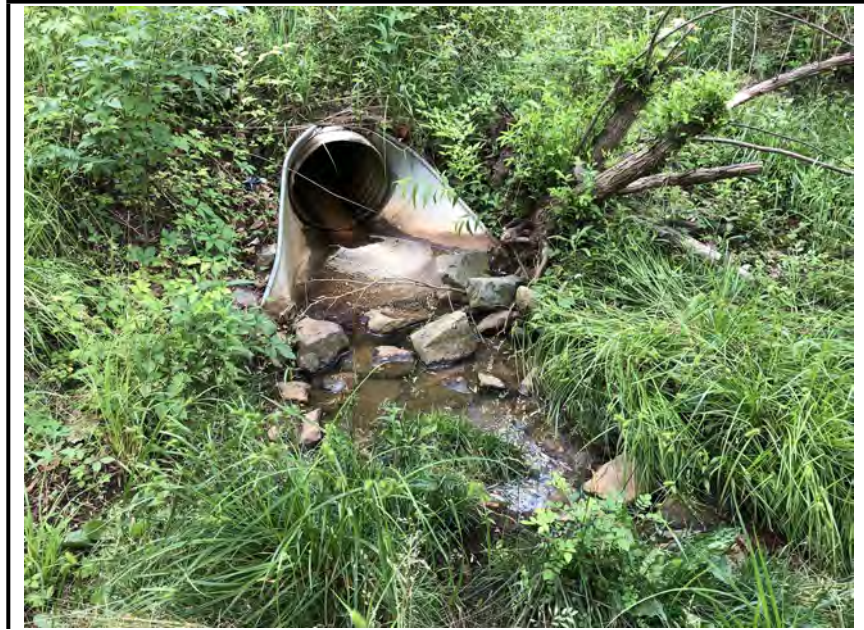
**Photo #5:** The second inflow culvert.

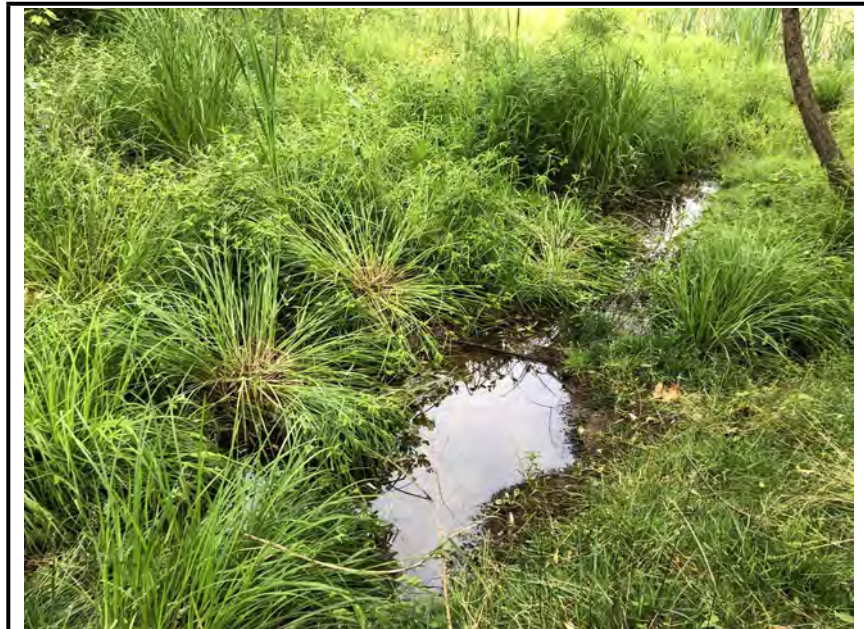
**Photo #6:** Inflow channel that lacks riprap to protect from erosion.

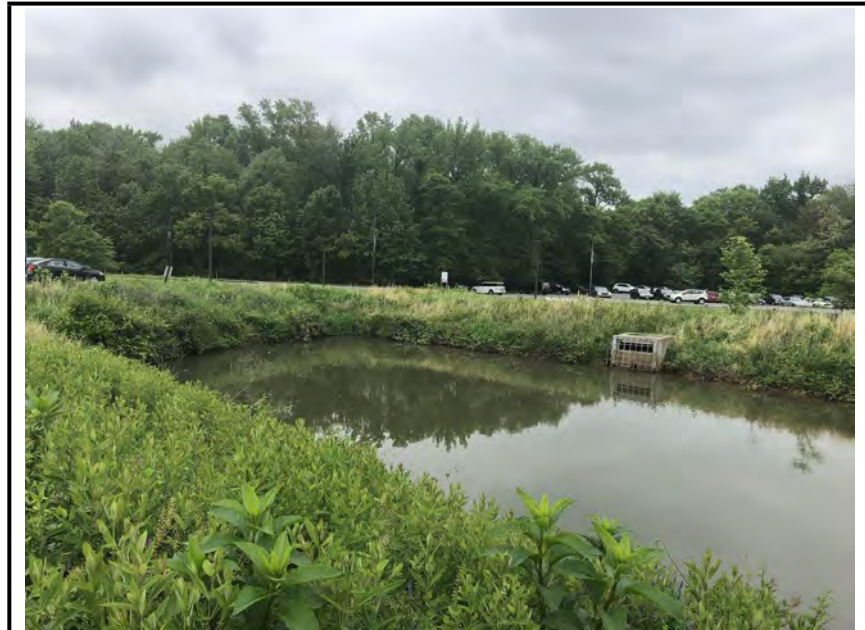
This facility is in good condition. The vegetation should be maintained, and there is trash present in the facility.

**Photo #1:** View into the facility. Outfall structure visible. Water is below the orifice.

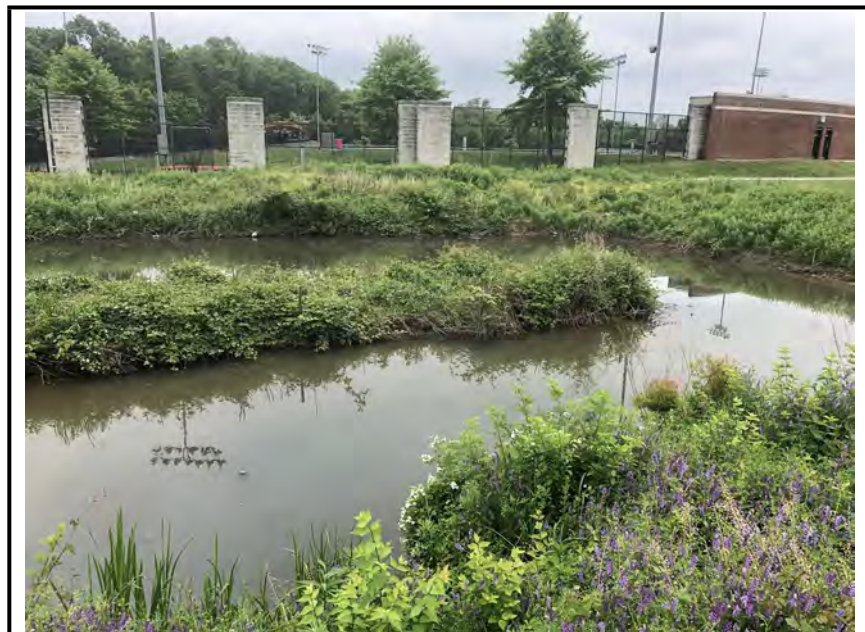
**Photo #2:** Possible forebay area. No weir is visible.

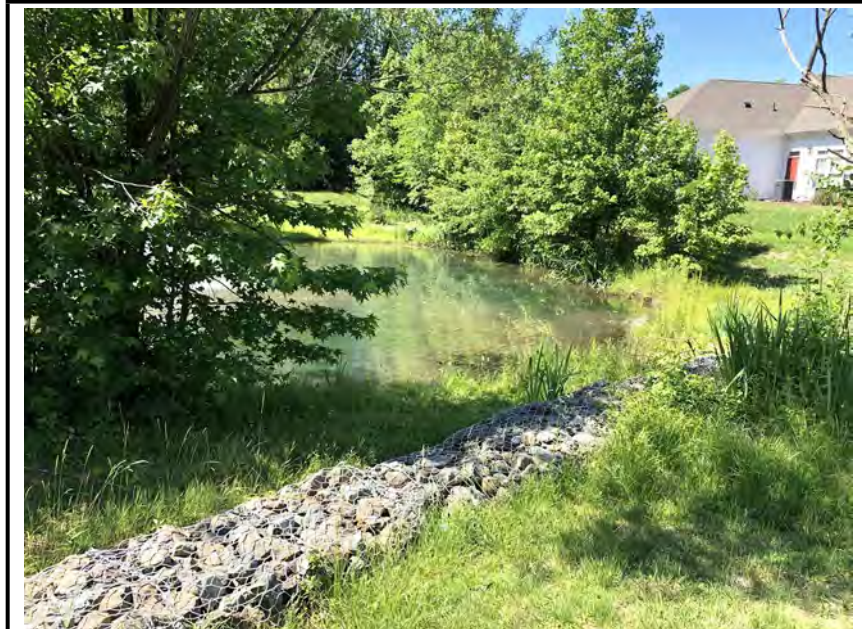
This facility is in good condition. The vegetation is well established and should continue to be landscaped. The fountain in the middle of the facility does not appear to affect its functionality.

**Photo #1:** The gabion weir that separates the forebay from the facility.

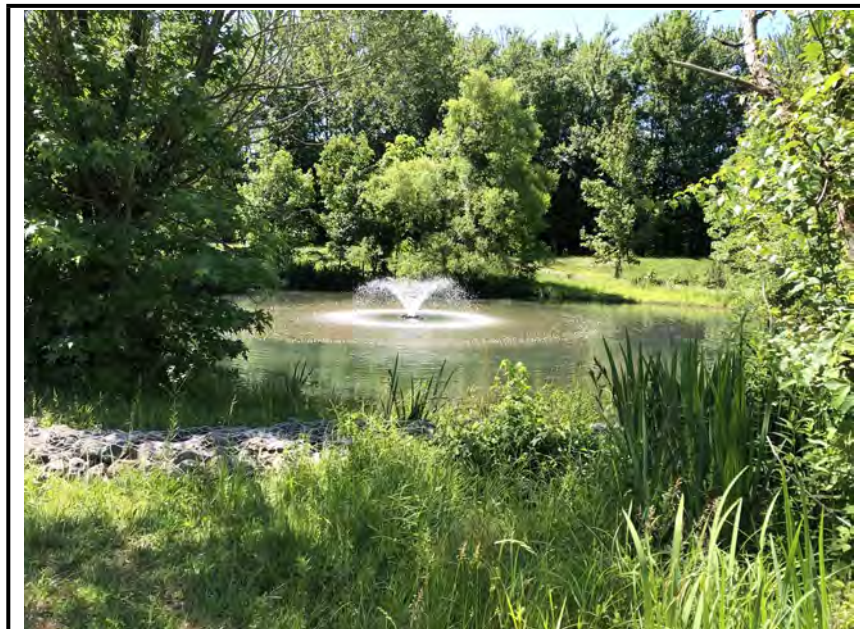
**Photo #2:** View into the facility.

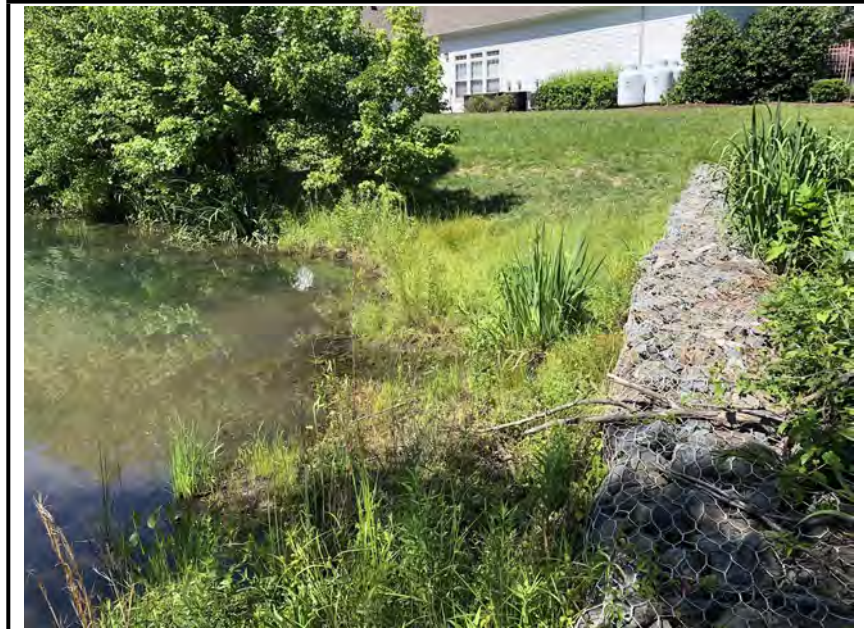
**Photo #3:** The gabion weir that separates the forebay from the facility.

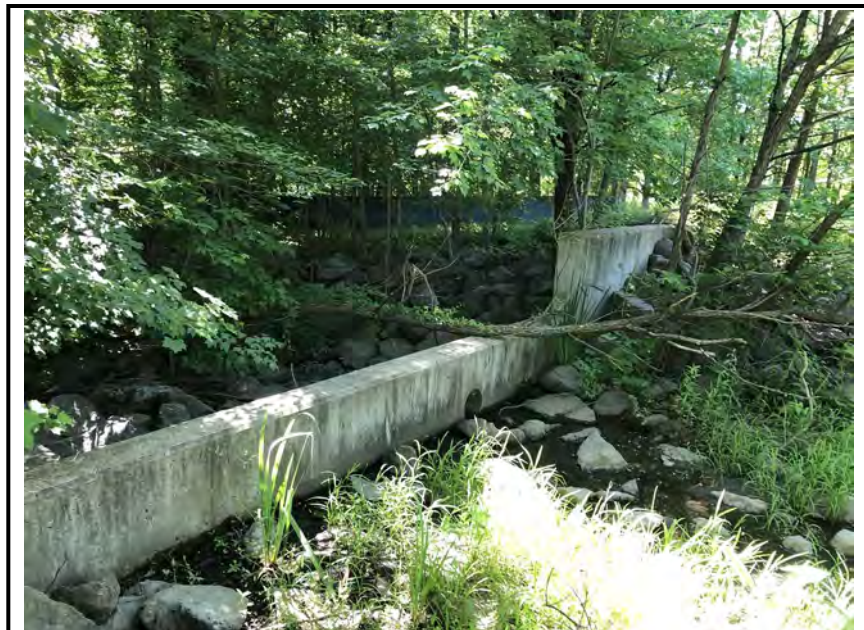
**Photo #4:** The outlet structure headwall.

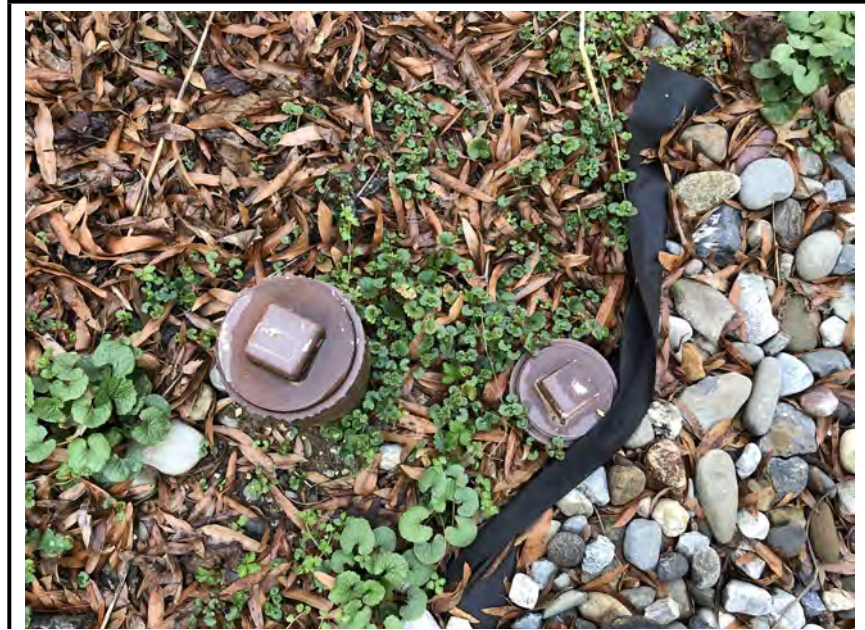
Runoff enters the facility through sheet flow and stone inflow paths. The geotextile fabric on the inflow paths is exposed and coming loose.

**Photo #3:** Exposed geotextile beneath stone inflow paths.

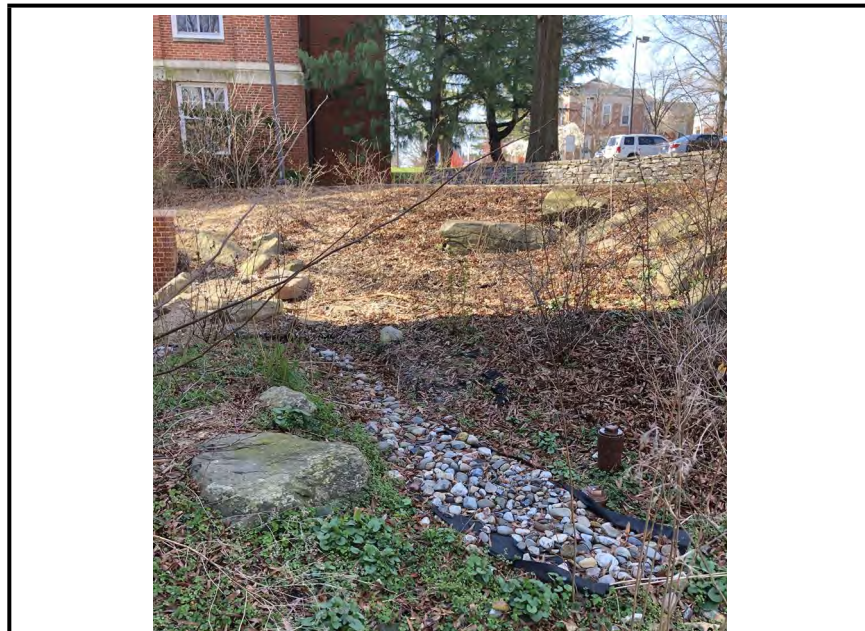
**Photo #4:** Stone inflow path into the facility.

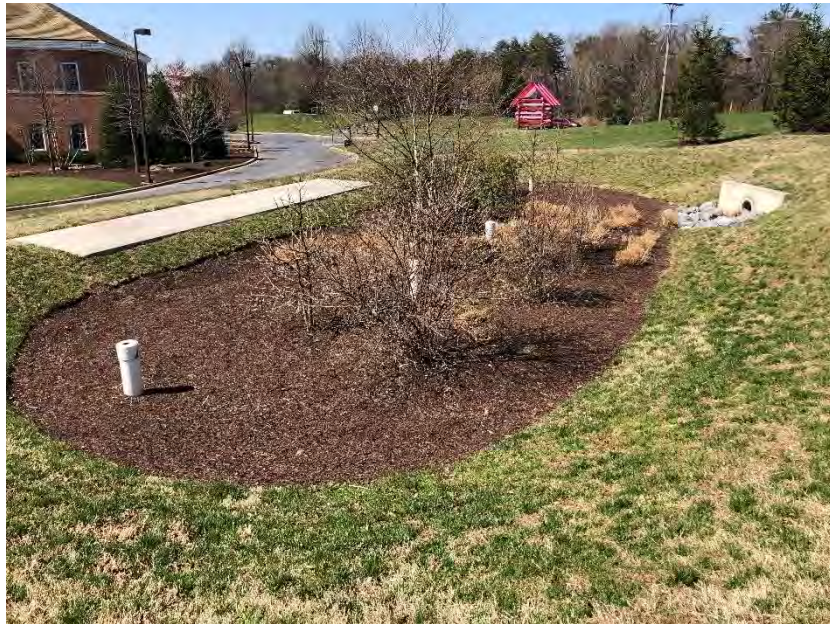
The facility is in good condition. The vegetation and mulch appear to be maintained, and the facility appears functional. One cleanout is broken.

Photo #1: View from above the facility.

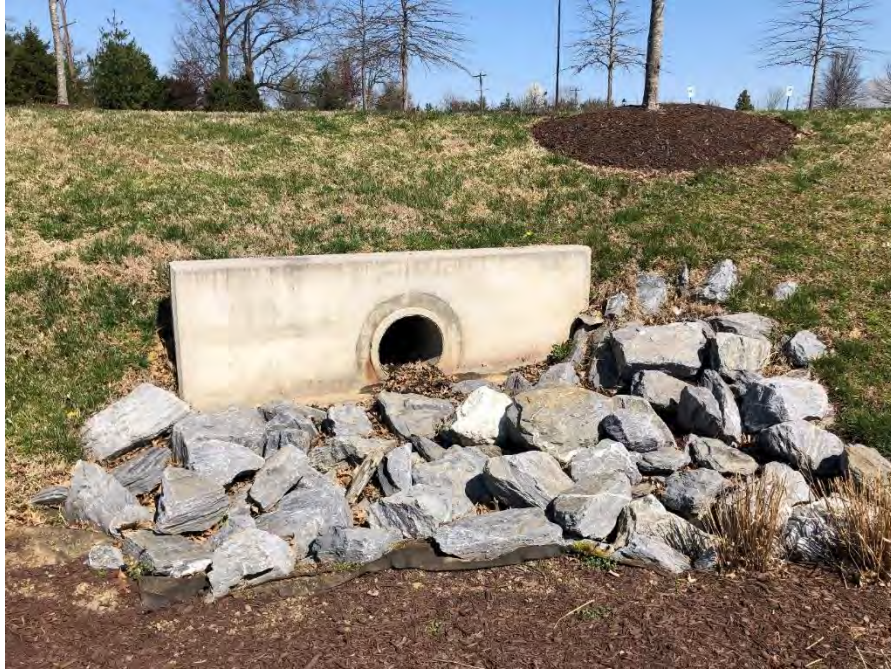
**Photo #3:** Inflow culvert into the facility.

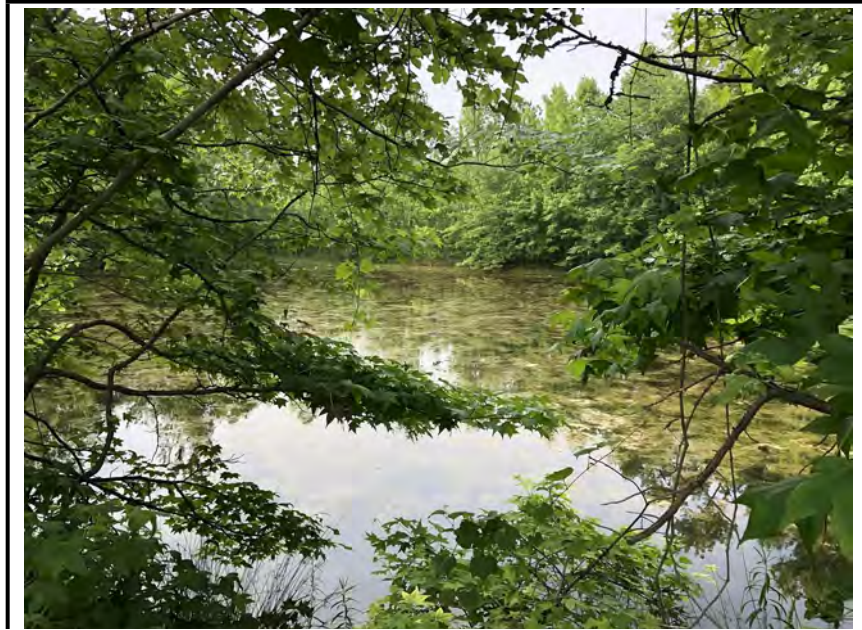
Overall the BMP is in poor condition. The water quality is poor, and there is trash and algae all over the facility. The facility is completely fenced in, which likely makes routine maintenance difficult to accomplish.

**Photo #1:** View into the facility.

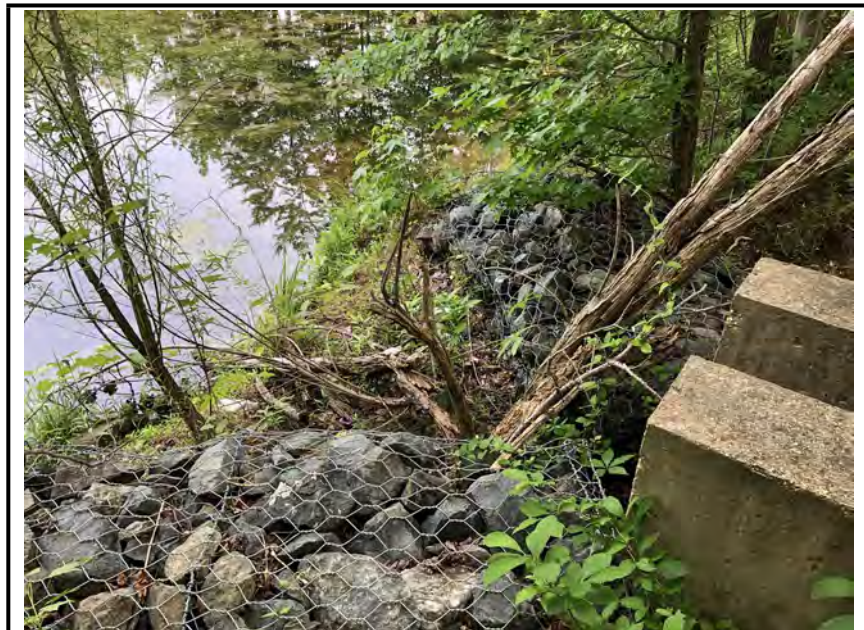
Water exits the facility through a concrete, v-notched weir. The weir is filled with debris but appears to be in functional condition.

**Photo #4:** The v-notched weir that leads to the facility outfall.

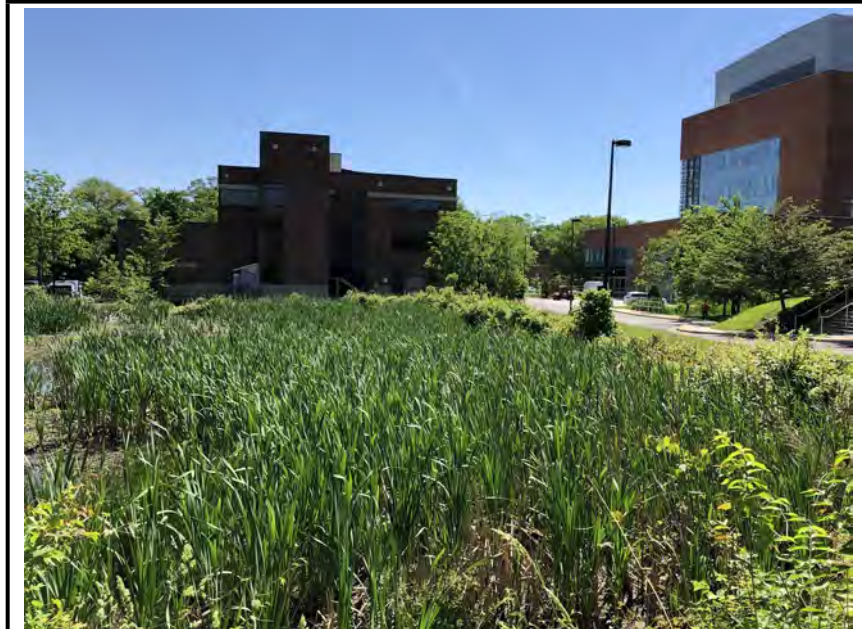
Overall the facility is in poor condition. The pond is almost completely full of cattails, and none of the vegetation on the side slopes have been maintained. There is heavy sedimentation and silt

**Photo #1:** View into the facility from the outfall.

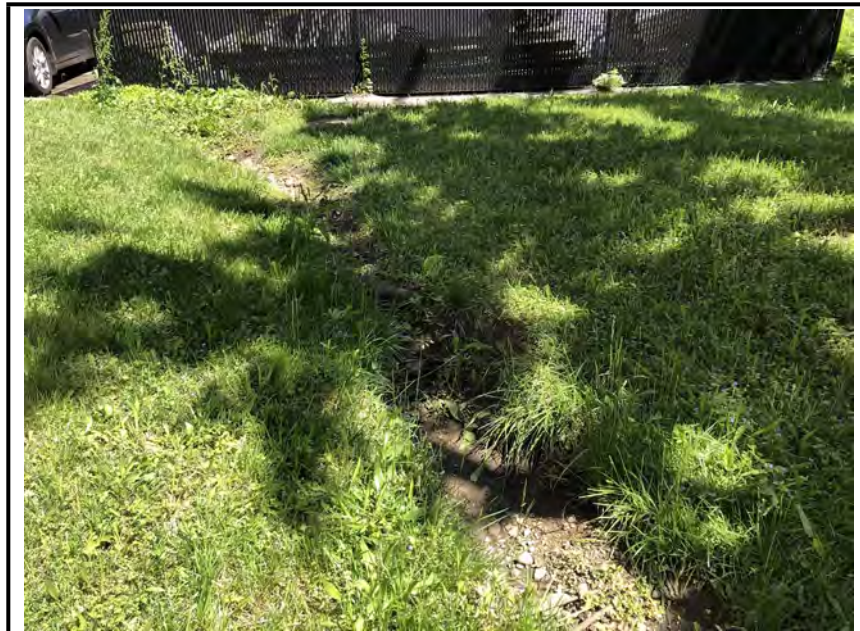
**Photo #2:** Erosional gully that leads into the facility inlet.

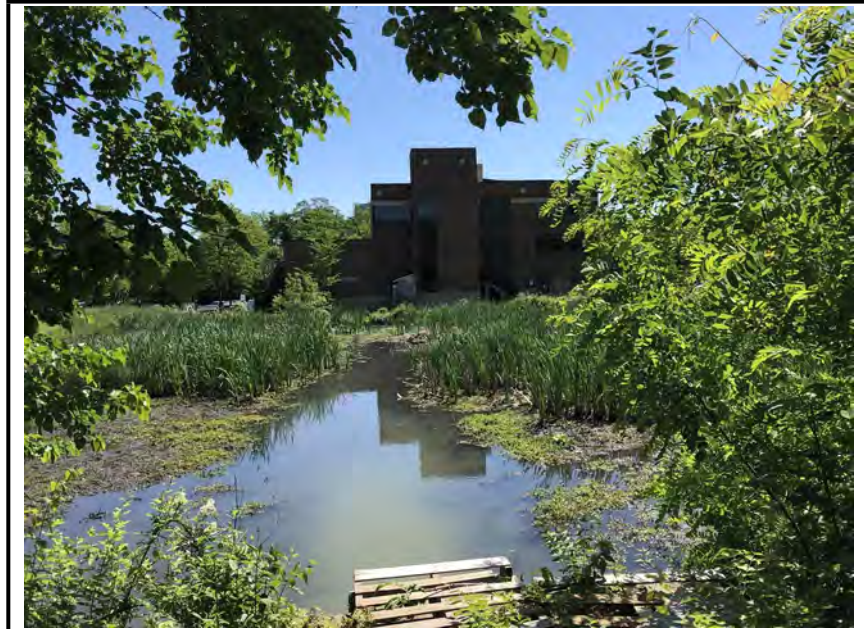
**Photo #3:** View into the facility from the inlet point.
