University of Maryland, College Park  
National Pollutant Discharge Elimination  
System MS4 Phase II  
FY2019 Annual Report  
General Discharge Permit #13-SF-5501

## **Stormwater Treatment Final Report & Recommendations**

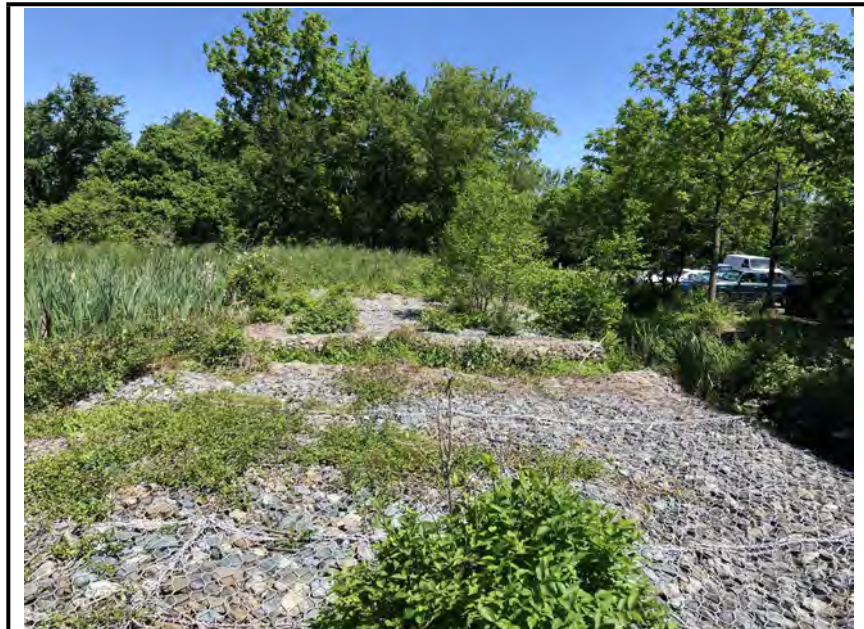
**Photo #4:** The gabion weir that flows into the swale.

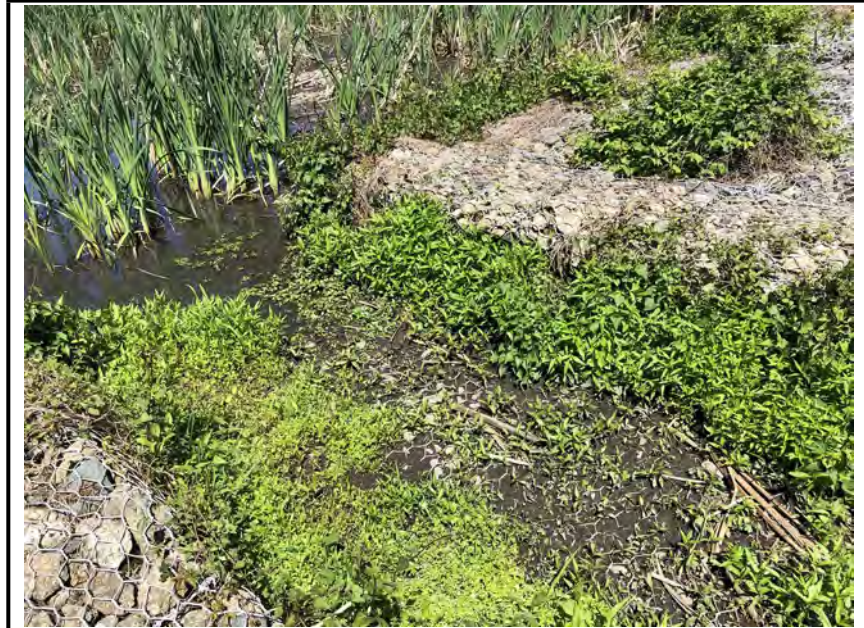
**Photo #5:** Sedimentation in the weir.

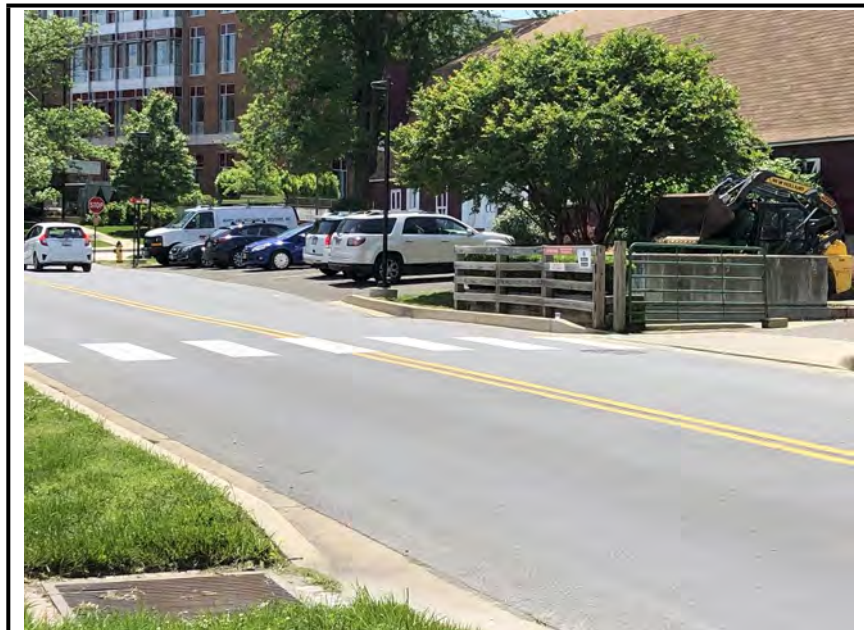
in center of the filter area. The exterior wall of the Biomolecular building that is adjacent to the swale is deteriorating. Additionally, the facility is directly downstream from the Campus Farm, which leaves its manure pile uncovered. As a result, animal manure is flowing into a storm drain that empty into the facility. At the time of inspection, manure was observed in the storm drain inlet directly downstream from the campus farm.

**Photo #6:** The fenced-in and uncovered manure pile, and the storm drain that it is directly downstream.

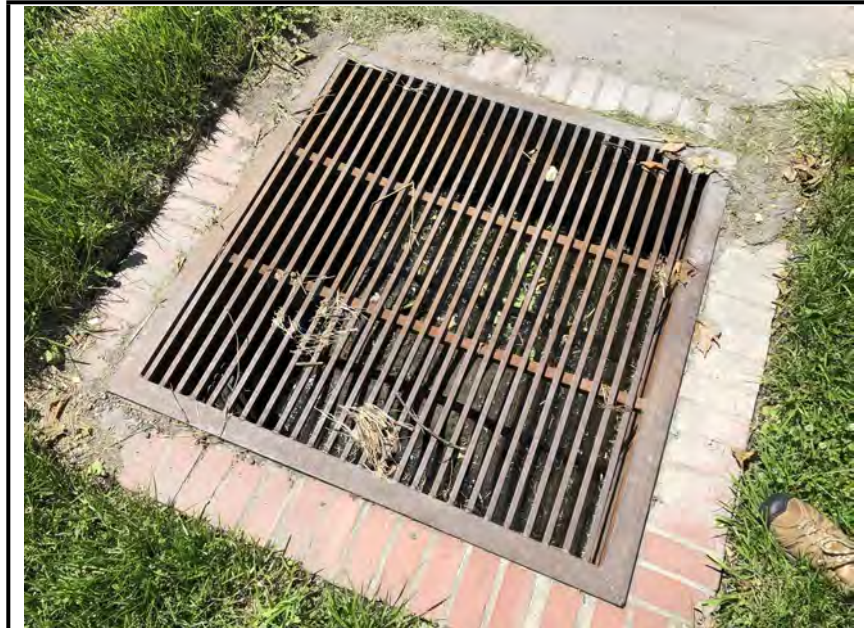
**Photo #7:** The aforementioned storm drain with manure inside.

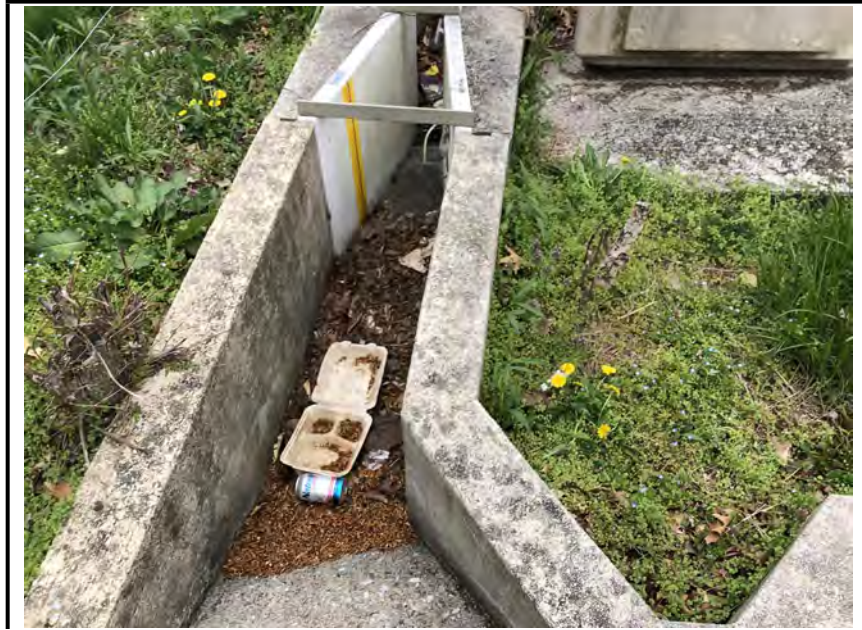
These facilities are in very poor condition. Any vegetation present in the facility has been overtaken by weeds and grass. There is exposed black plastic sheeting surrounding the sides of both of facilities. There is left over silt fence between the facilities and the stream. It does not appear that these facilities have been maintained in years.

**Photo #1:** Trash and leaf debris clogging one of the concrete channels.

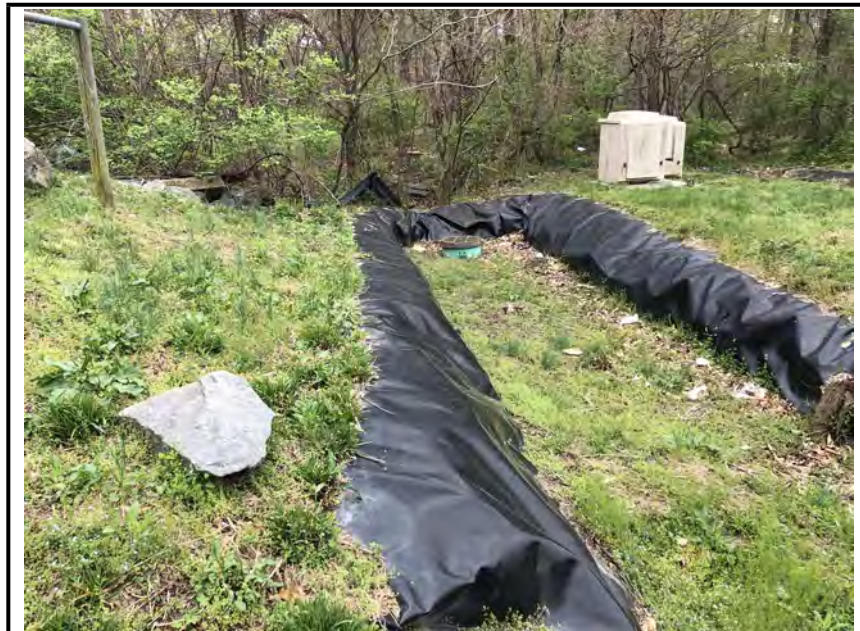
**Photo #2:** View into one of the bioretentions.

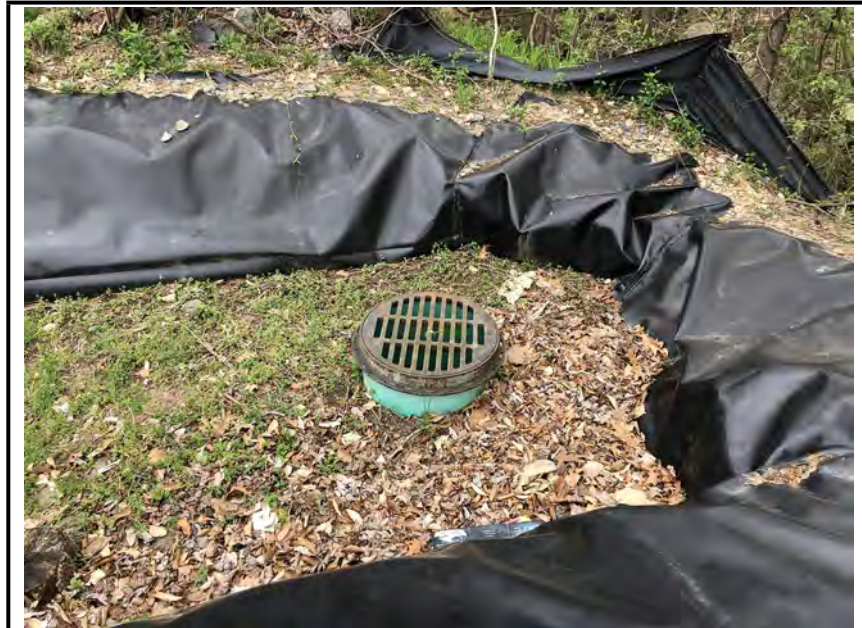
**Photo #3:** The riser outlet on SWF 22, and erroneous silt fence behind the facility.

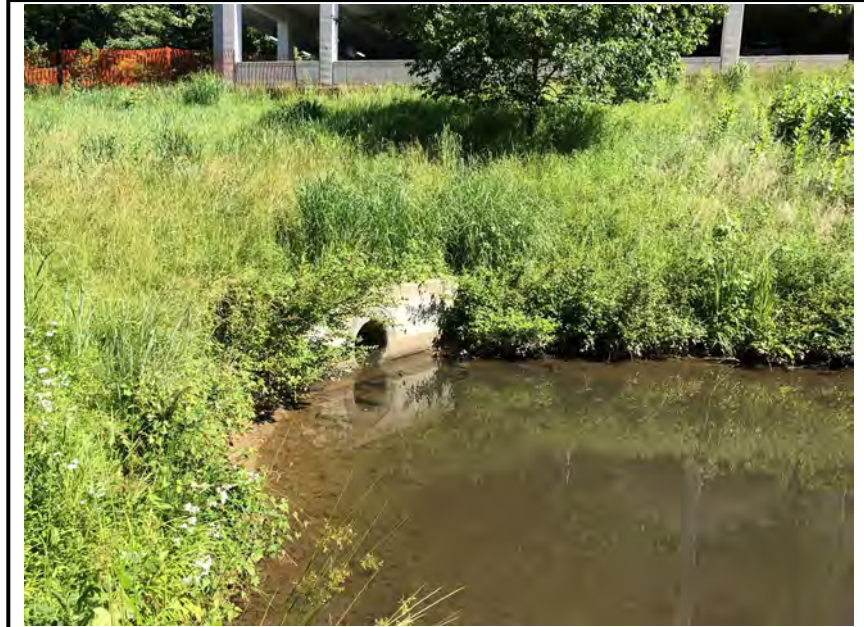
**Photo #3:** The concrete inflow culvert.

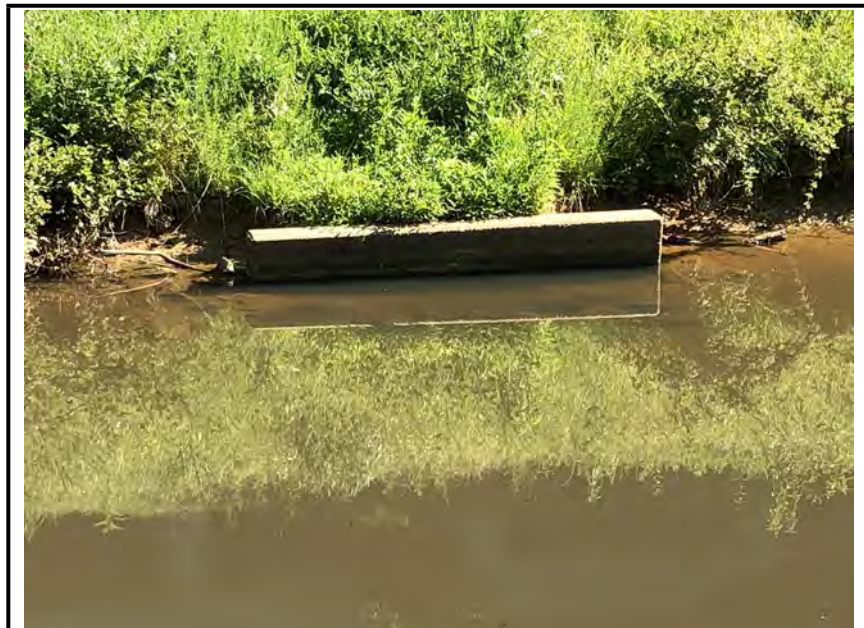
**Photo #4:** The unidentifiable submerged headwall.

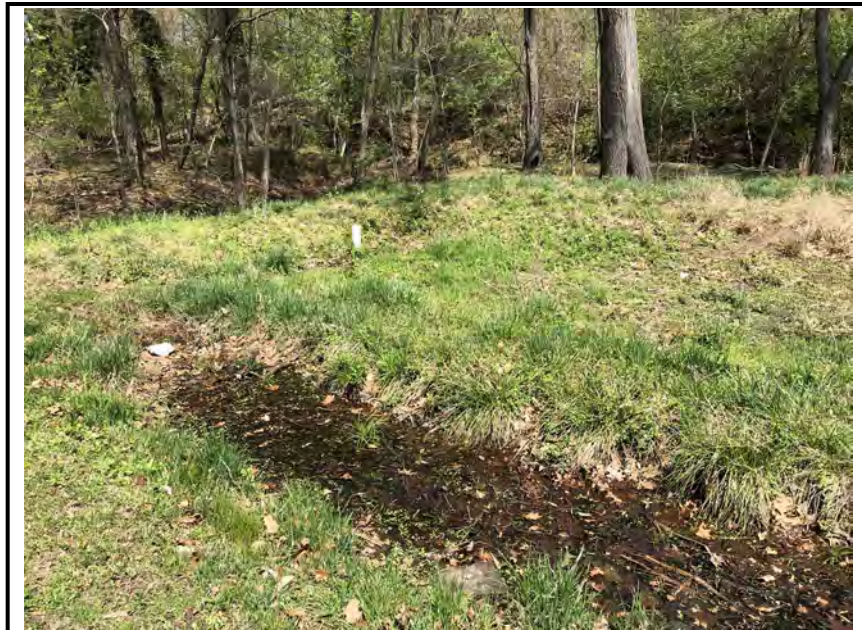
The facility is in fair condition. The only vegetation present is grass and brush. There is a high buildup of brush in the filter area. The forebay has standing water, and the weir has been eroded.

**Photo #1:** Standing water in the forebay.

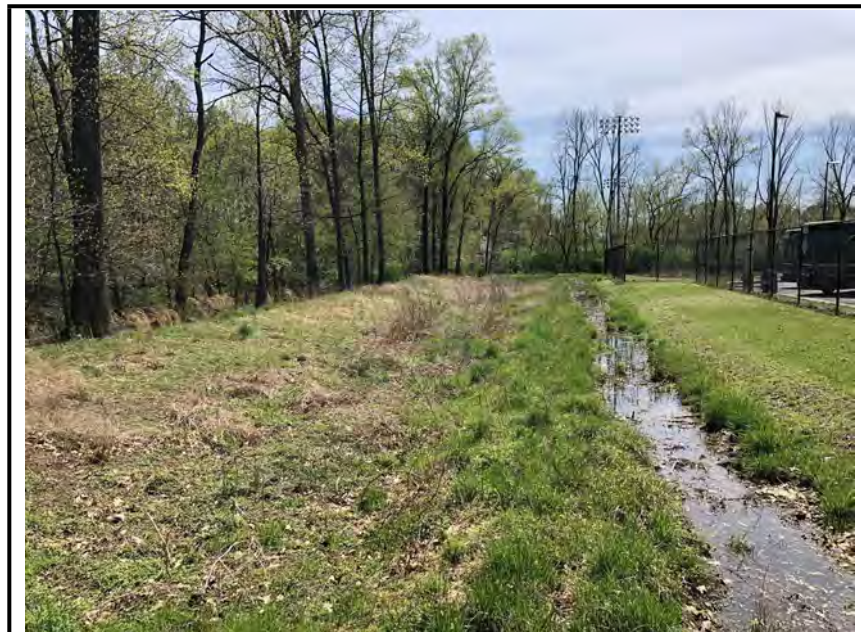
**Photo #2:** The dry swale to the left, and the forebay to the right.

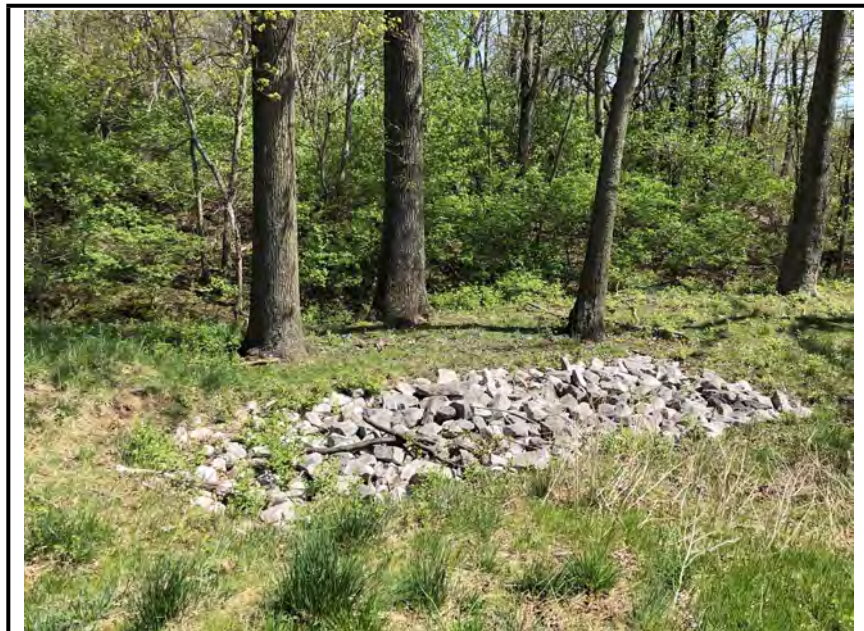
Stormwater exits the facility via infiltration. There is also a riprap overflow channel that drains directly into the adjacent stream.

**Photo #4:** The riprap overflow channel.

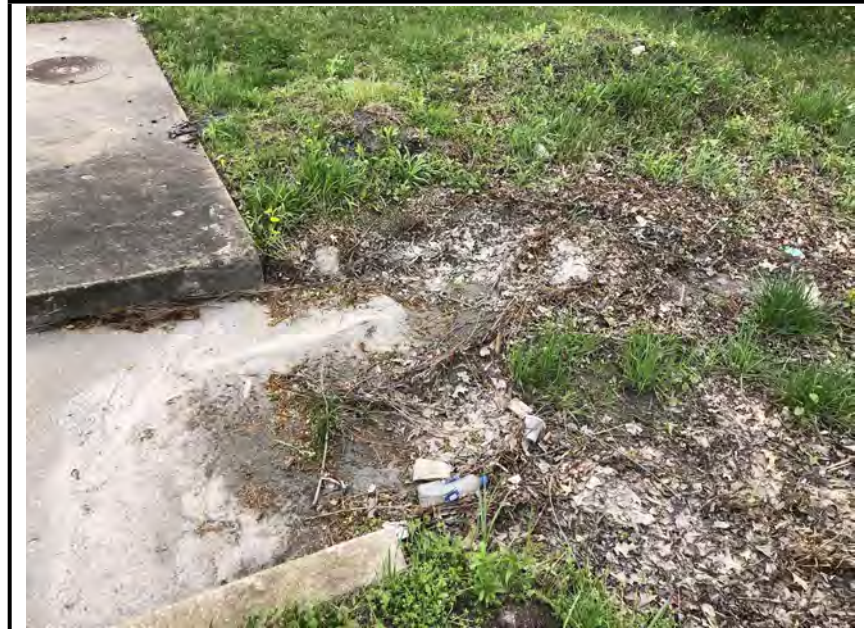
The facility is in poor condition. The only vegetation present is grass. The facility is full of mud, sticks, and leaf debris. It looks like a depressed grass area, rather than a stormwater facility. The filter area appears clogged and is ill defined.

**Photo #1:** The curb cut through which runoff enters the facility.

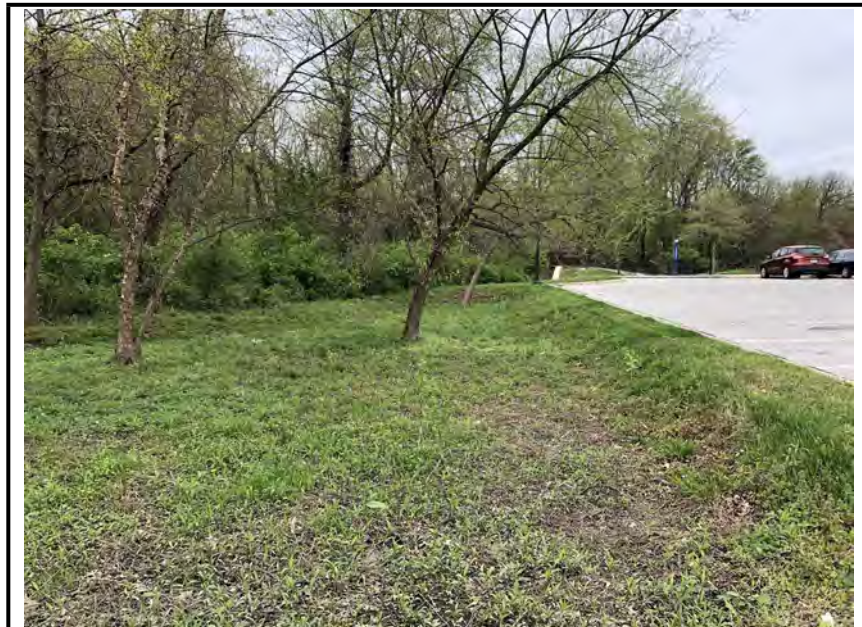
**Photo #2:** The filter area of the facility.

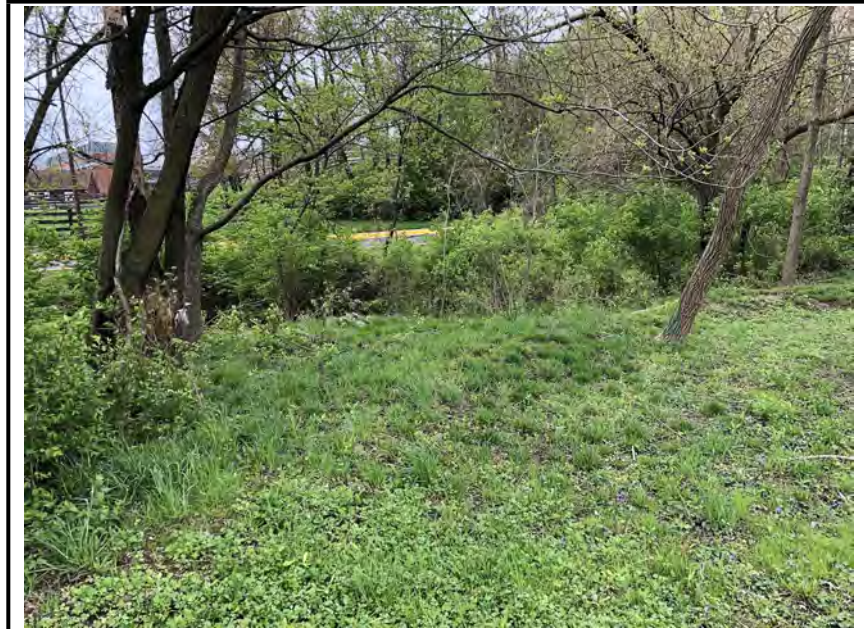
**Photo #3:** The filter area of the facility.

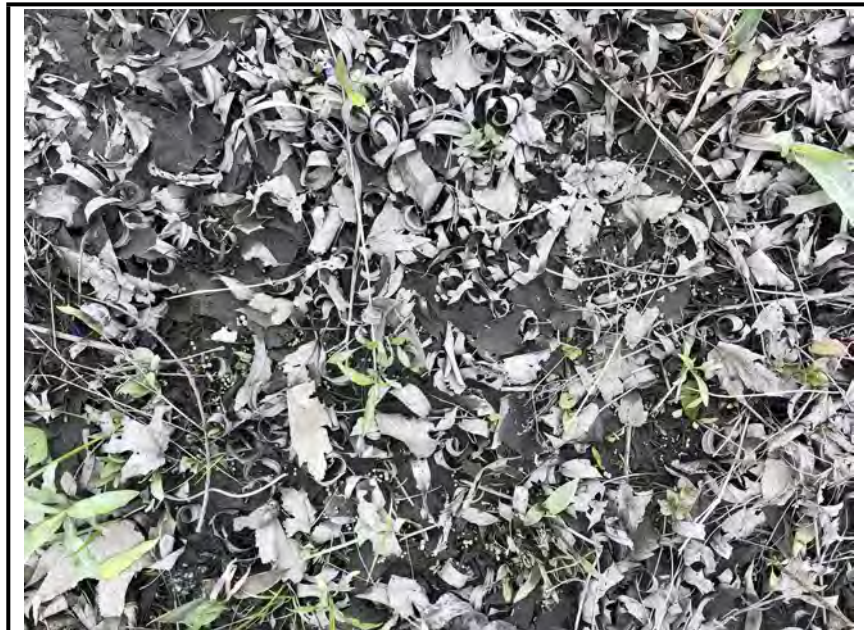
**Photo #4:** Close up of the filter area.

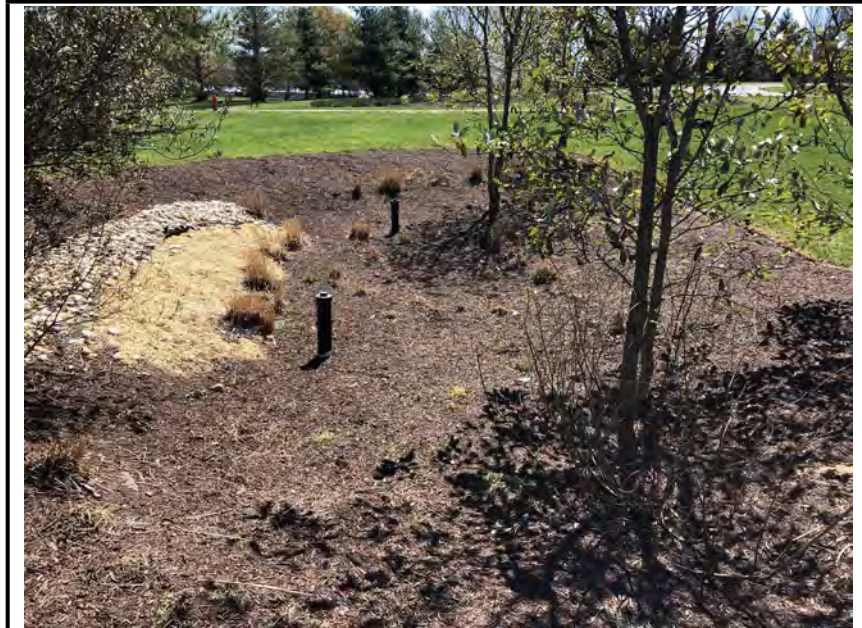
Overall, these facilities are in good condition. The filter fabric is exposed in some areas, but the landscaping has been maintained well and the facilities appear to be functional.

Photo #1: View into facility 033.

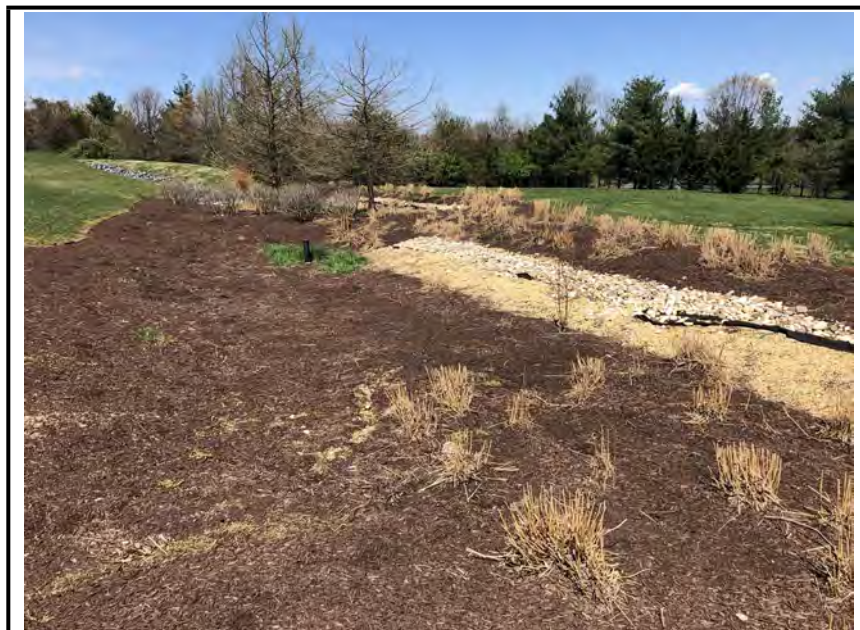
Photo #2: View into facility 034.

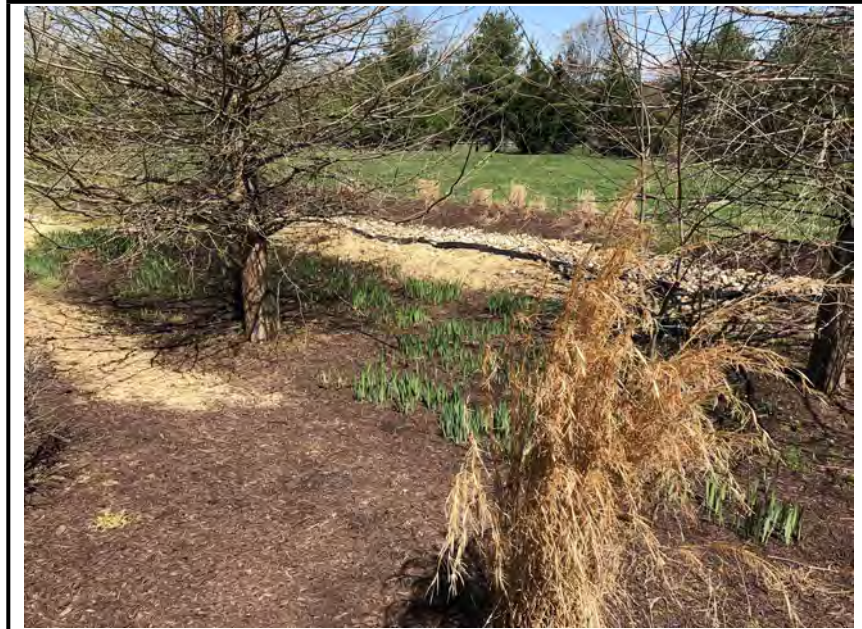
**Photo #3:** View into facility 035.

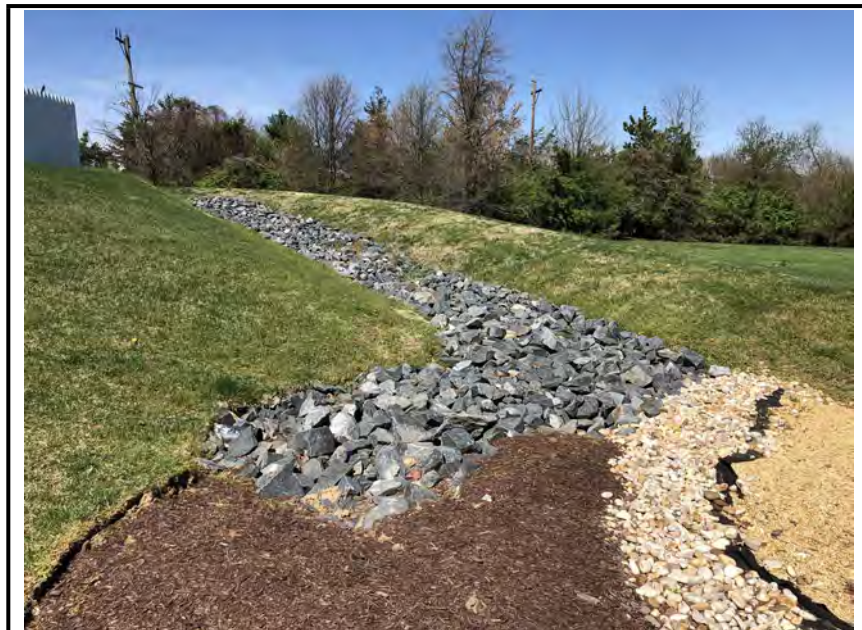
**Photo #4:** The riprap channel that leads into facility 035. Exposed filter fabric visible.

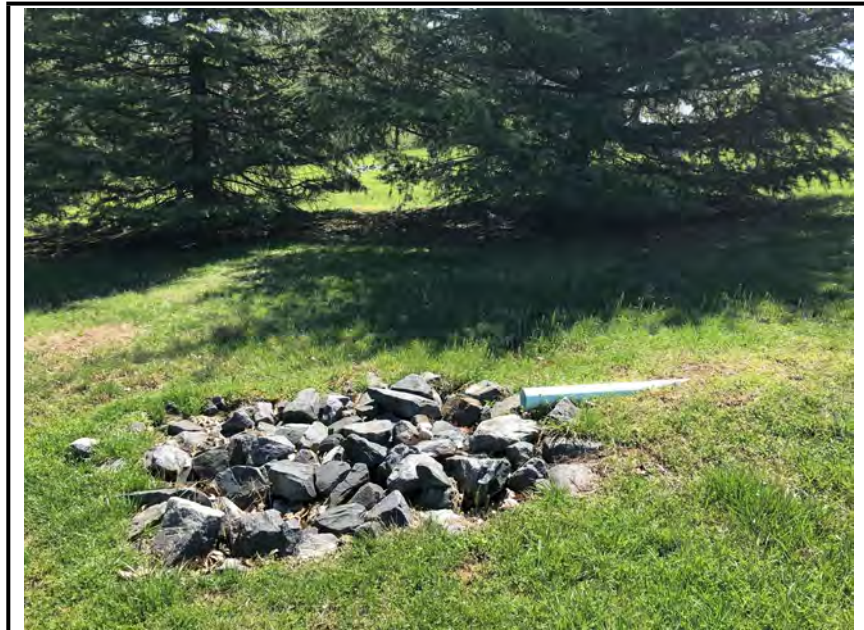
Runoff exits these facilities through infiltration. The underdrains daylight downhill. These pipes are not fully buried and show signs of erosion.

**Photo #5:** One of the exposed underdrains.

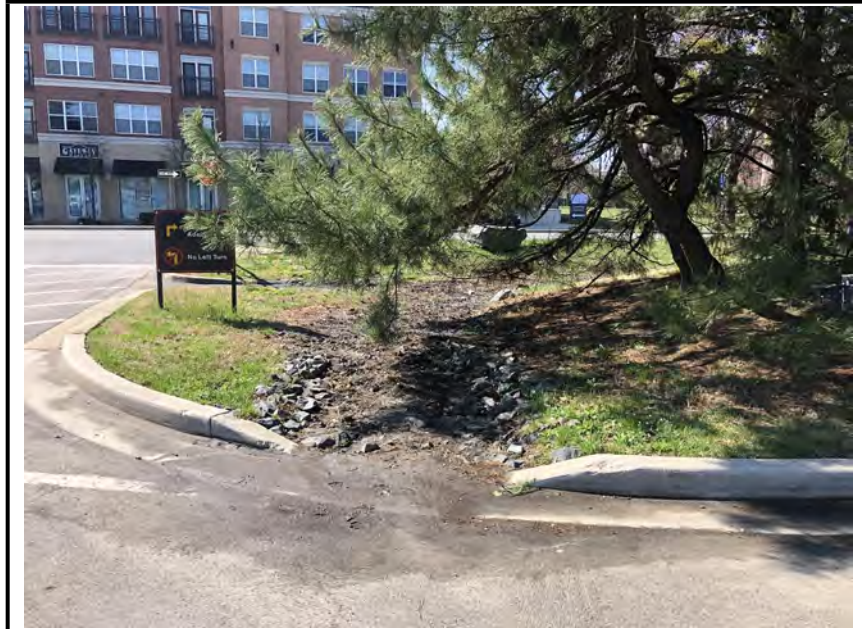
**Photo #1:** One of the curb cuts that leads to the facility.

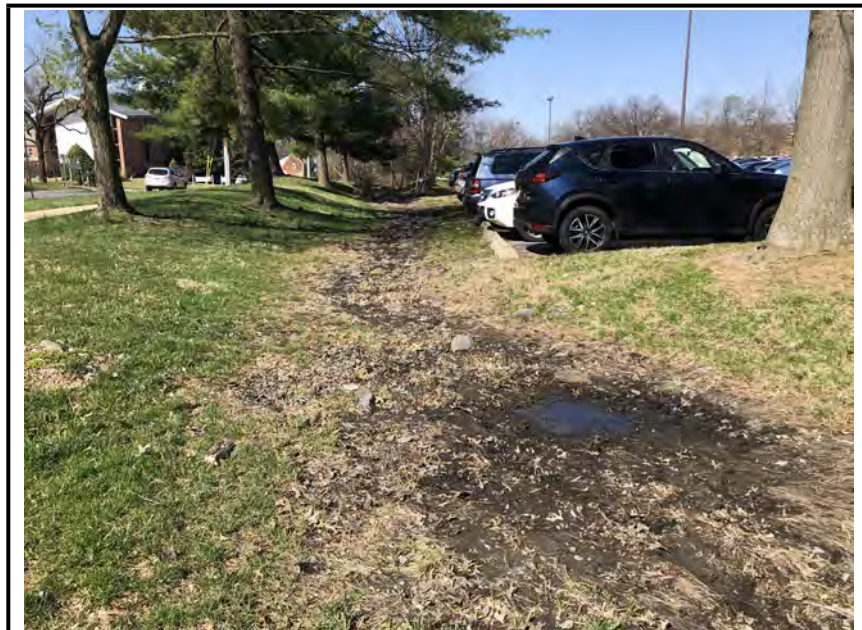
**Photo #2:** The pretreatment riprap channel.

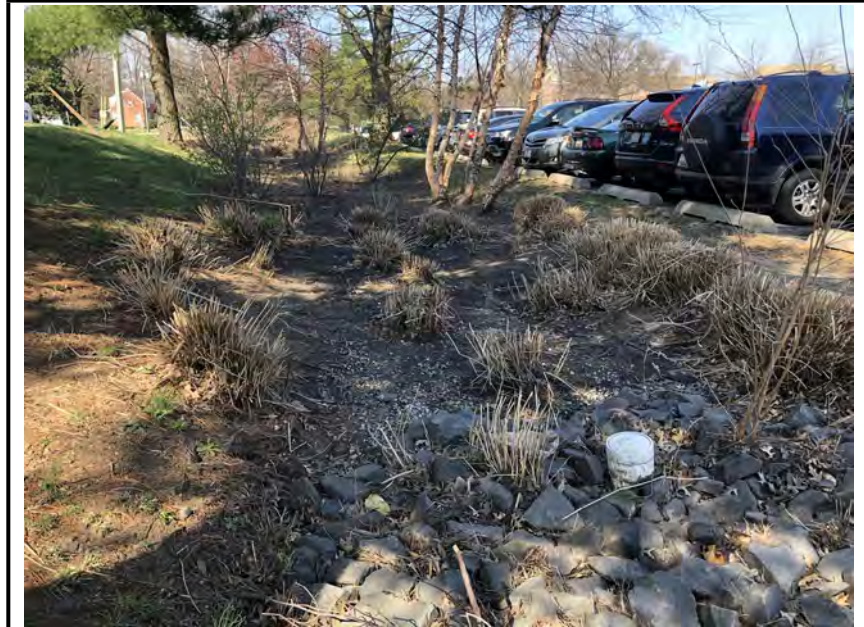
Photo #3: View onto the filter area.

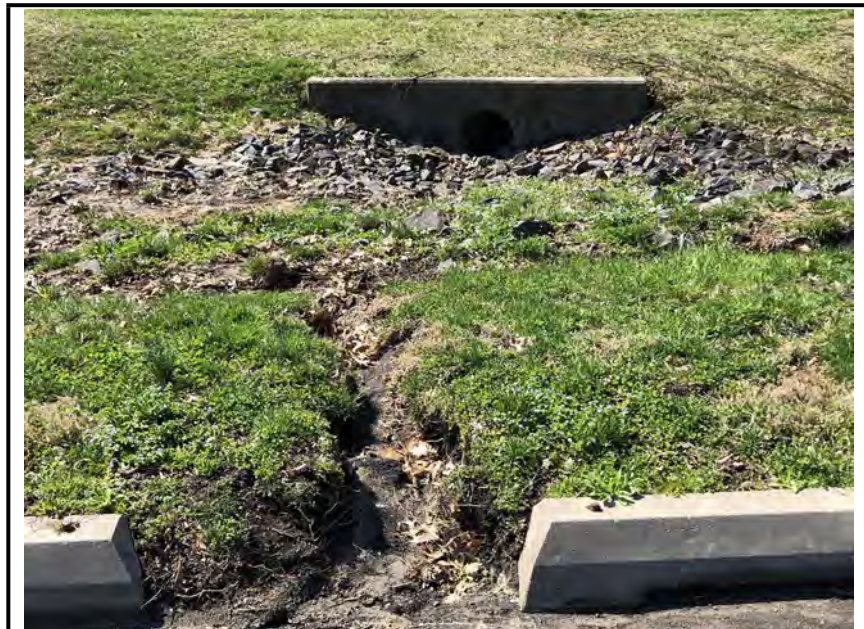
This facility is in fair condition. More riprap should be added to the inflow channel. Silt should be removed from the filter area and inflow channels. There are erosional gullies at the outfall culvert.

Photo #13: Erosional gullies downstream from the outlet culvert.

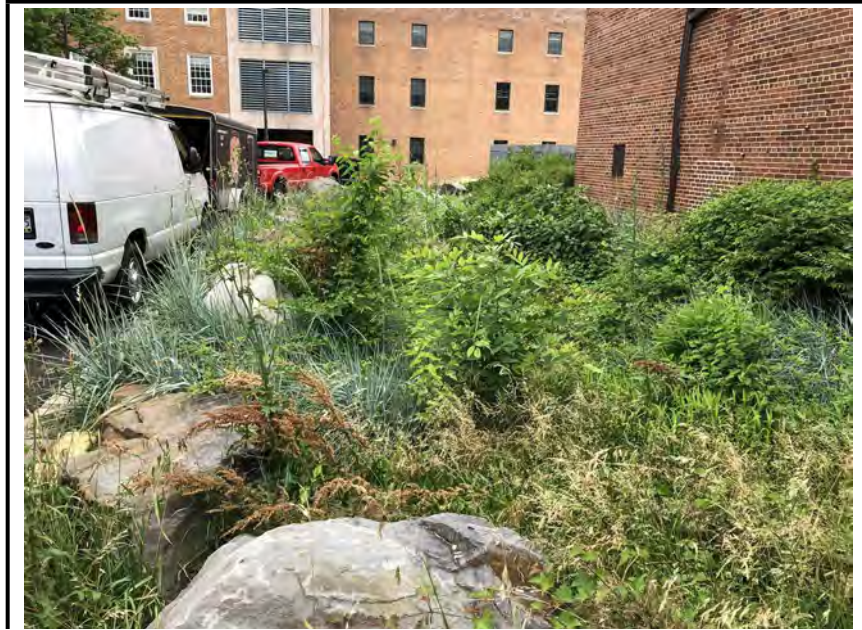
This facility is extremely overgrown. It does not appear to have been landscaped in several years. Overall this facility is in fair condition.

**Photo #1:** View into the facility.

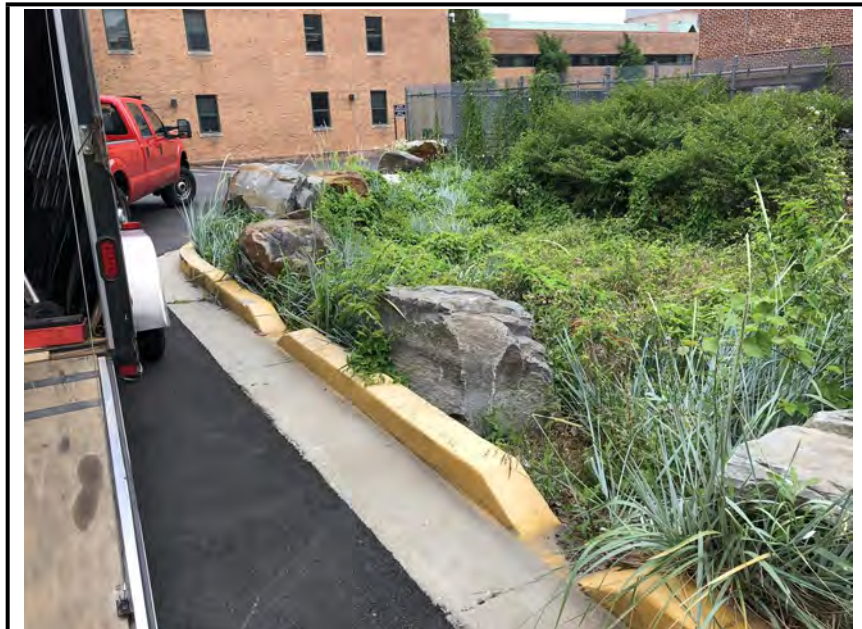
**Photo #2:** Curb cuts that lead into the facility.

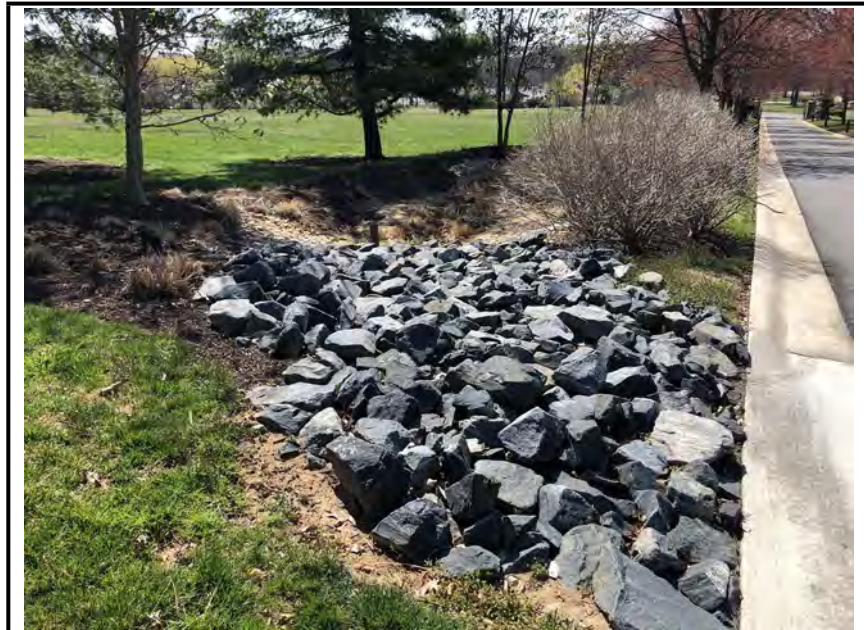
Runoff enters the facility through a wide riprap-lined curb cut. The riprap is in good condition.

**Photo #3:** The riprap lined curb cut.

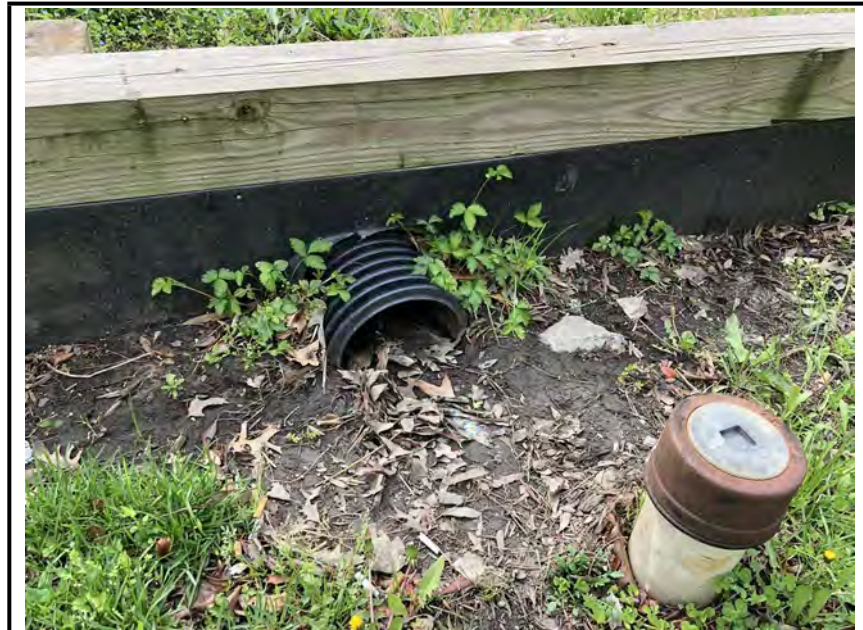
Photo #1: Clogged inflow pipe.

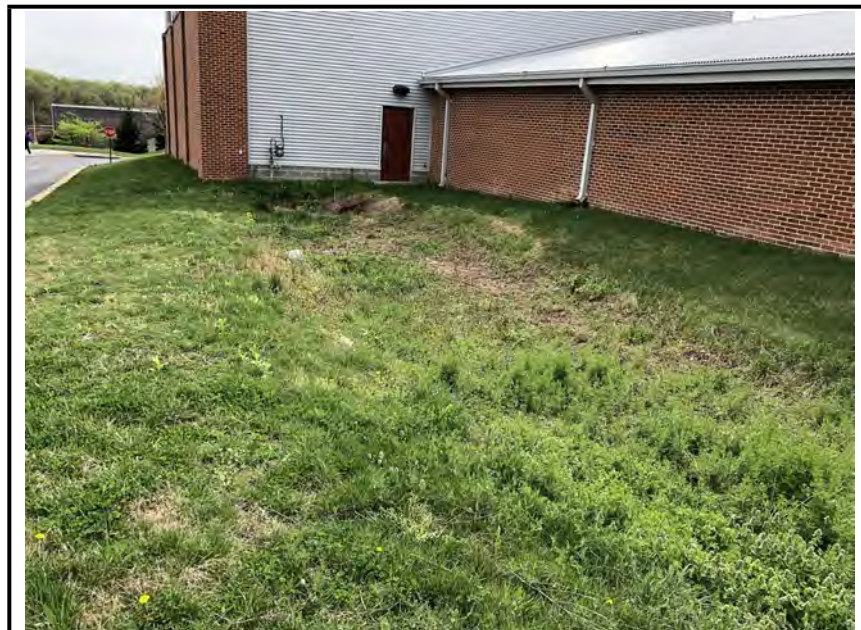
Overall, this facility is in poor condition. The only vegetation present are weeds and grass. The side slopes have eroded. It does appear to be a functional facility.

Photo #2: Vegetation inside the facility.

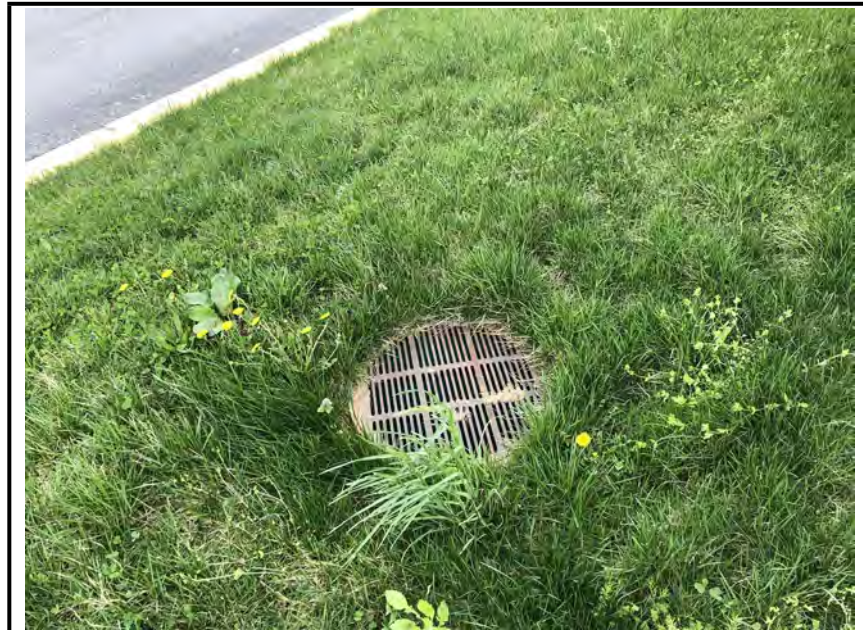
Photo #3: The grate outlet in the facility.

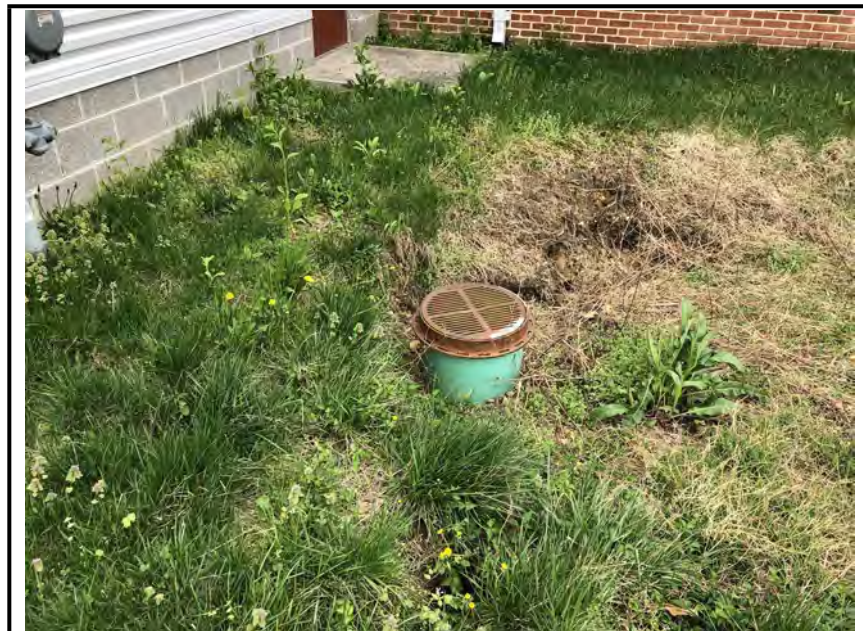
Photo #4: The riser outlet in the facility.

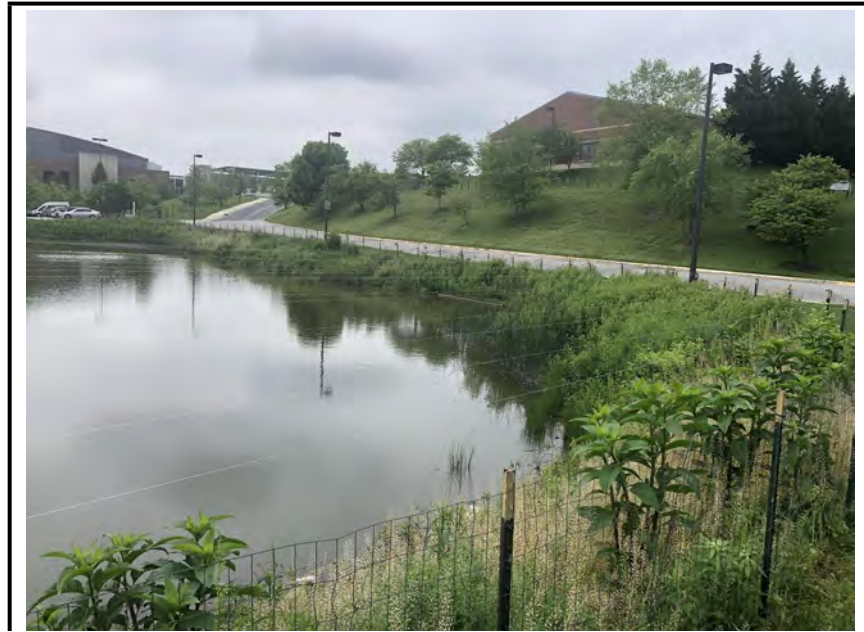
Overall the facility is in poor condition. The water level in the facility suggests that the facility is clogged. The BMP is not functional.

**Photo #1:** View into the facility.

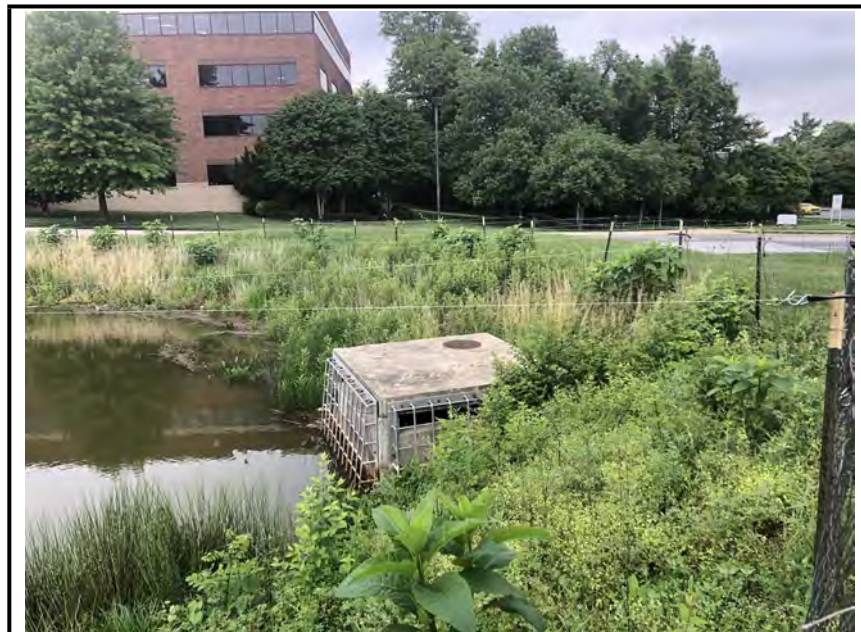
**Photo #2:** The outfall structure. Water is at the overflow level.

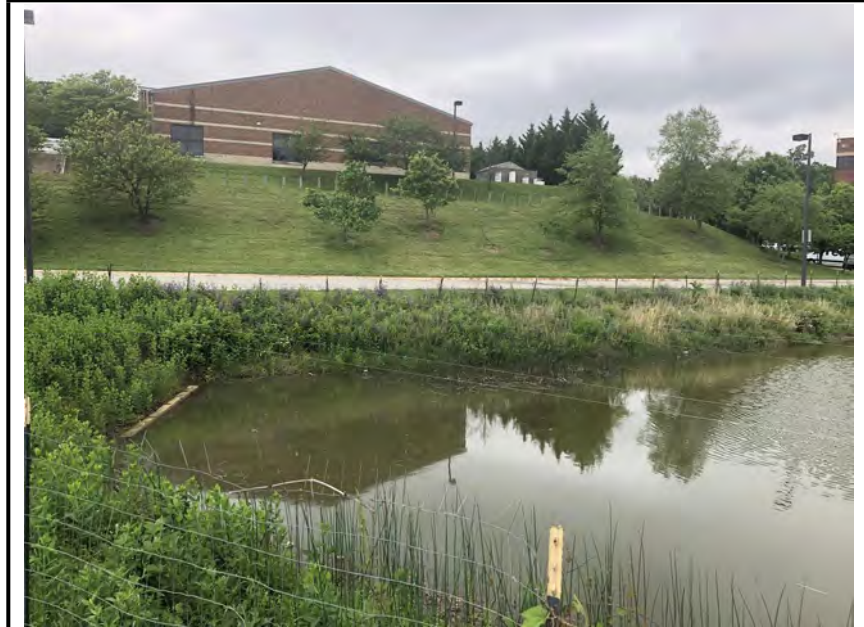
**Photo #3:** The top of one of the headwalls visible at water surface.

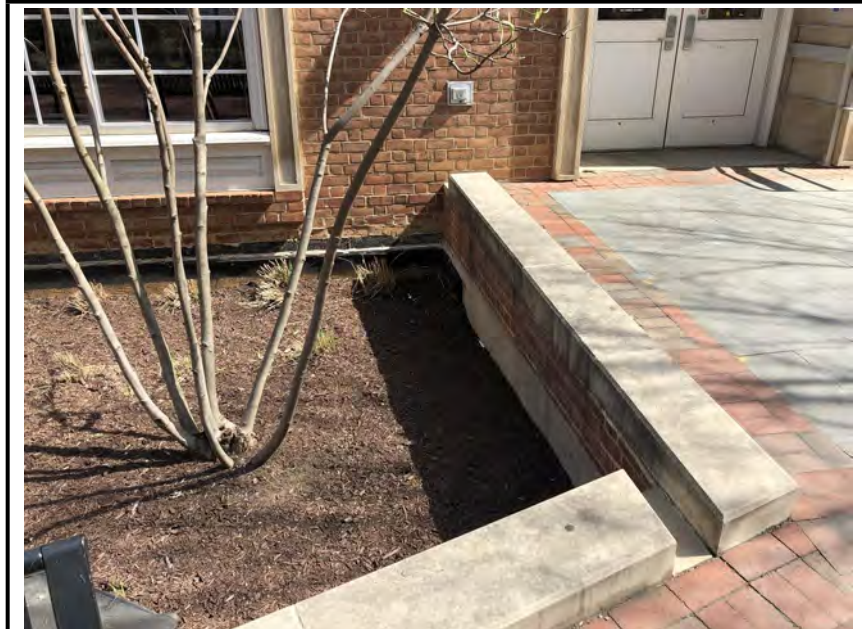
**Photo #1:** Curb cuts that lead into one of the forebays.

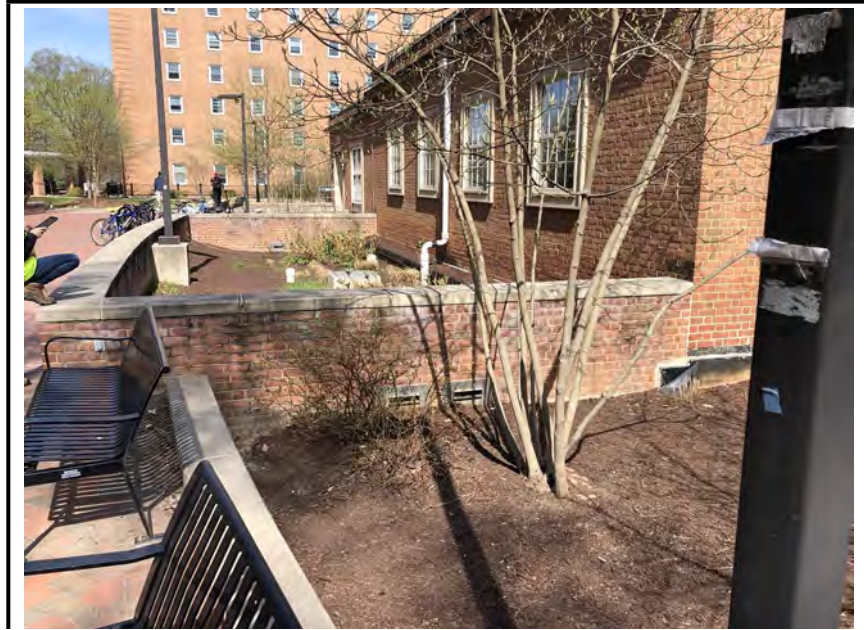
Photo #3: Wall openings that lead from the forebay into the filter area.

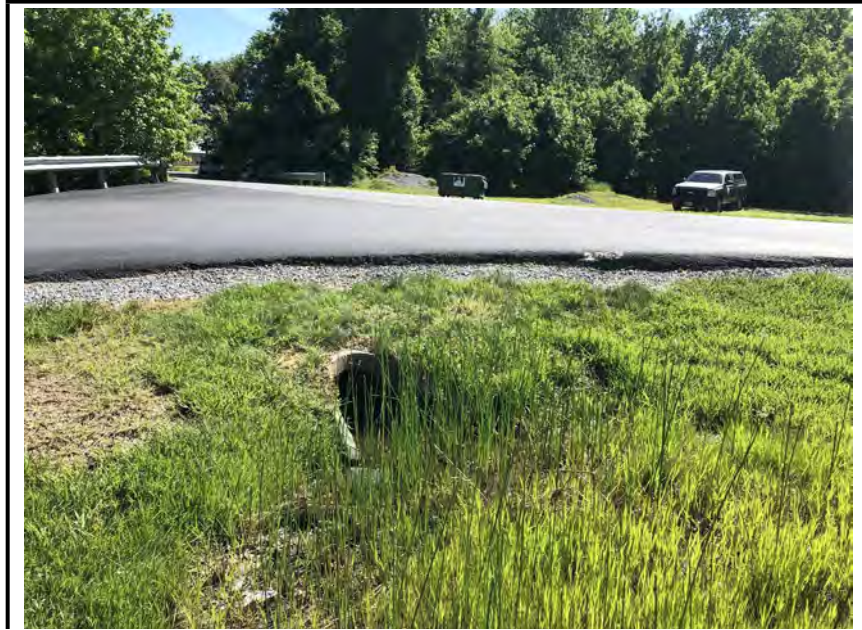
This facility is in poor condition. It does not appear to have been maintained for many years. The density of the overgrowth made this facility difficult to inspect, but it does not appear to be functional due to the stagnant water observed in the culvert.

**Photo #1:** The inflow culvert to the facility.

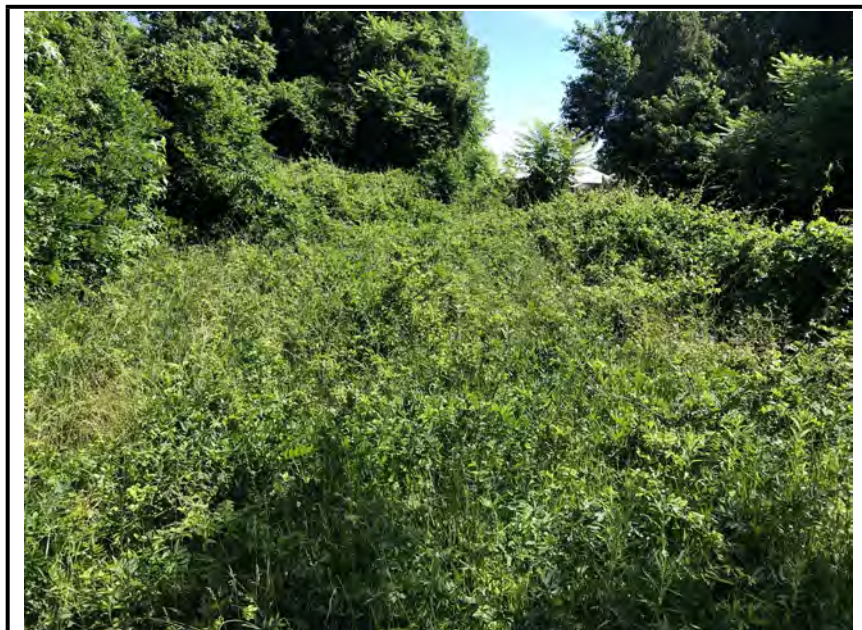
**Photo #2:** View into the facility obscured by dense vegetation.

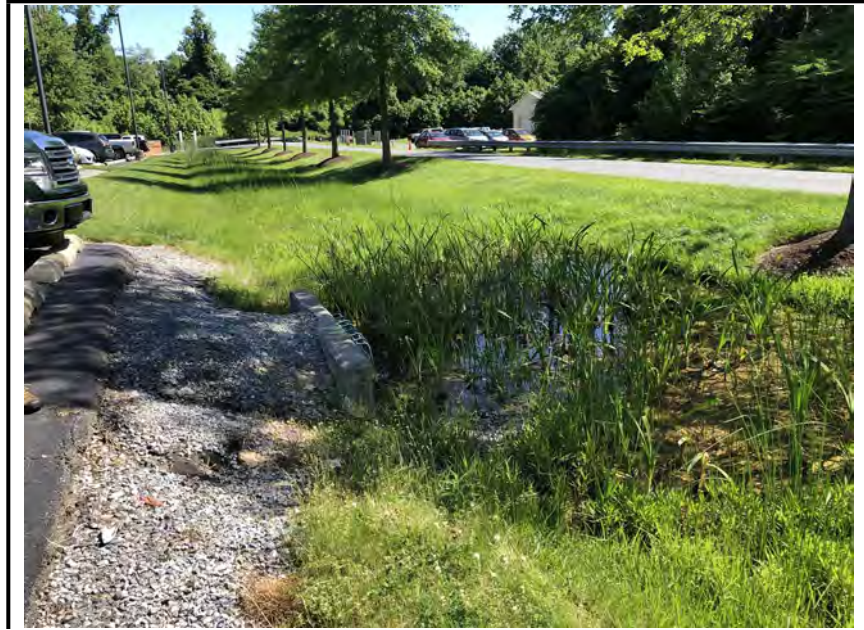
**Photo #3:** Pocket of standing water in the swale.
