University of Maryland, College Park  
National Pollutant Discharge Elimination  
System MS4 Phase II  
FY2019 Annual Report  
General Discharge Permit #13-SF-5501

## **Stormwater Treatment Final Report & Recommendations**

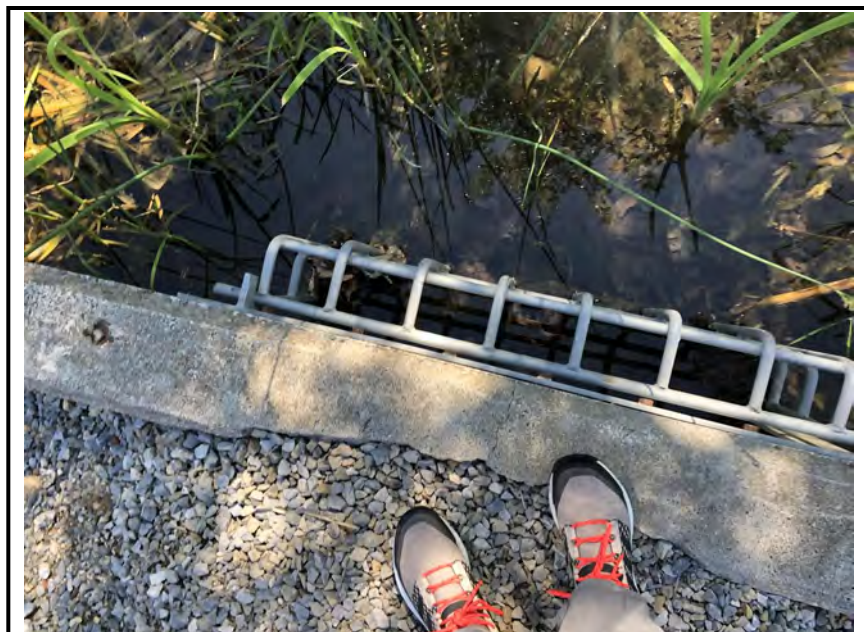
**Photo #4:** The outlet structure.

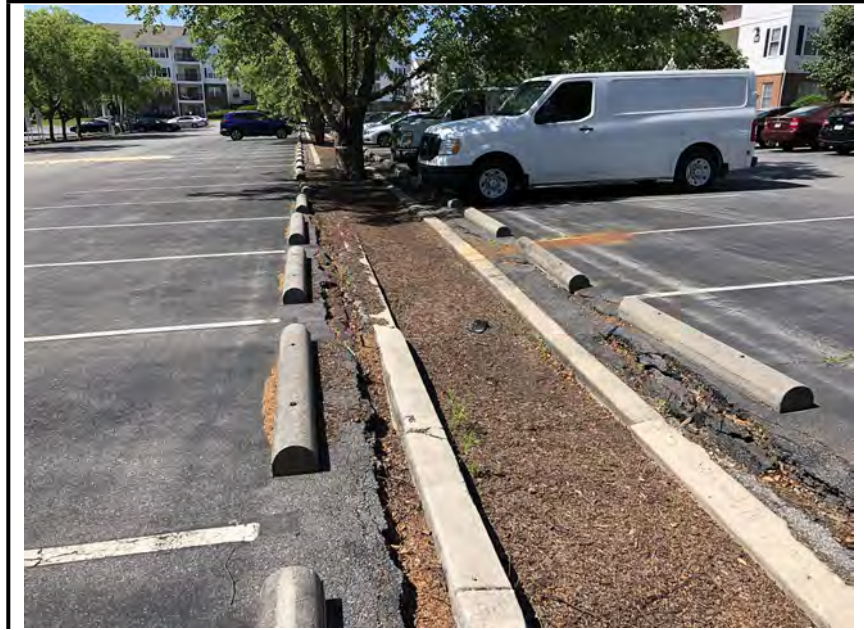
This facility is in poor condition. There is no vegetation aside from some weeds and a few trees. The surface is very uneven, and parts of the adjacent pavement have eroded into the filter area.

Photo #1: View into the facility.

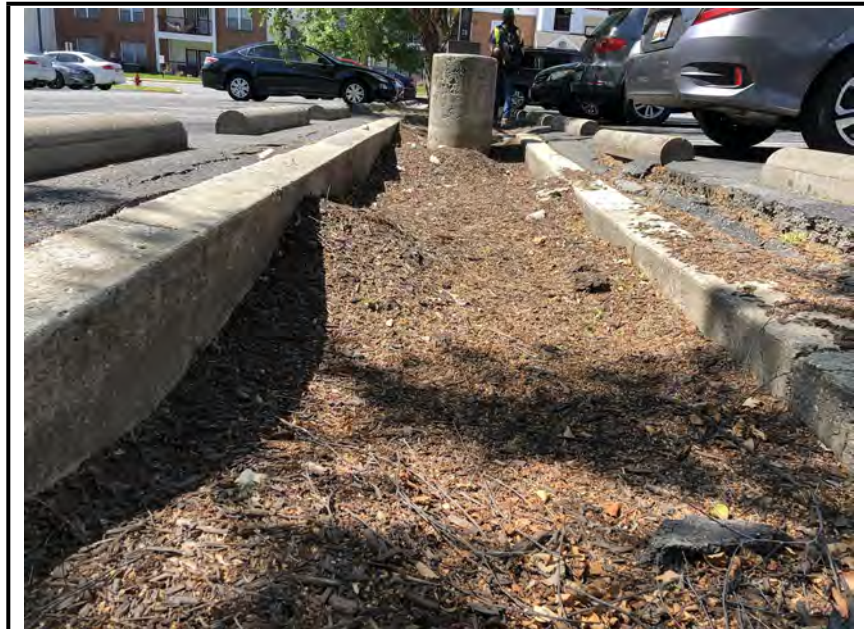
Photo #2: The uneven ground surface inside the facility.

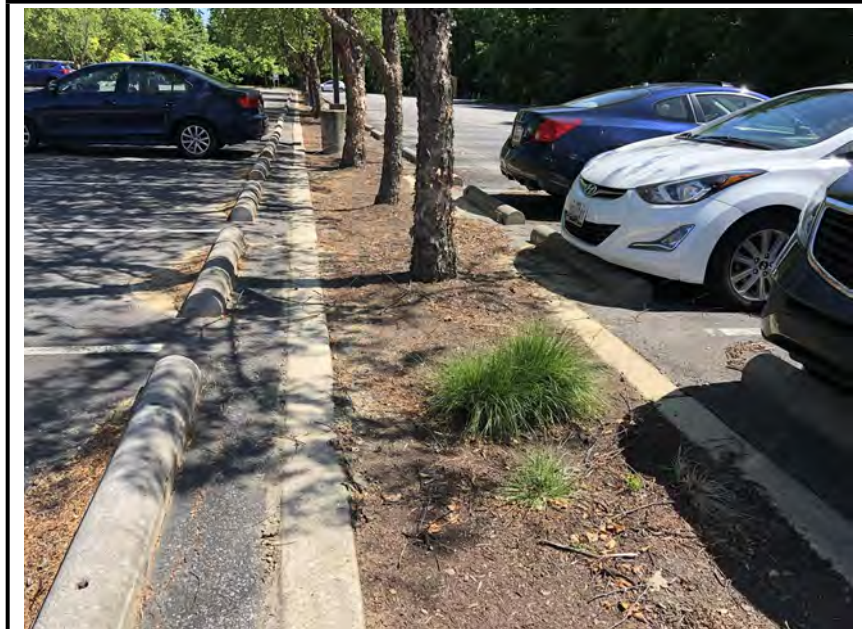
Overall this facility is in poor condition. There is no vegetation other than a few trees and one herbaceous plug. The filter area is unevenly eroded, and there is no storage depth.

**Photo #1:** View into the facility.

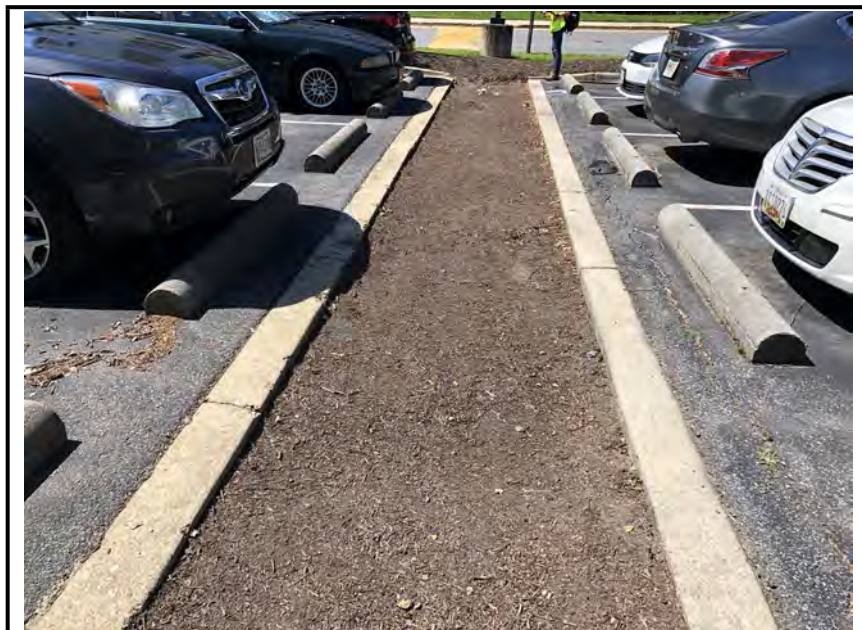
**Photo #2:** The unvegetated end of the facility.

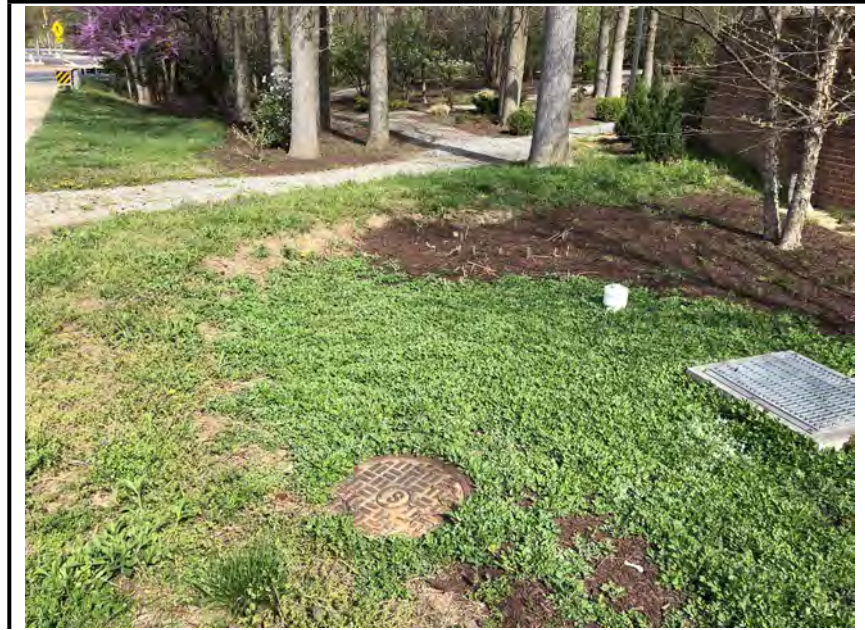
Overall, this facility is in good condition. The filter area has been overtaken by weeds and should be landscaped properly. The facility appears to be functional.

Photo #1: Weeds inside the filter area.

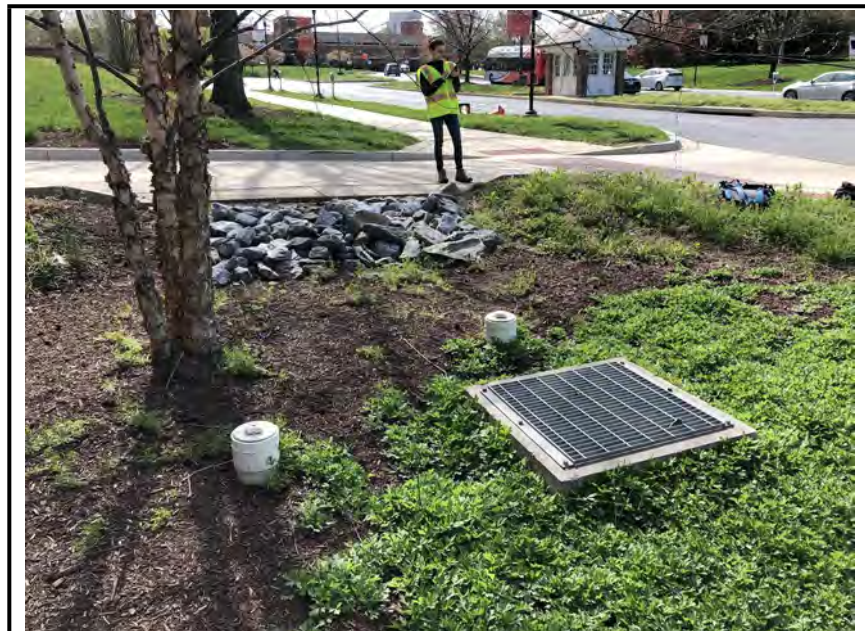
Photo #2: View of the facility.

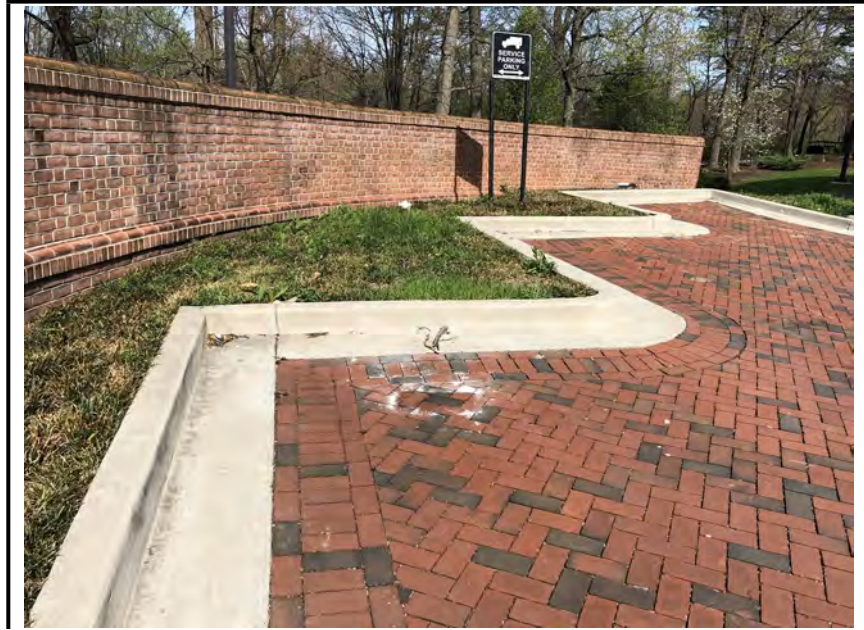
This facility is in fair condition. The pavers have settled unevenly, and there are various stains on the bricks. The curb is not flush to the pavers and is chipping in some areas.

**Photo #1:** Stains on the pavers.

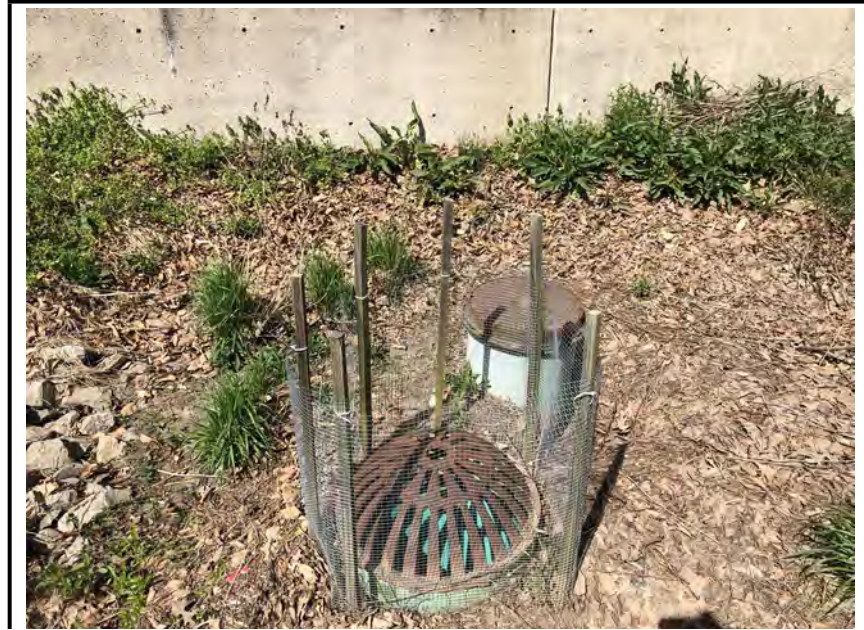
Photo #1: Riser outlet structure in facility.

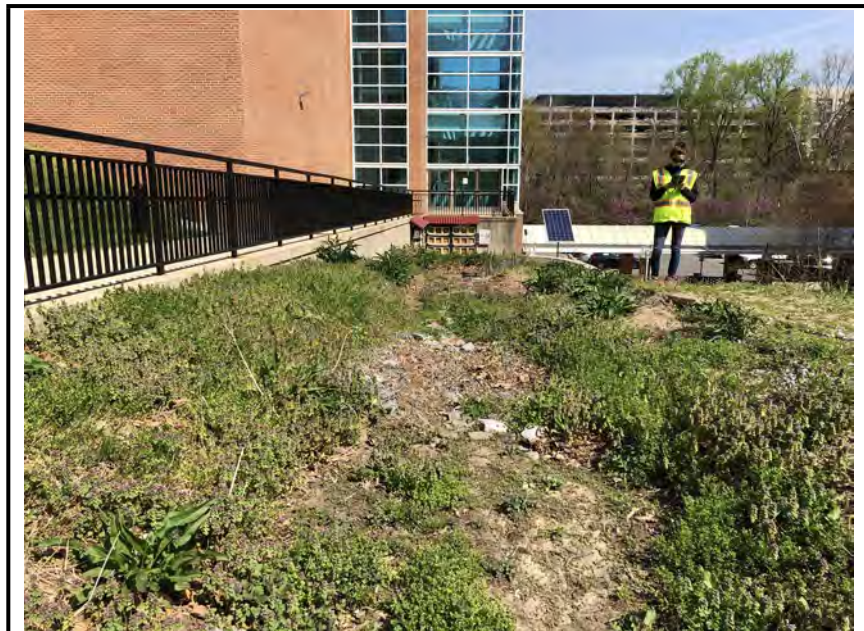
Overall the facility is in good condition. The filter area has been overtaken by weeds, which is choking out other vegetation. The facility appears to be functional. This bioretention is actually a pretreatment stage for the rainwater harvesting system (SWF 077) and would likely not be given credit as a stand-alone facility.

Photo #3: View into the facility.

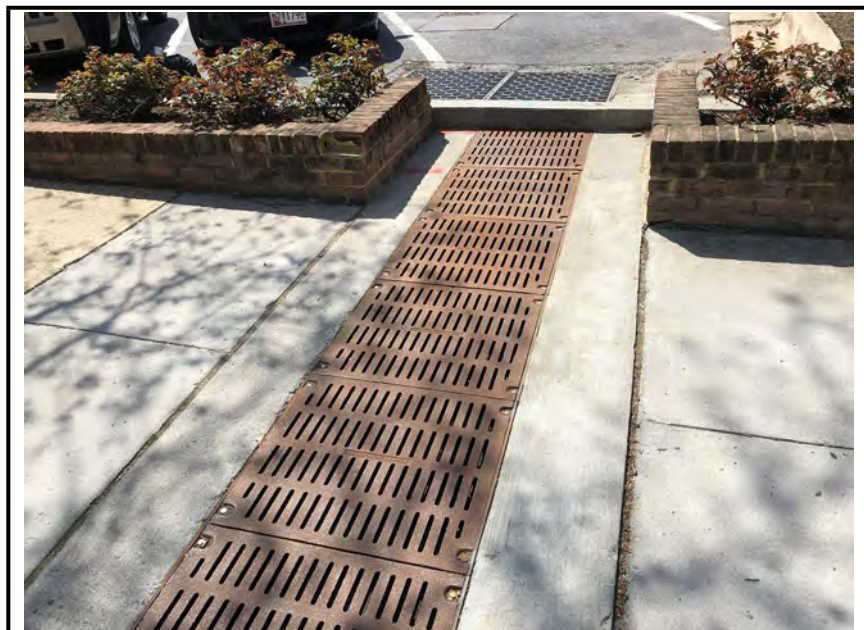
Photo #4: Trench drain that leads to the facility.

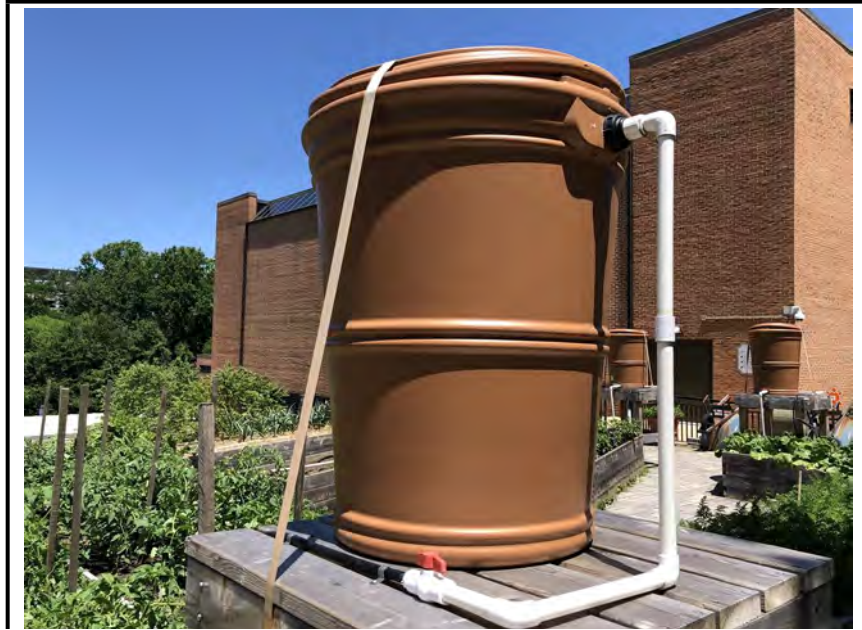
Photo #1: One of the 50-gallon rain barrels that store water for irrigation.

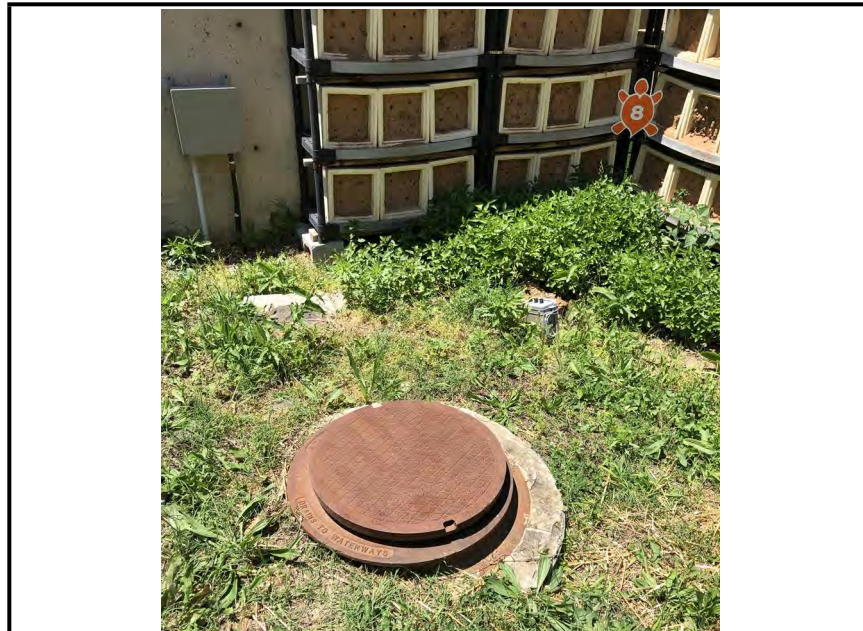
**Photo #3:** The manhole that leads to the cistern.

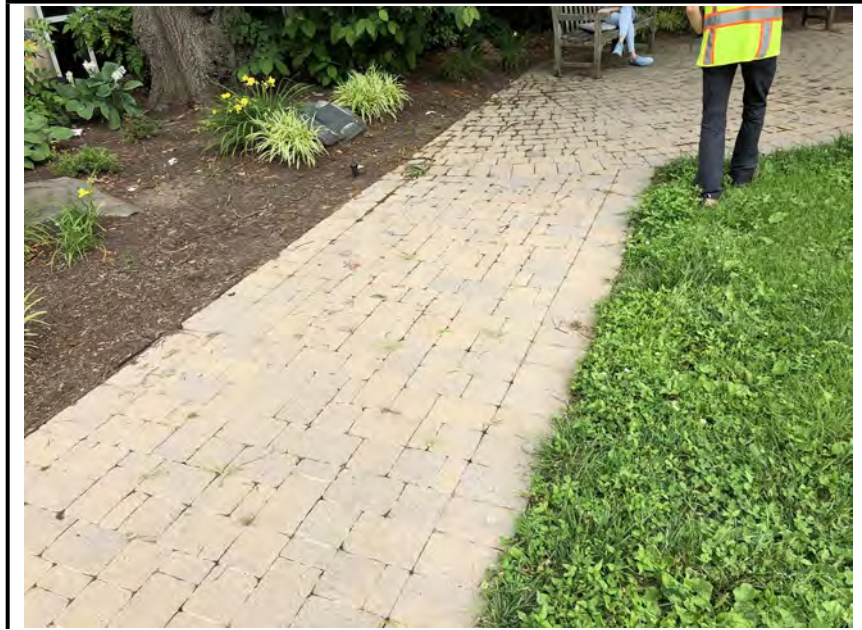
**Photo #1:** View of the facility.

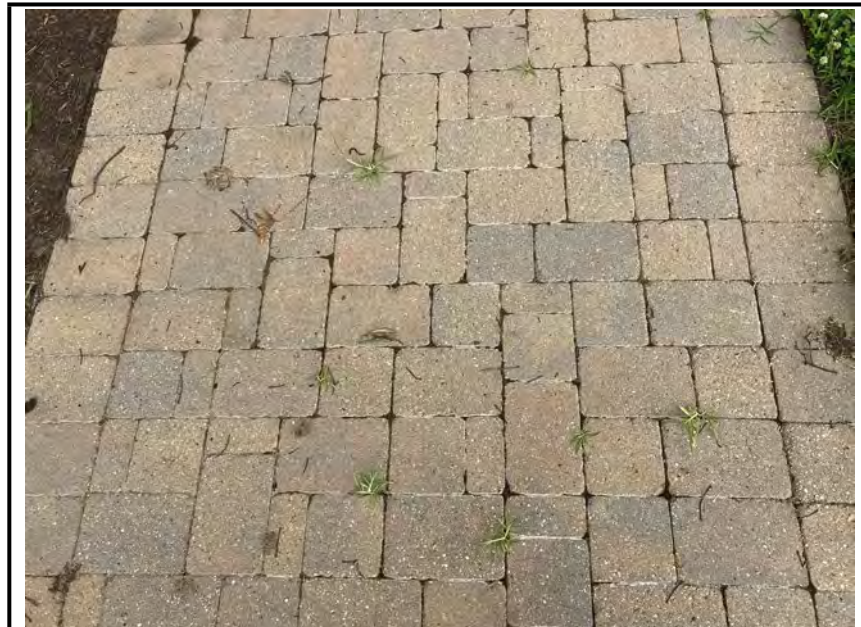
This facility is in good condition. Moss and other vegetation grows in some of the gaps between pavers and should be removed. The facility appears to be functional.

**Photo #2:** Vegetation growing in cracks in the pavers.

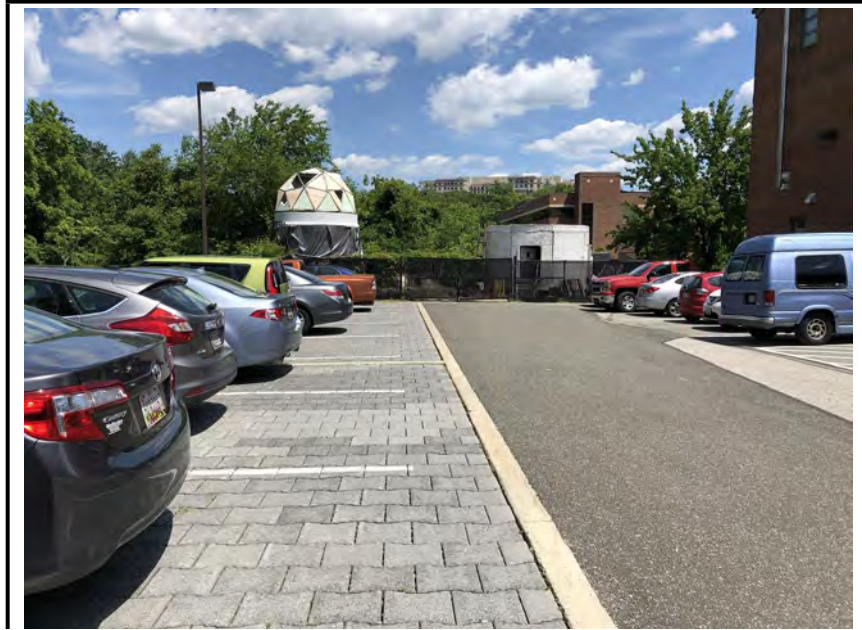
This facility is in fair condition. There is not much gravel between the pavers, and the pavers have settled along the border. The curb along the border prevents sheet flow from entering the facility.

Photo #1: View onto the facility.

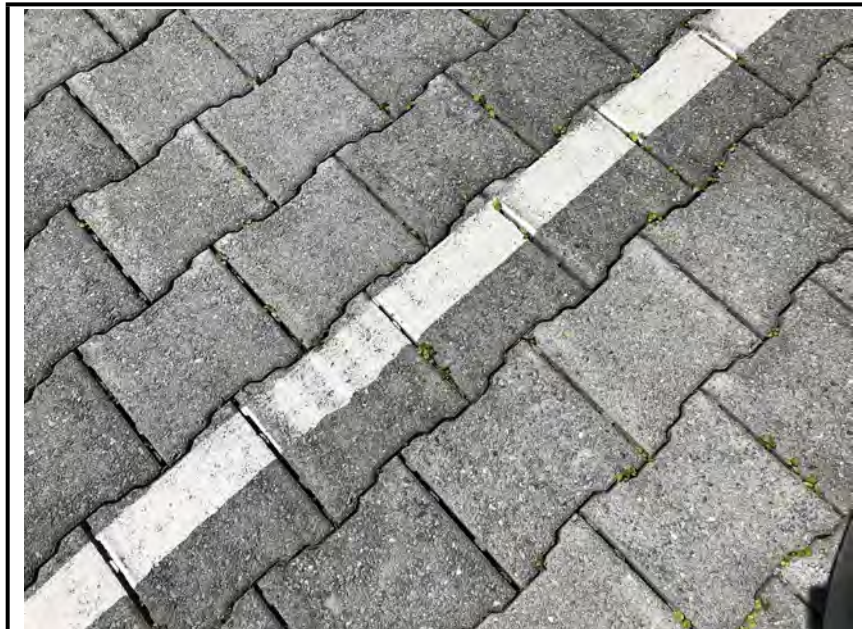
Photo #2: Close up view of the pavers.

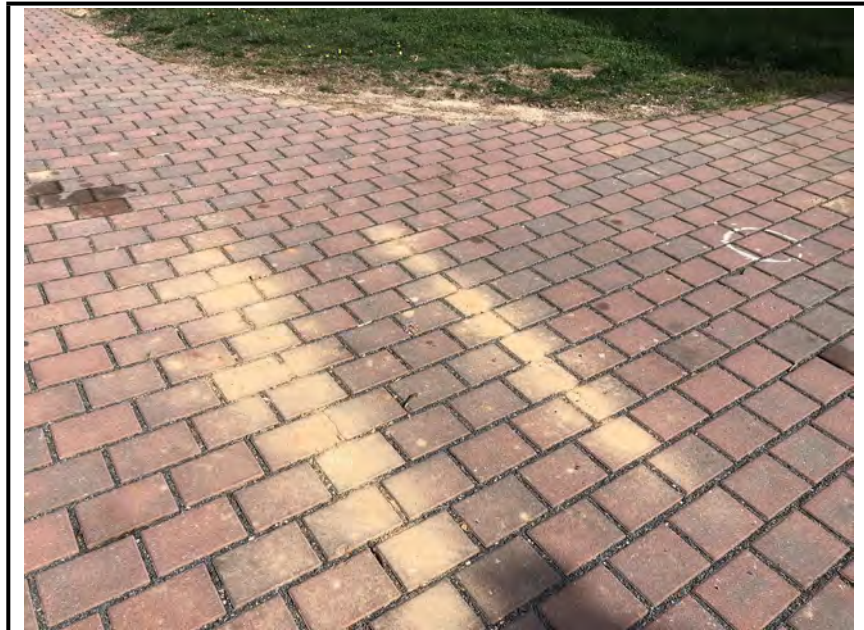
**Photo #3:** Dirt covering pavers.

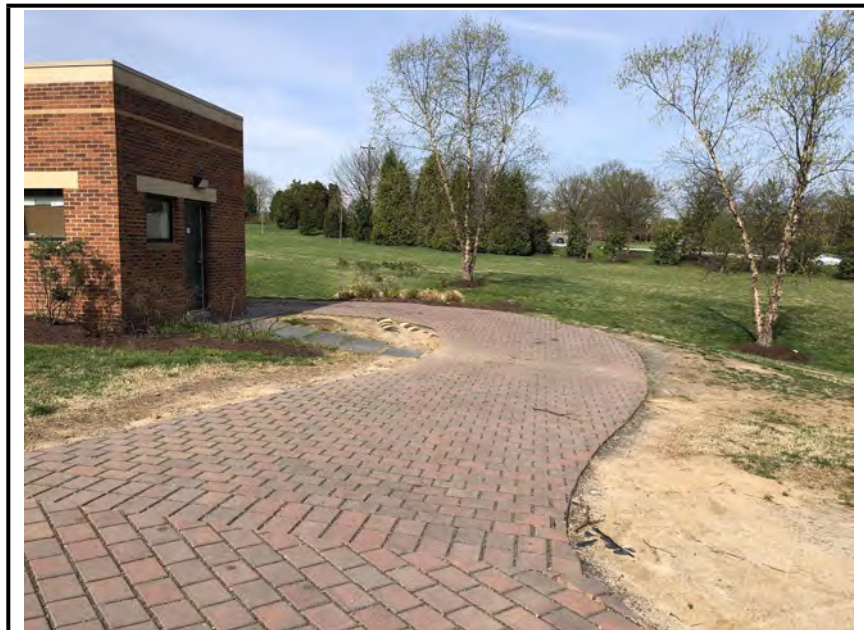
**Photo #4:** Eroded grass next to the pavers.

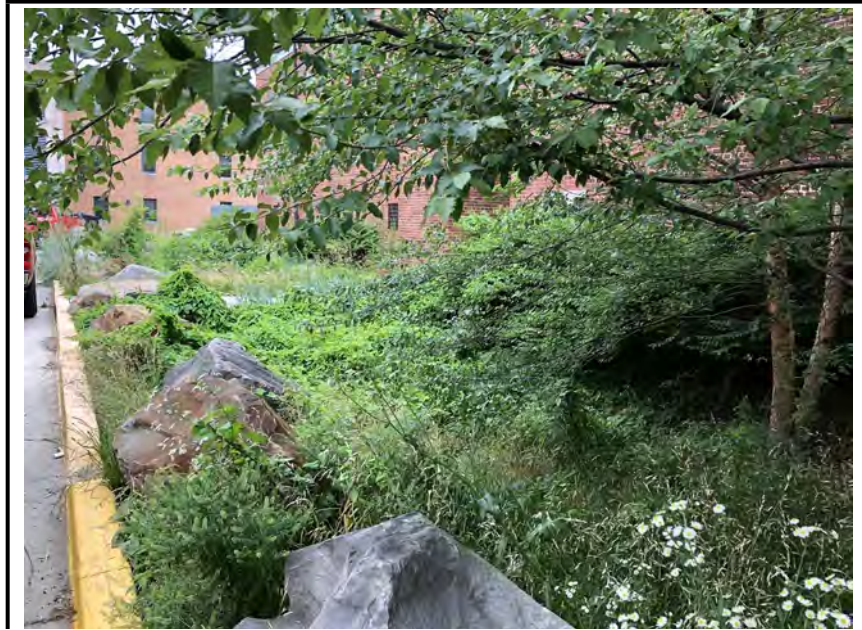
The facility is in fair condition. The outlet elevation is not high enough to ensure adequate ponding. The facility is also very overgrown and should be trimmed and landscaped.

**Photo #1:** The view into the facility.

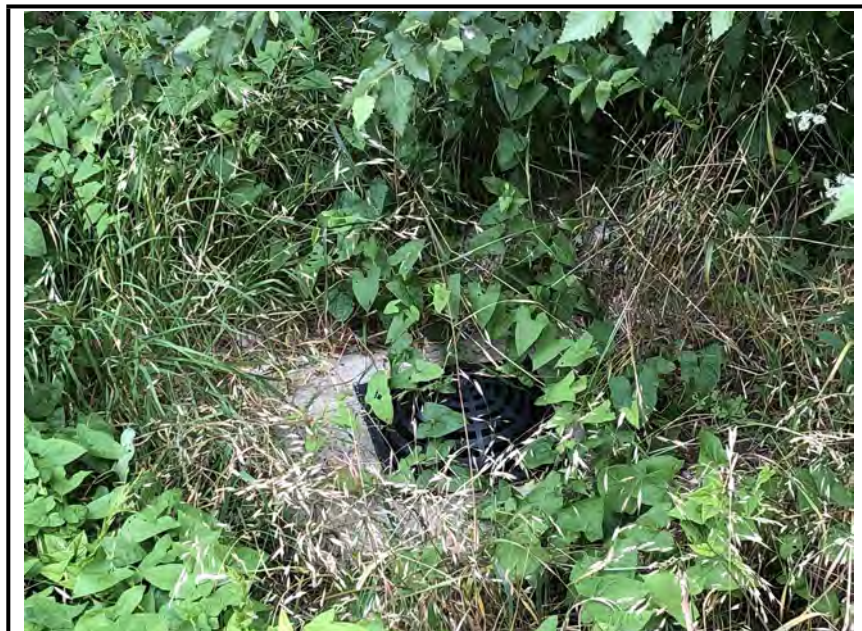
**Photo #2:** The outlet structure.

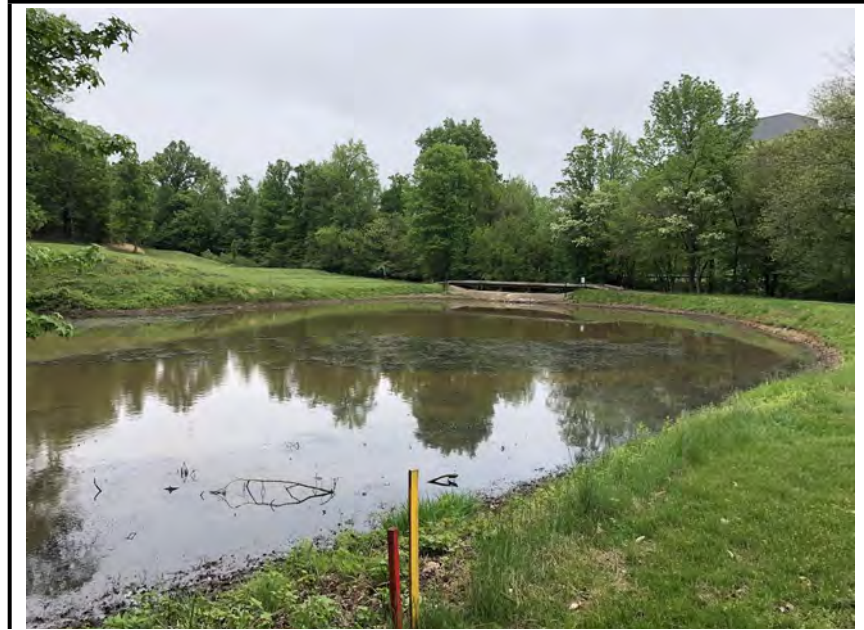
Overall, this facility is in poor condition. It is very overgrown and eroded, and there is oil visible on the water surface. There are some black PVC pipes in the filter area that are broken.

**Photo #1:** View into the facility.

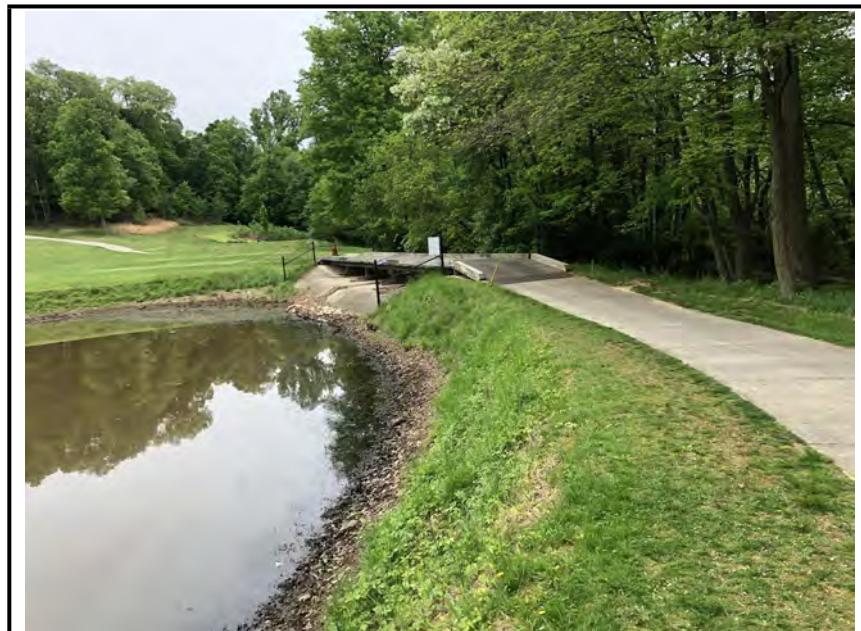
Stormwater exits this facility through a dam, which is in very poor condition. The concrete is crumbling, and the low flow pipe is encased in a broken wooden box. There is considerable debris buildup on the front of dam, as well as errant sand bags lying around.

**Photo #2:** Front of the dam.

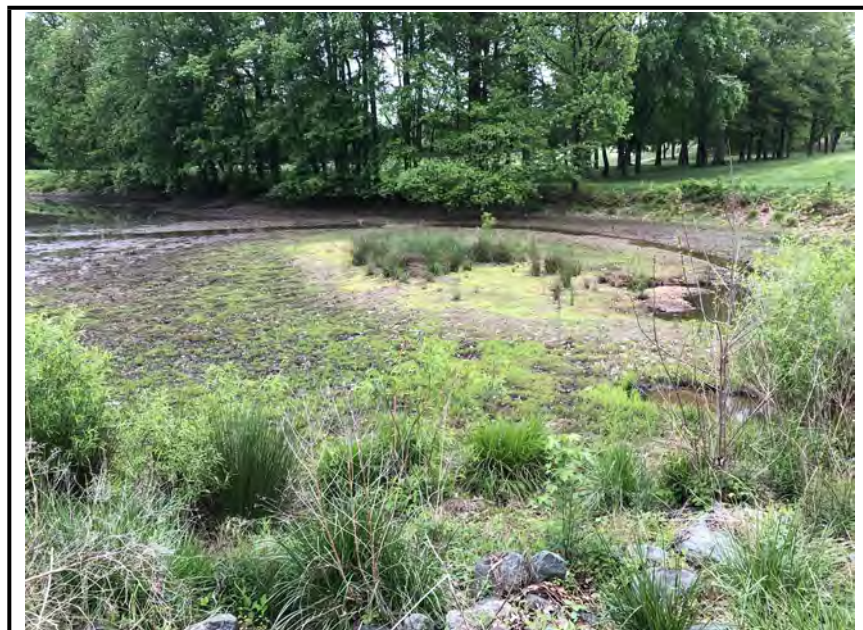
**Photo #4:** Filter area of the facility.

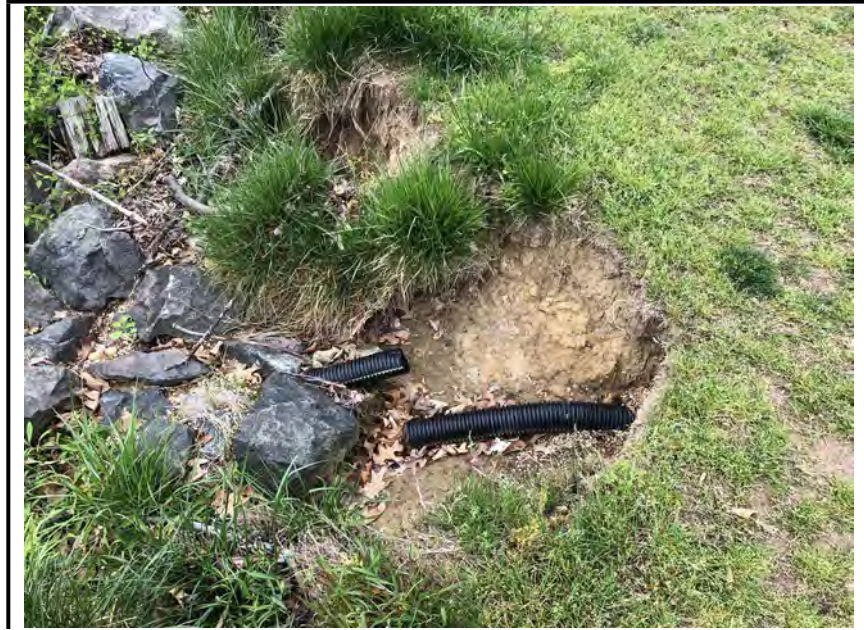
Photo #5: Broken pipe on edge of the filter area.

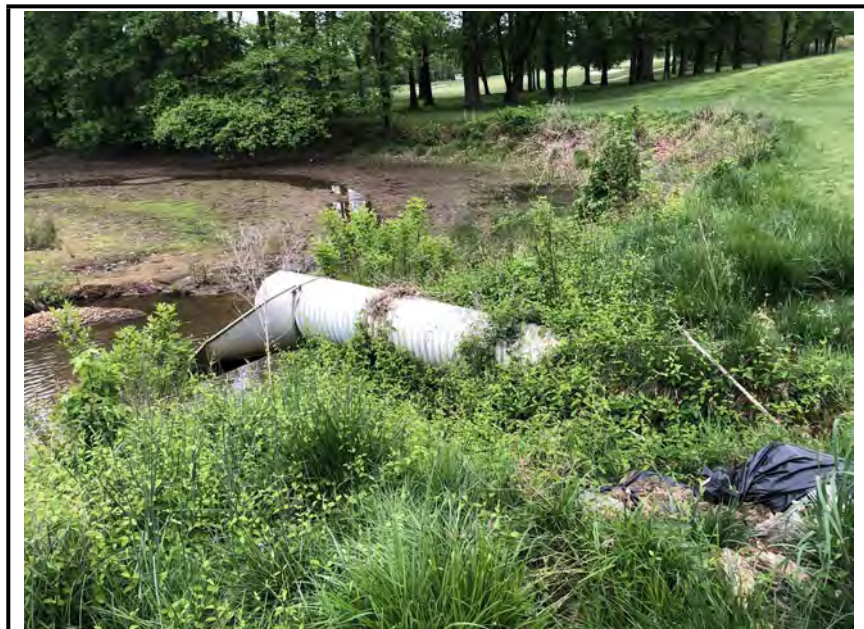
Photo #6: Exposed inflow culvert.

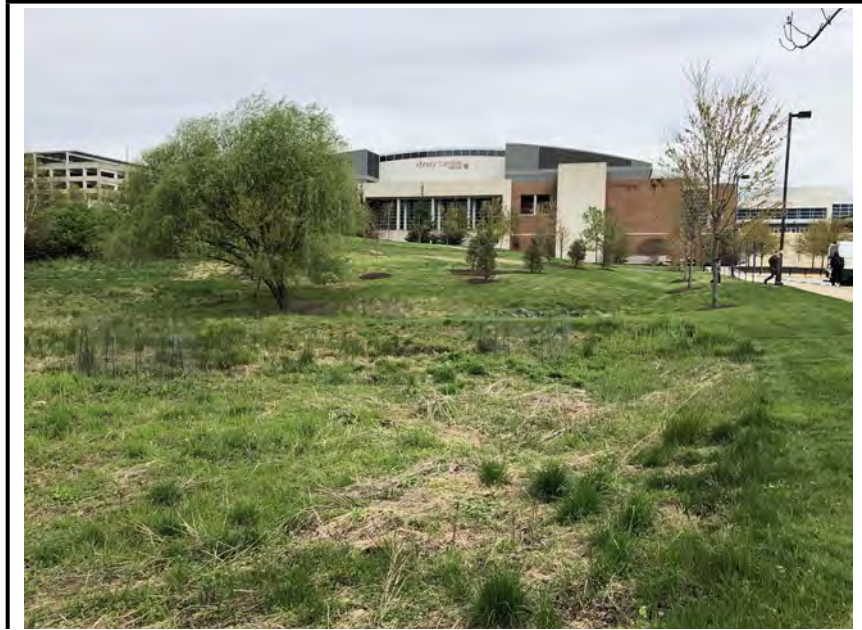
This facility is in poor condition. There is standing water surrounding each cleanout. The filter bed appears to be clogged. The only vegetation are weeds and grass, and low flows do not appear to be able to enter the facility.

Photo #1: View into facility.

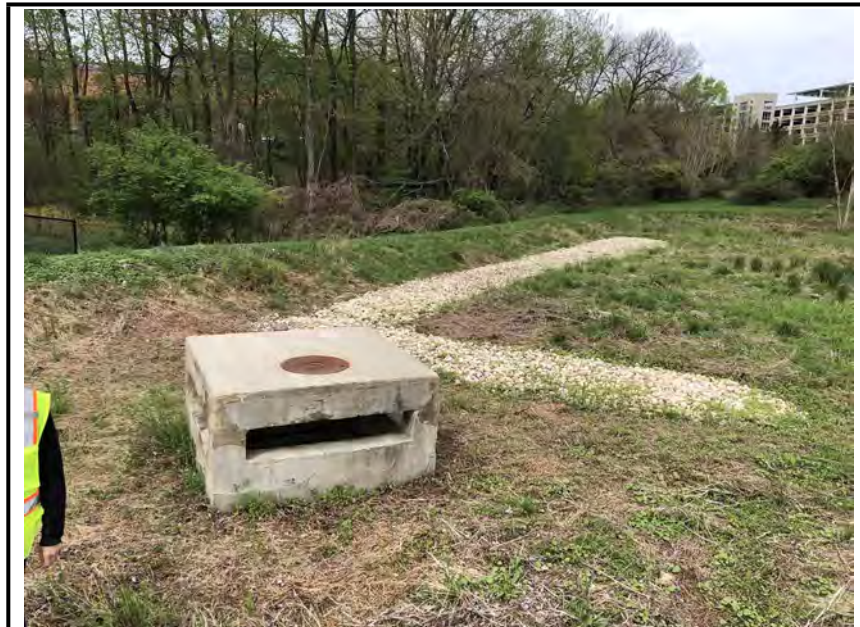
Photo #2: Outlet structure.

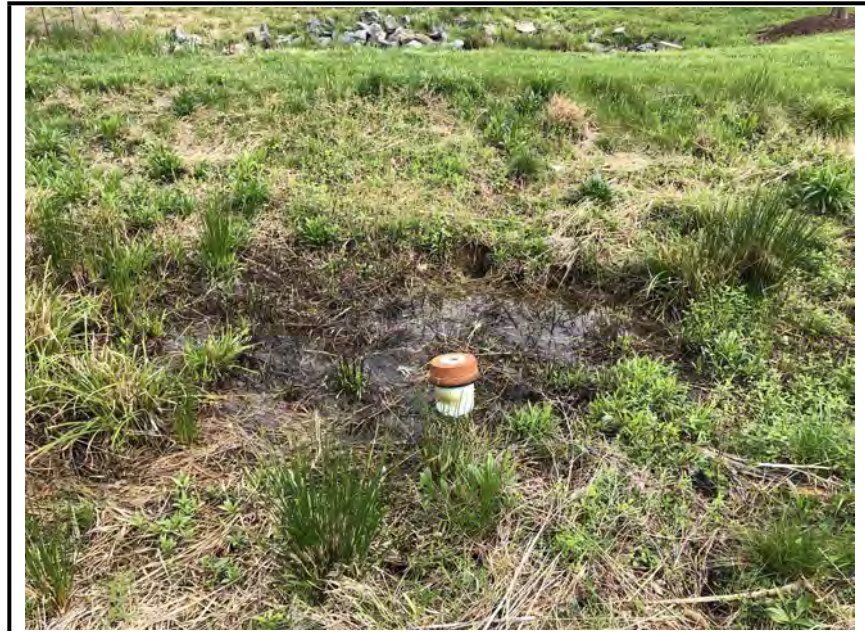
**Photo #3:** Ponding water around one of the cleanouts.

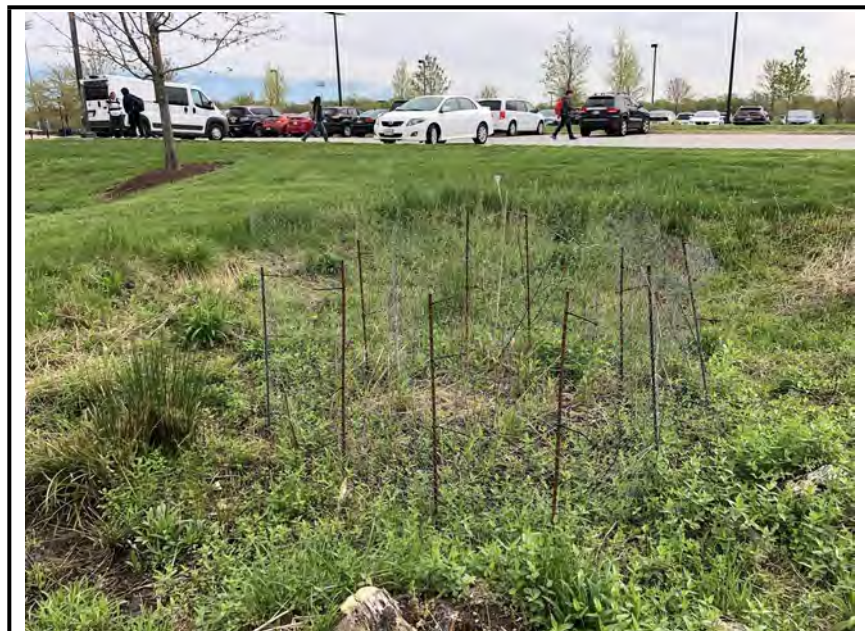
**Photo #4:** Chicken wire inside of facility filter area.

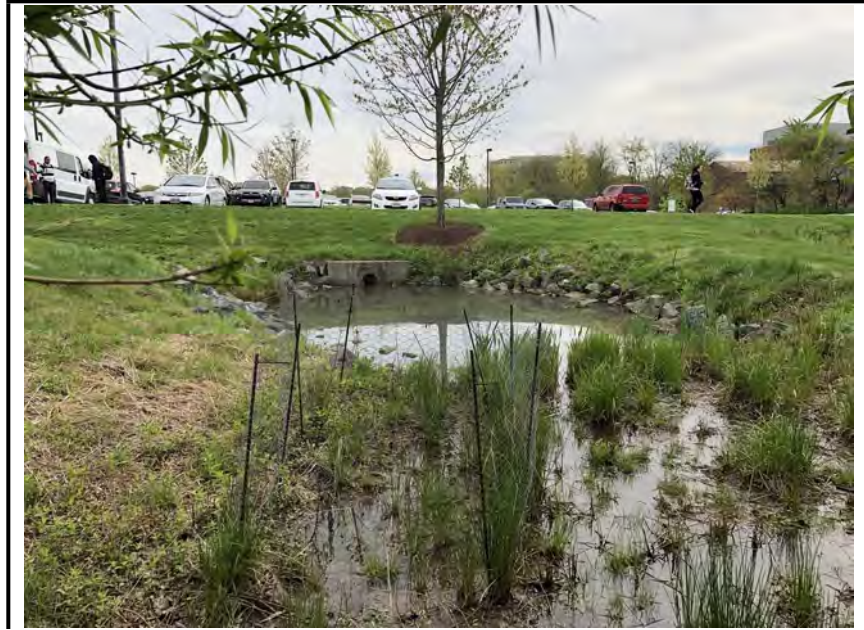
Photo #5: Forebay pretreatment area.

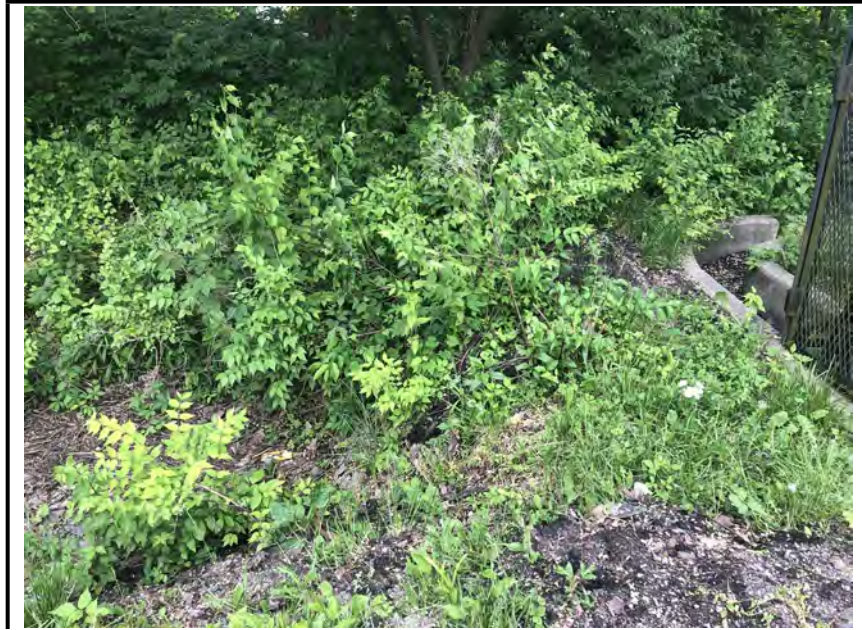
Overall, this facility is in fair condition. The vegetation is overgrown, and the filter area is full of weeds and invasive species. Inside the facility there is trash, rocks, and leaf debris.

**Photo #1:** Overgrown vegetation in the filter area.

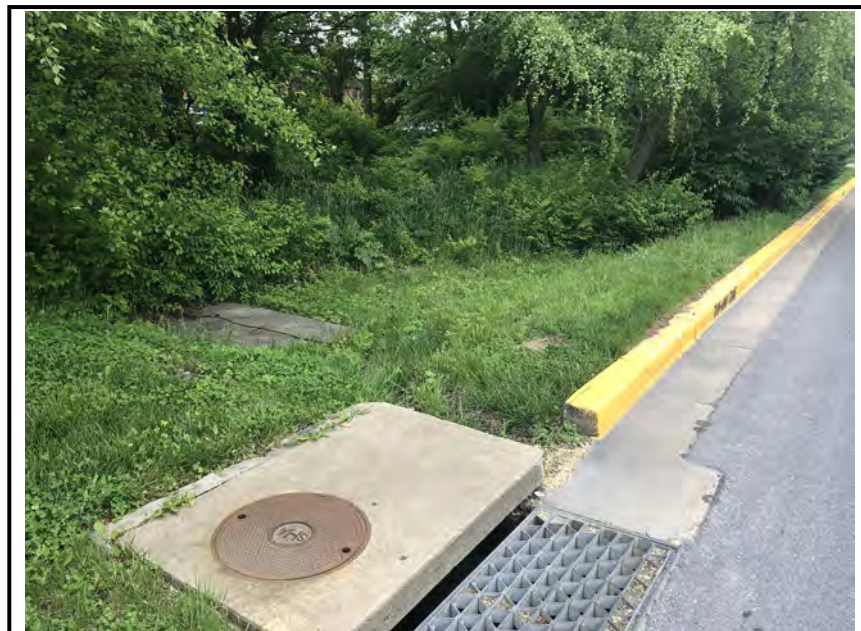
**Photo #2:** Inlet next to the inflow curb cut.

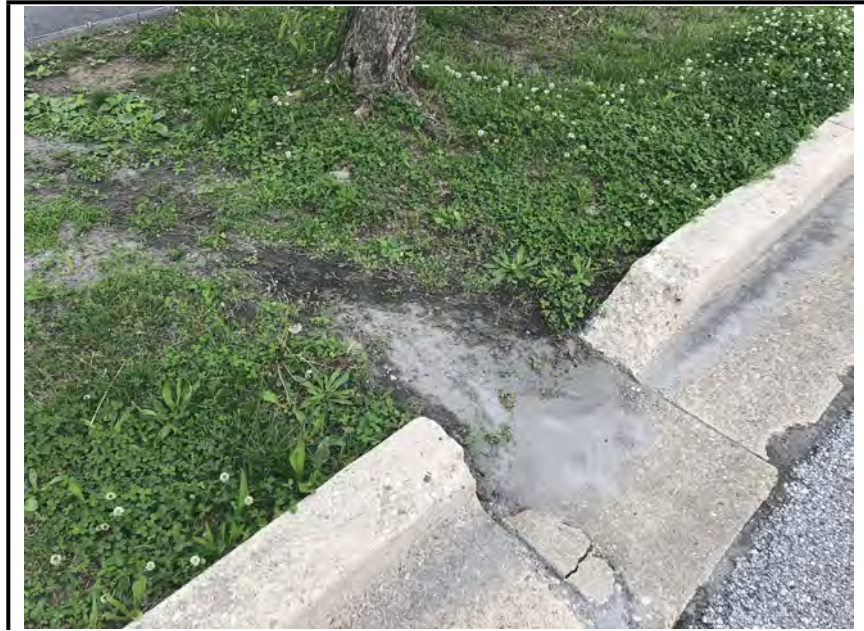
This facility is in fair condition. The metal on one curb cut is broken, and the curb cut is clogged and touching pavement with no opening.

**Photo #1:** Eroded curb cut.

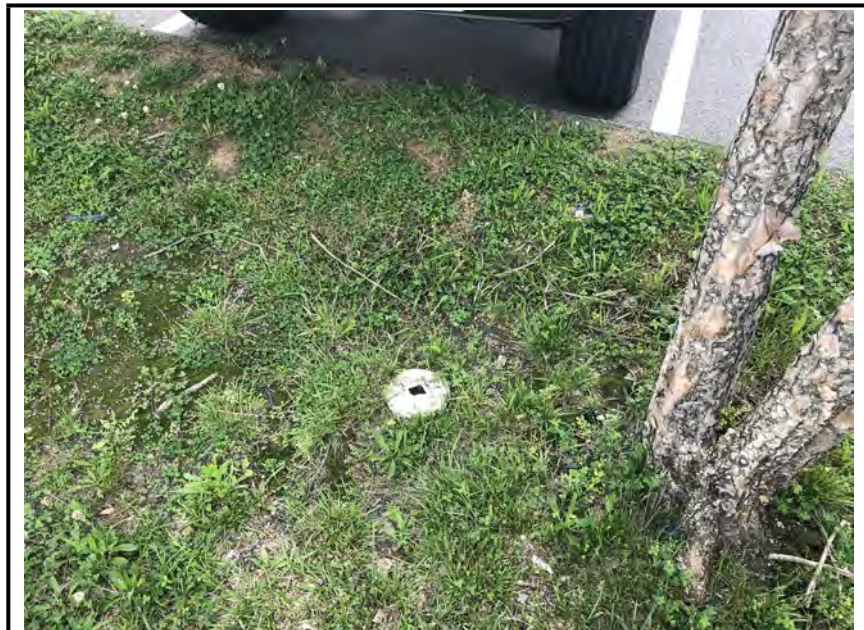
Runoff exits the facility through infiltration. The broken cleanout inside the facility suggests the presence of an underdrain.

**Photo #2:** Broken cleanout.

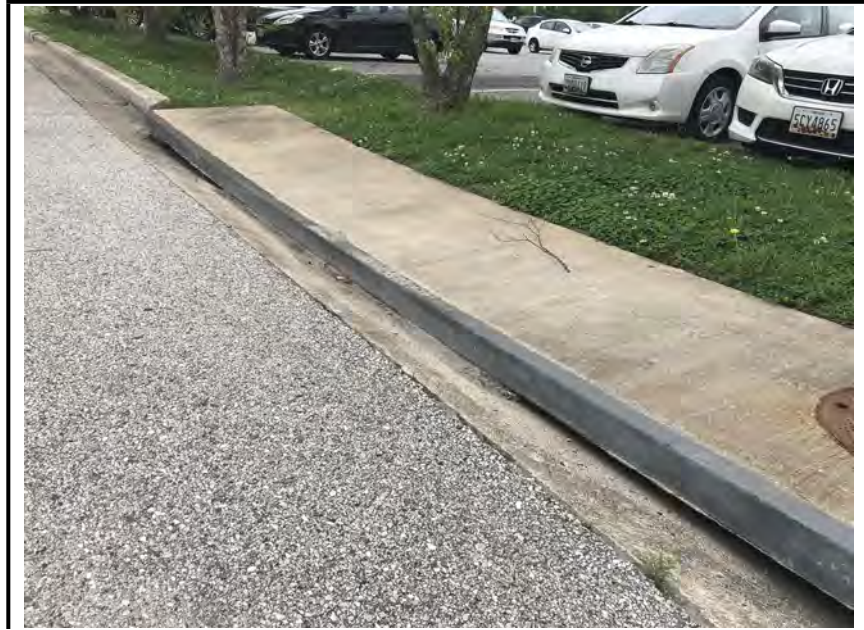
Photo #3: Collapsing curb inlet.

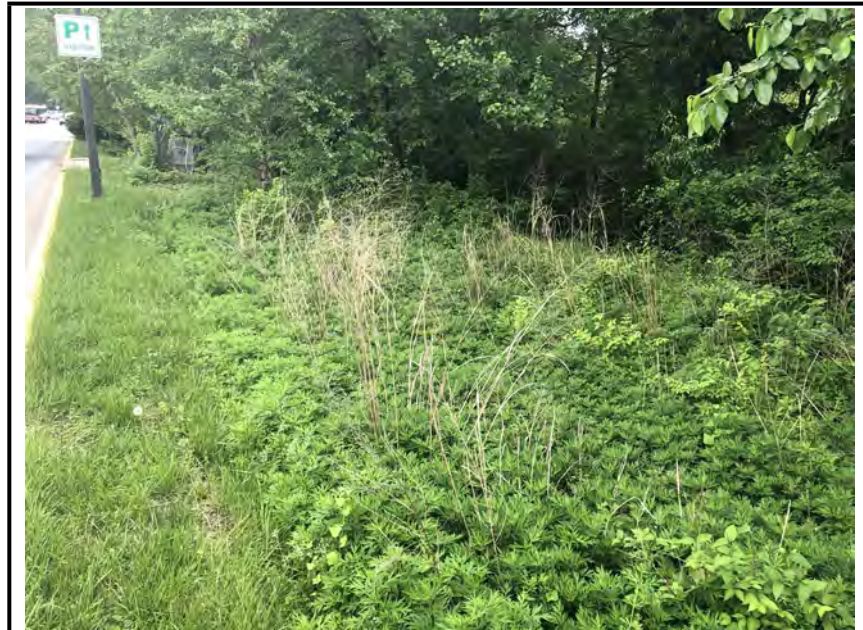
Overall the facility is in poor condition. The location and height of the outfall suggests that water is not infiltrating through the media. The facility is not designed in a way that would make it function effectively. Additionally, the facility area is overgrown and filled with weeds.

Photo #1: View of the overgrown filter area.

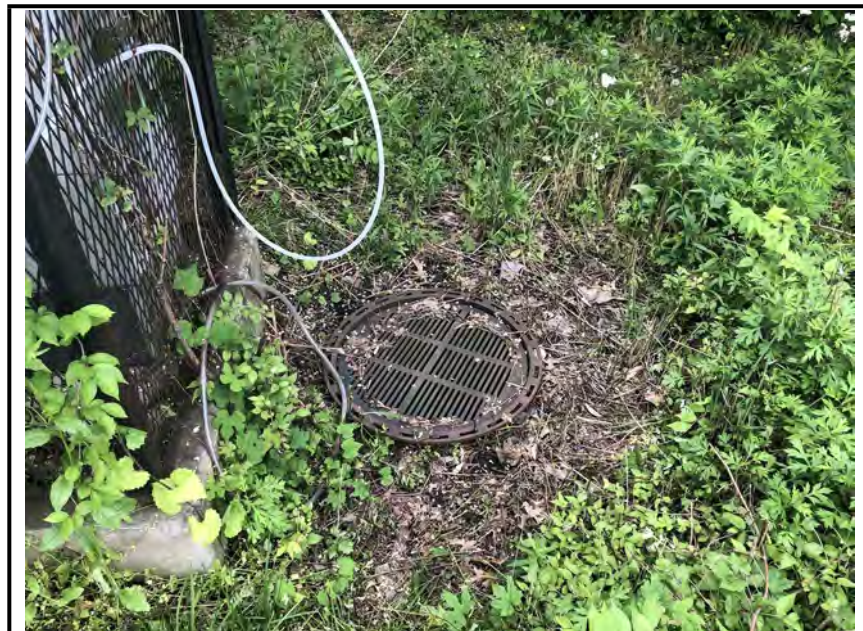
Photo #2: Outlet structure next to the inflow channel.

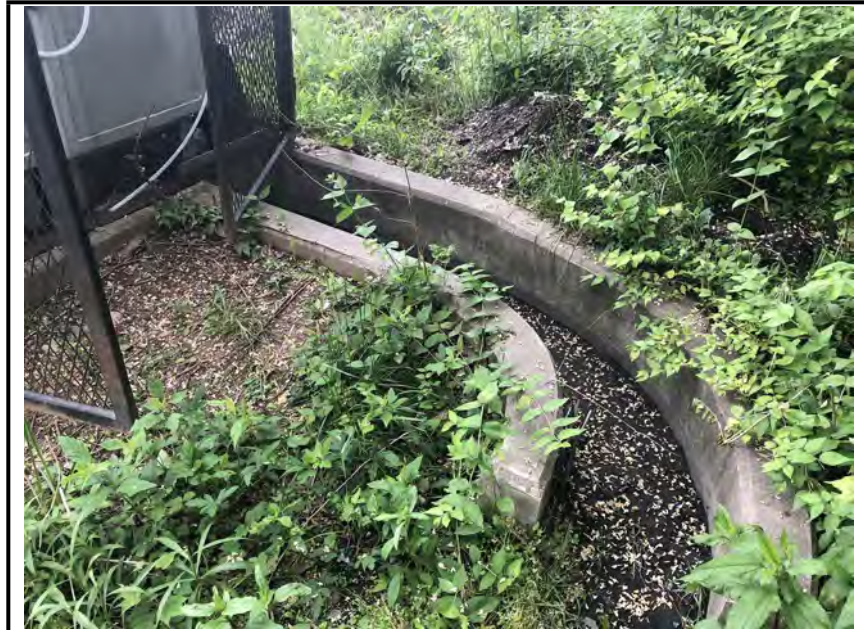
Photo #3: Inflow channel to the facility.

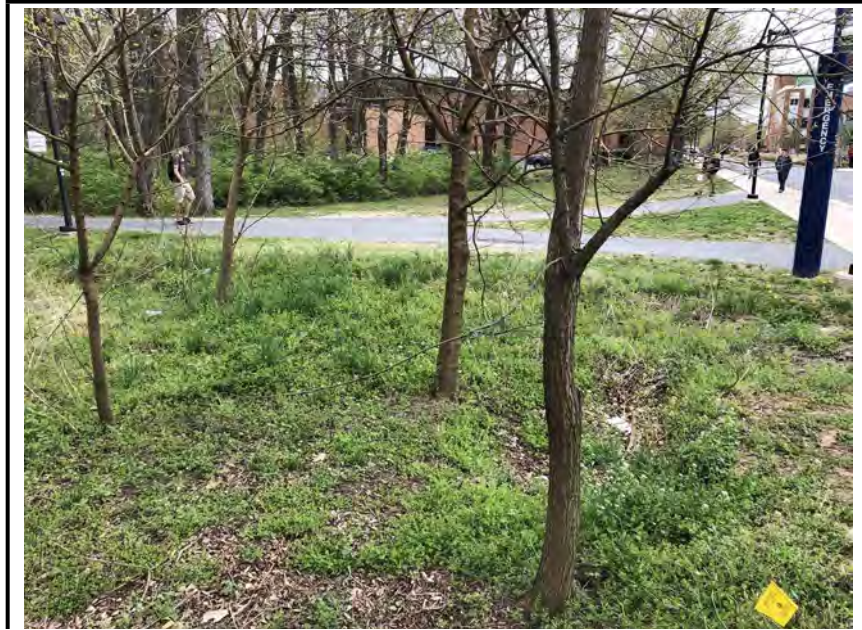
Overall this facility is in poor condition. The facility is indistinguishable from the forest and grass areas that surround it. It appears that no maintenance has been done for many years. Two cleanouts are missing tops, and the sides of the facility are heavily eroded.

**Photo #1:** View into the facility.
