University of Maryland, College Park  
National Pollutant Discharge Elimination  
System MS4 Phase II  
FY2019 Annual Report  
General Discharge Permit #13-SF-5501

## **Stormwater Treatment Final Report & Recommendations**

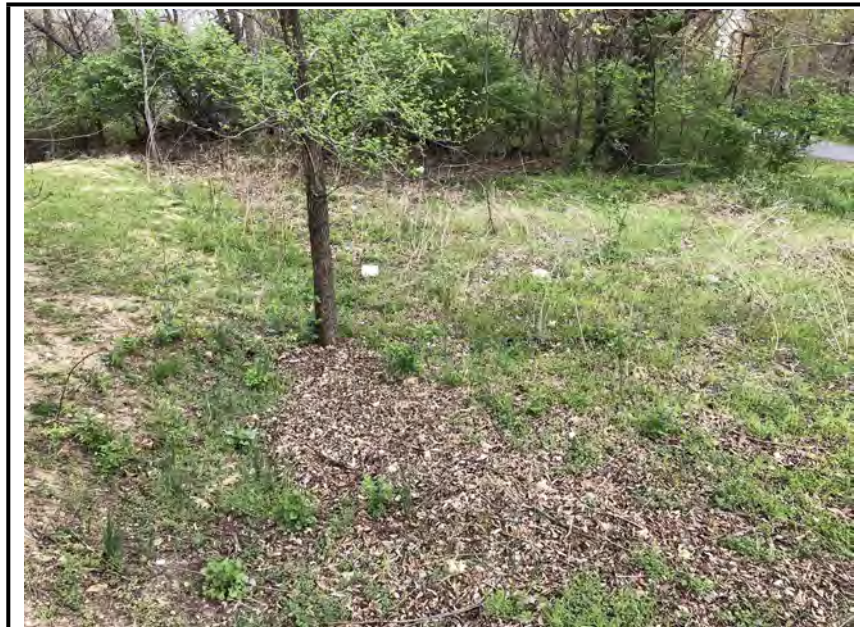
**Photo #2:** The filter area of the facility.

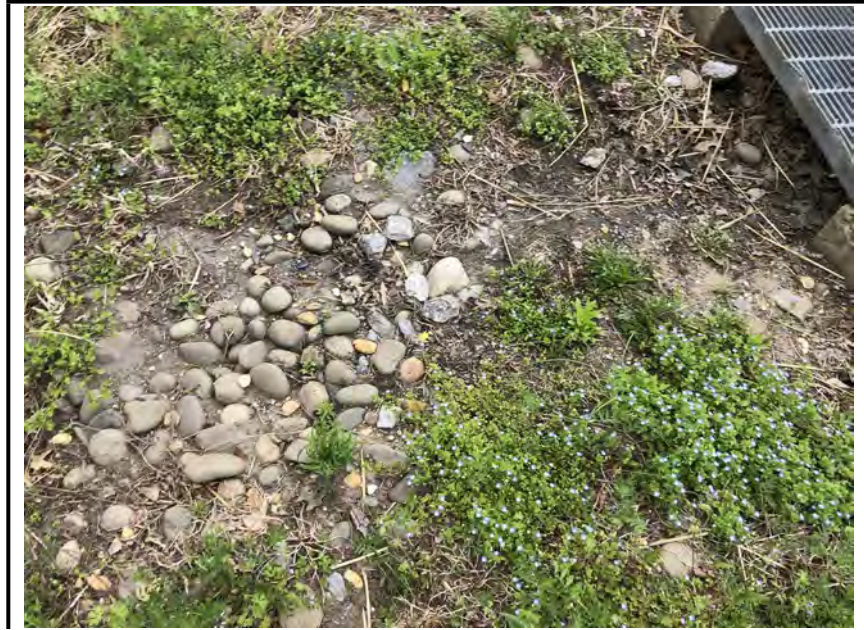
**Photo #3:** The inflow point of the facility.

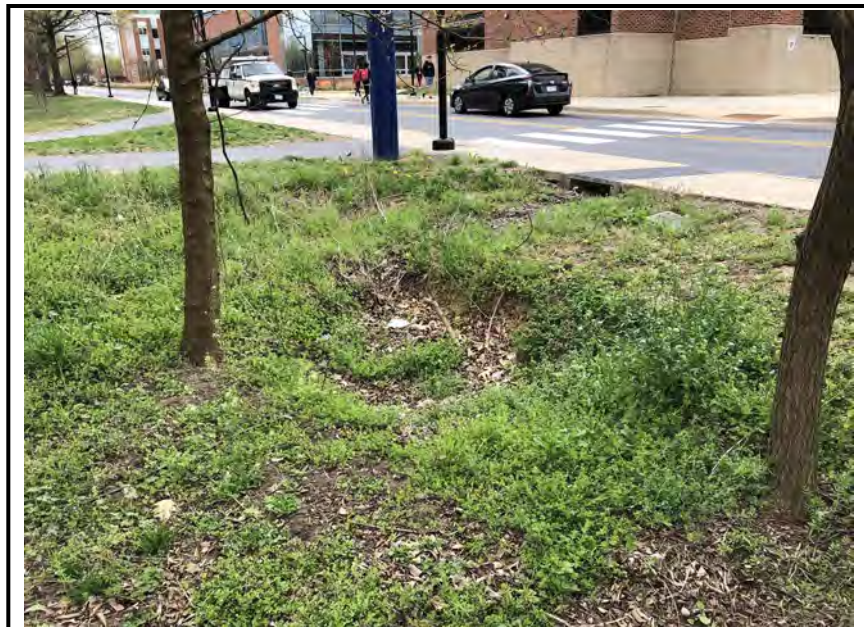
**Photo #4:** Erosion on the side slopes.

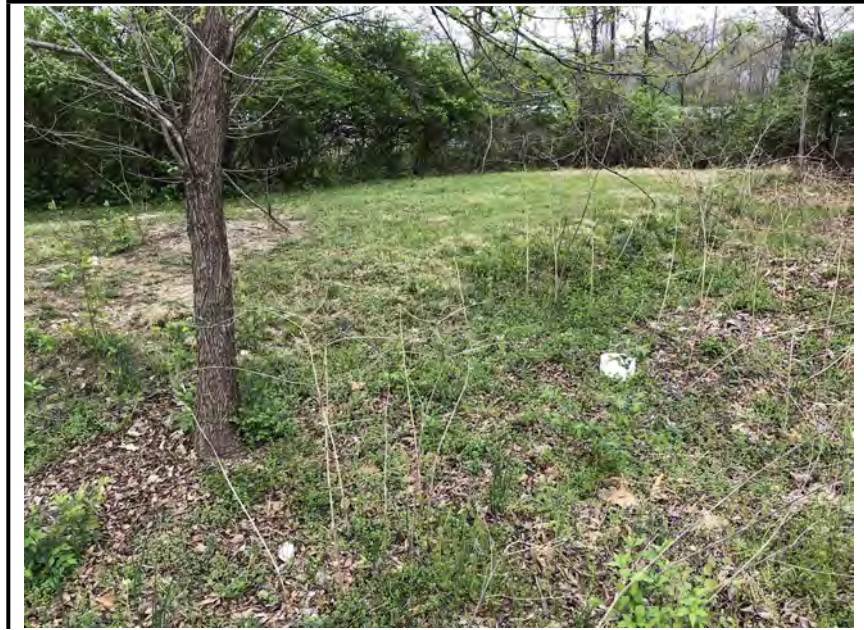
Photo #5: View into the facility and surrounding area.

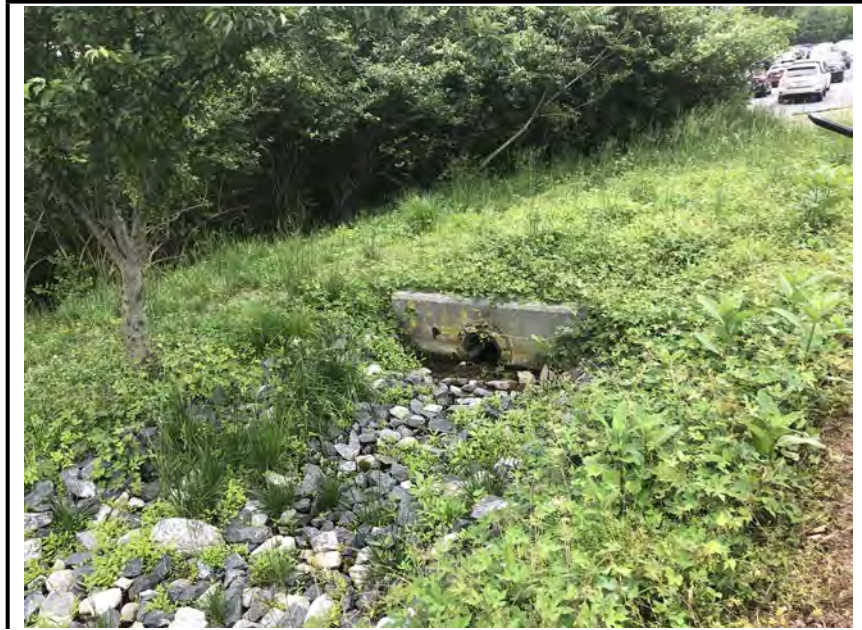
**Photo #1:** The inflow culvert to the facility.

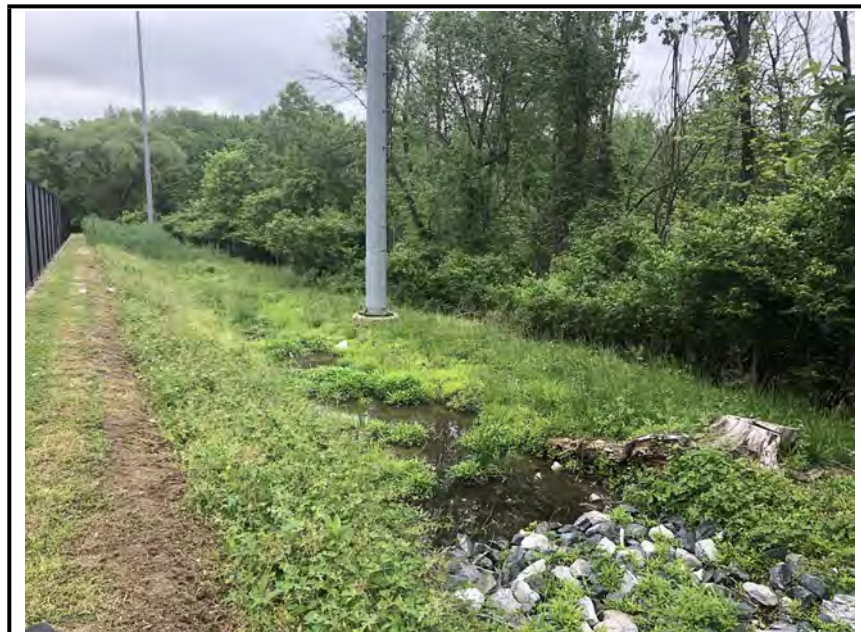
This facility is in fair condition. There is a thick grove of bamboo, an invasive species, in the middle of the facility. Additionally, there is a large amount of trash and standing water in the filter area. The side slopes have eroded, and the grass in the filter area is being overtaken by weeds.

**Photo #2:** View into the facility.

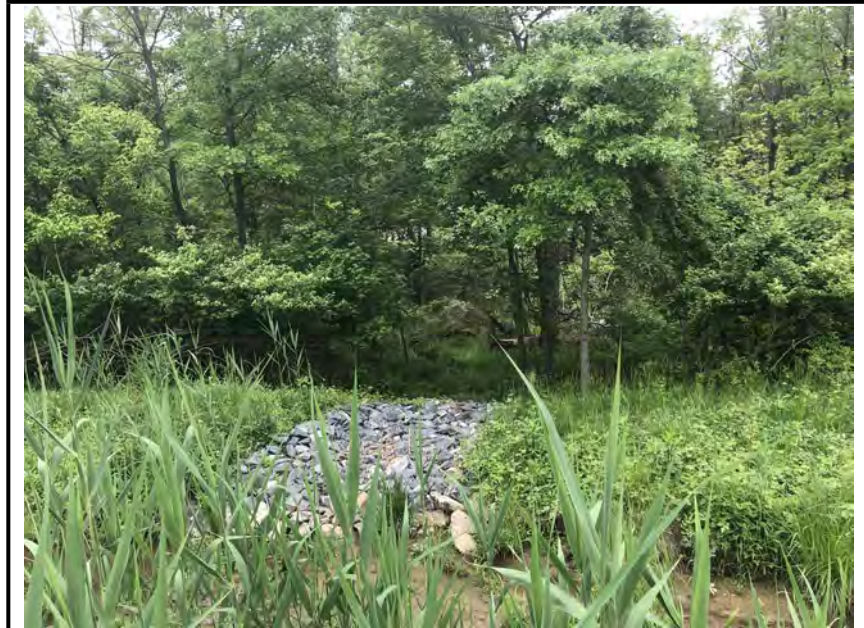
**Photo #3:** The riprap spillway.

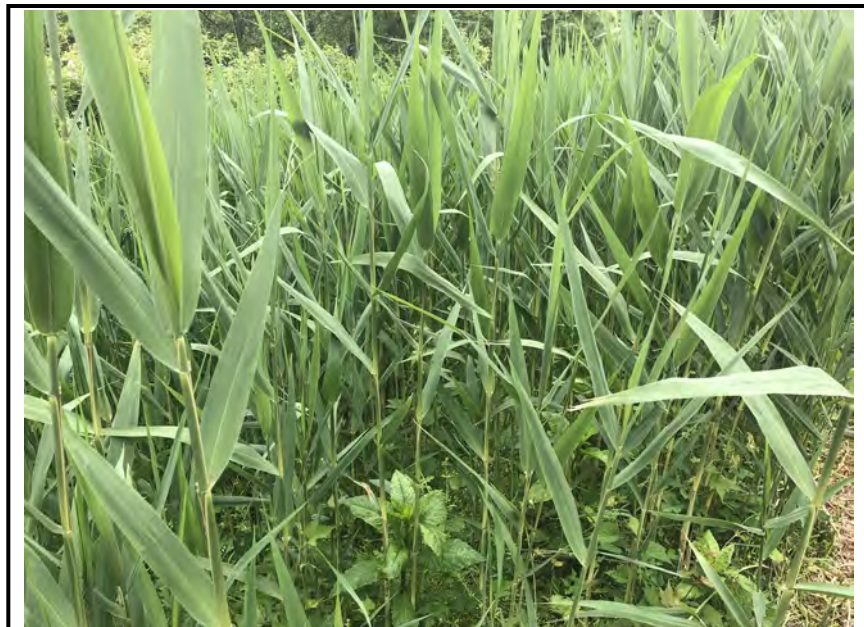
**Photo #4:** The thick grove of bamboo in the filter area.

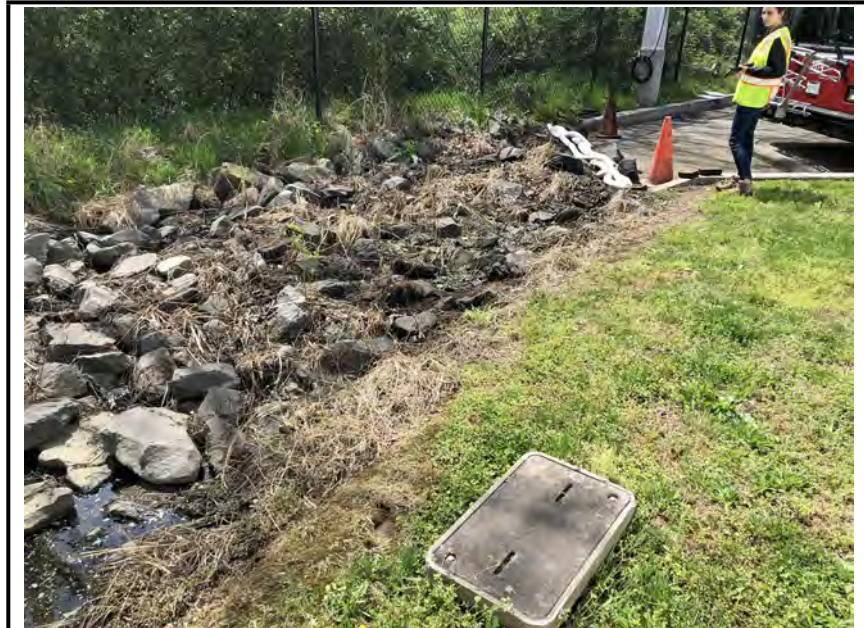
**Photo #3:** The riprap inflow channel.

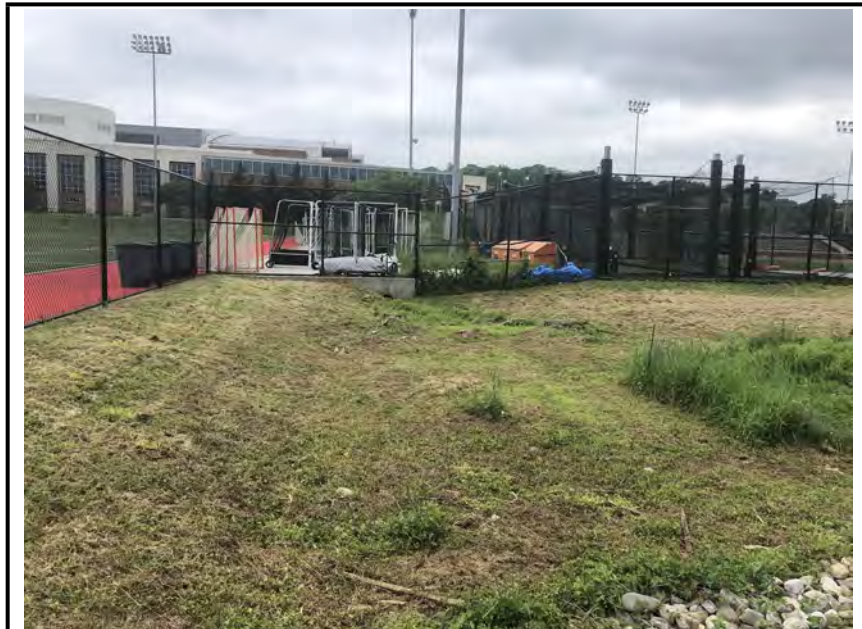
This facility is in poor condition. The entire filter area has been mowed, and the only vegetation present is grass and one planting area that is inexplicably surrounded by chicken wire. The side slopes have eroded so that this looks more like a depressed grass area than a stormwater facility. There is one line of river rock in the middle of the filter area. The cleanouts have been broken by a lawn mower.

**Photo #2:** View into the facility.

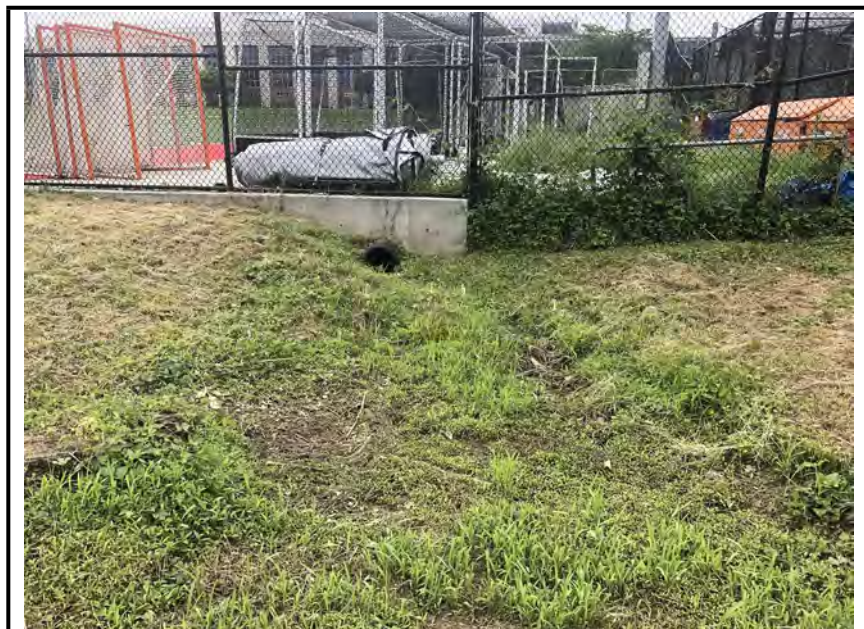
**Photo #4:** Inflow pipe and channel.

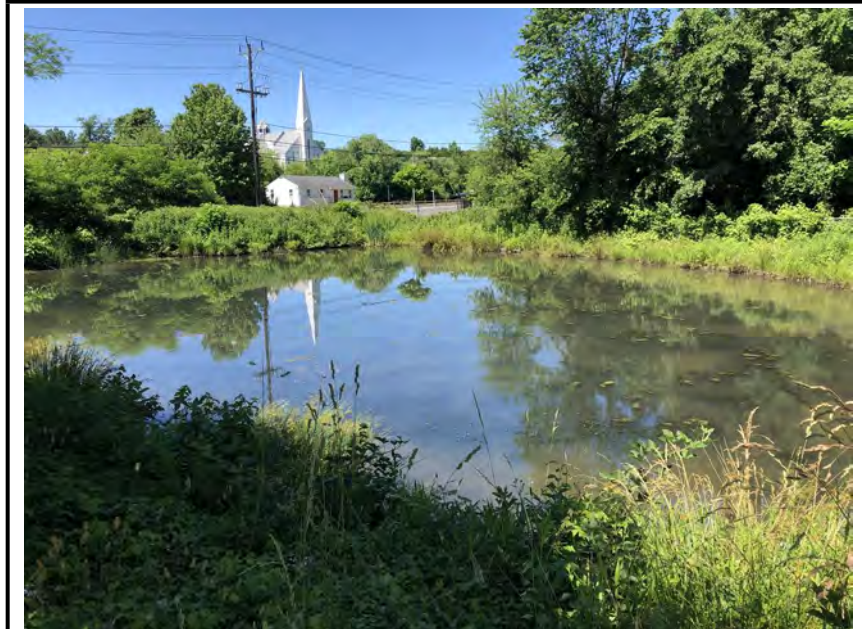
**Photo #1:** View into the facility.

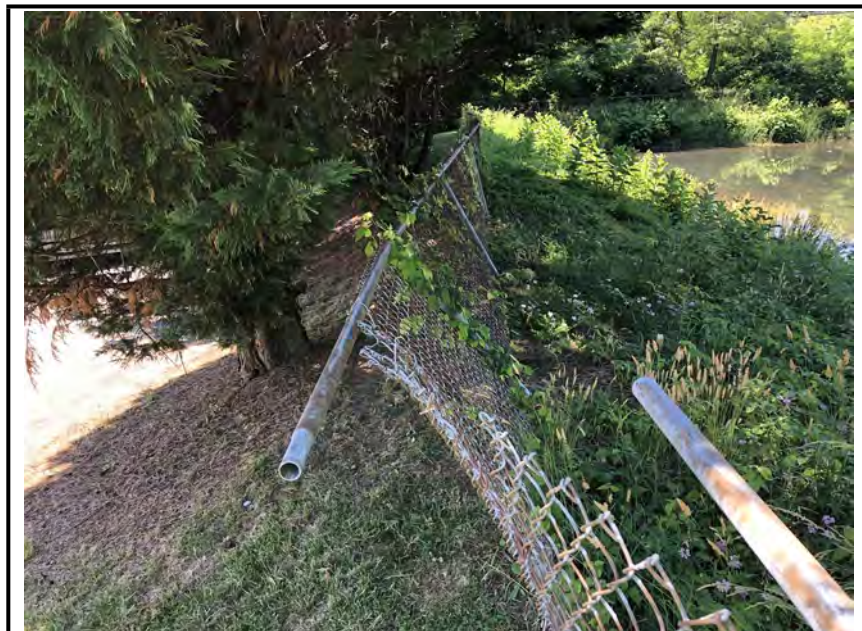
**Photo #2:** A section of broken fence.

This facility is in fair condition. The inflow swale should be cleared out, and riprap should be installed in the channel. The fence is broken in many places should be removed.

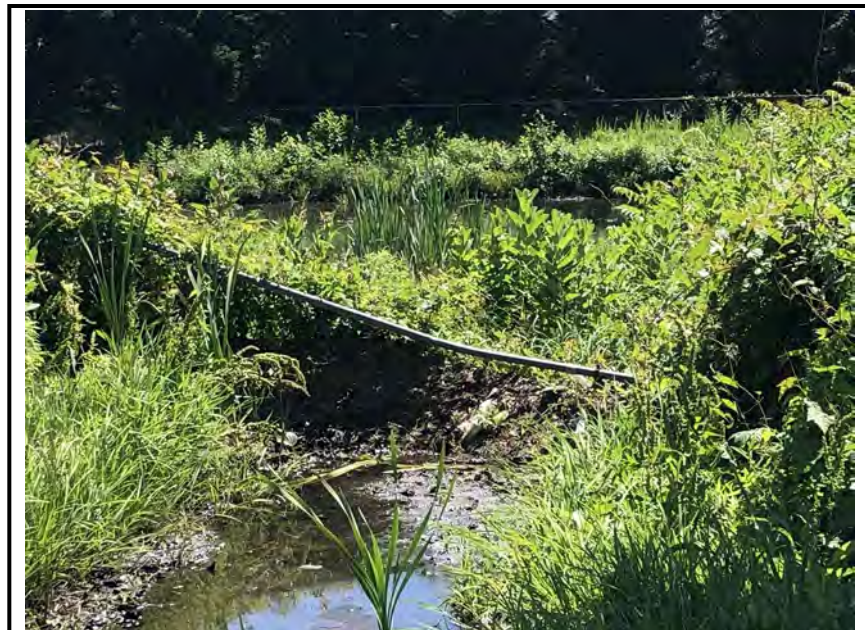
**Photo #4:** The section of collapsed and clogged fence in the inflow swale.

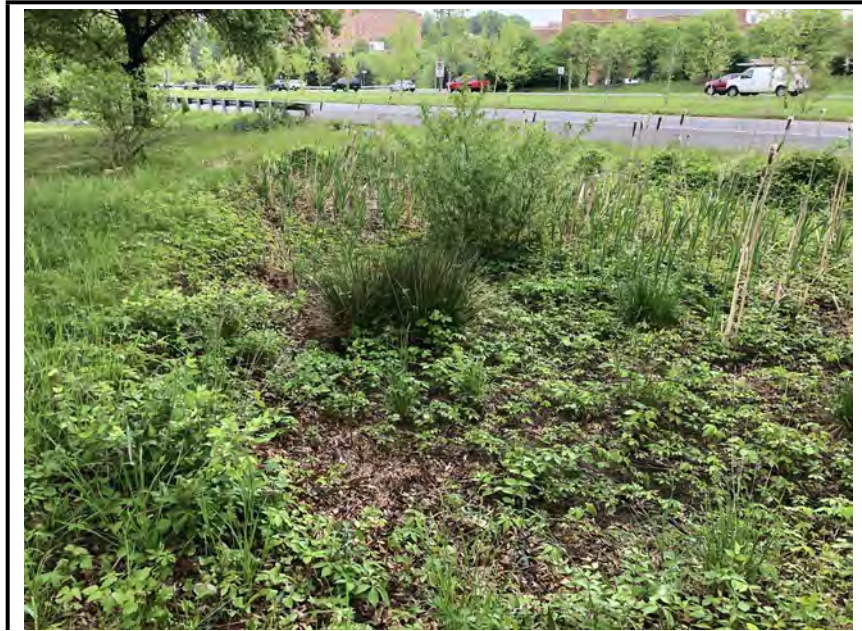
The rain garden is in poor condition and has not been maintained. Invasive plants such as cattails, poison ivy, and English ivy are present within the filter area and on the side slopes. Leaf debris is present throughout the facility. Side slopes show signs of erosion.

Photo #1: View into the facility.

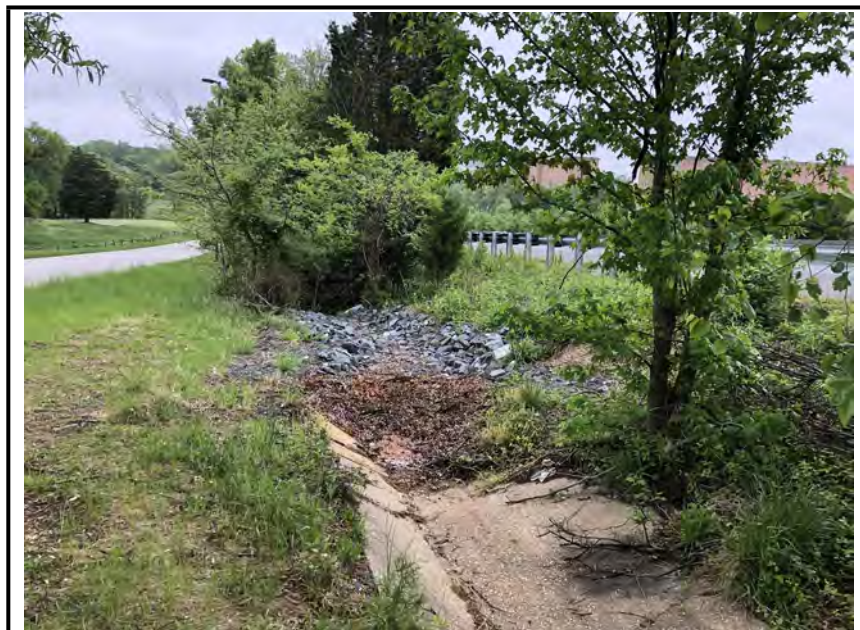
Photo #2: Inflow into the facility.

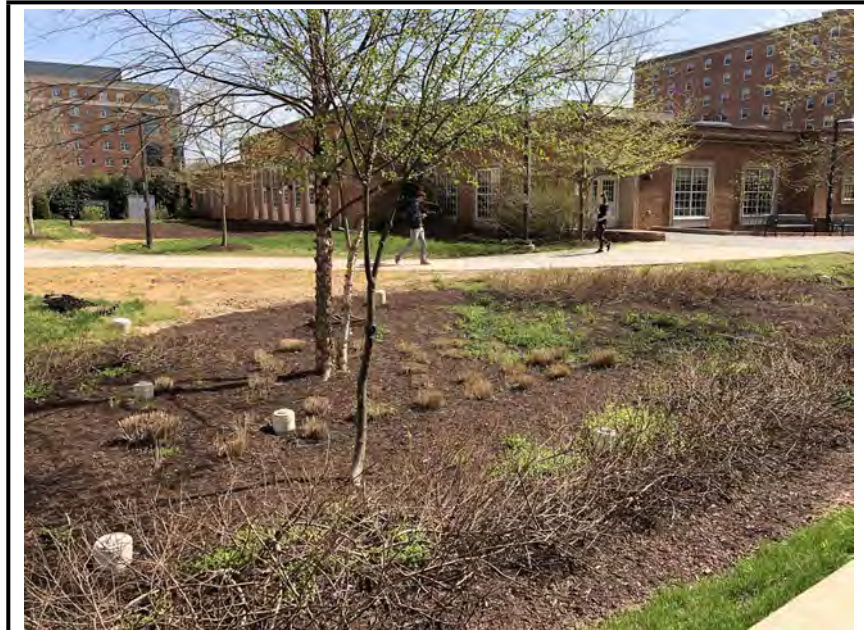
This facility is in poor condition. The forebay shows signs of erosion that suggest that it is undersized. Three of the cleanouts are missing pieces. The weir is covered by mulch and is level with the bottom elevation of the forebay.

Photo #1: View into the facility.

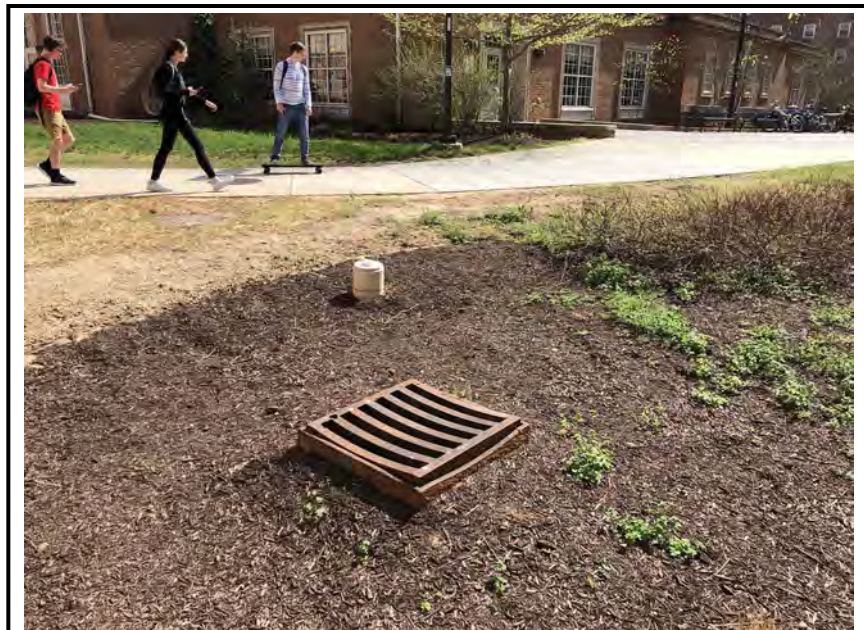
Photo #2: The riser outlet structure.

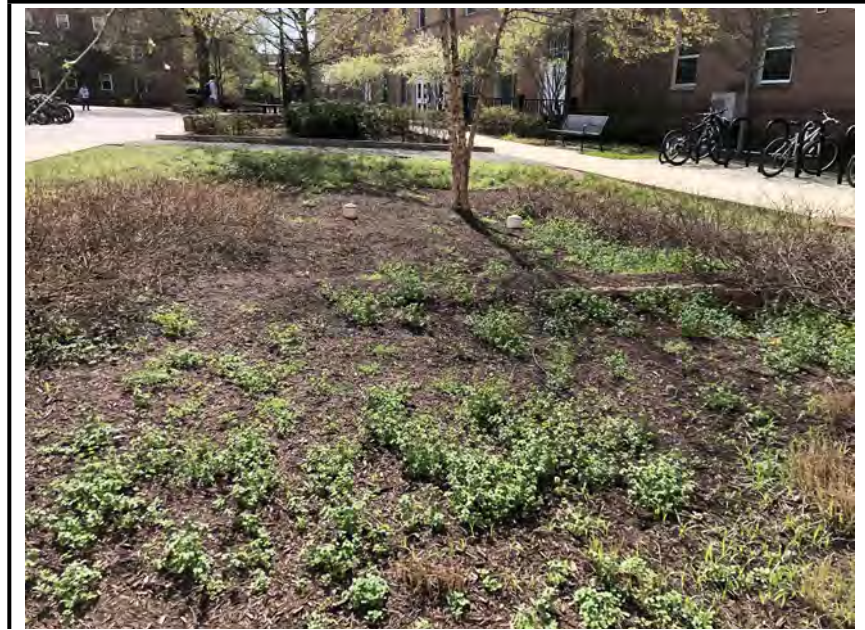
**Photo #3:** View of the facility from the forebay.

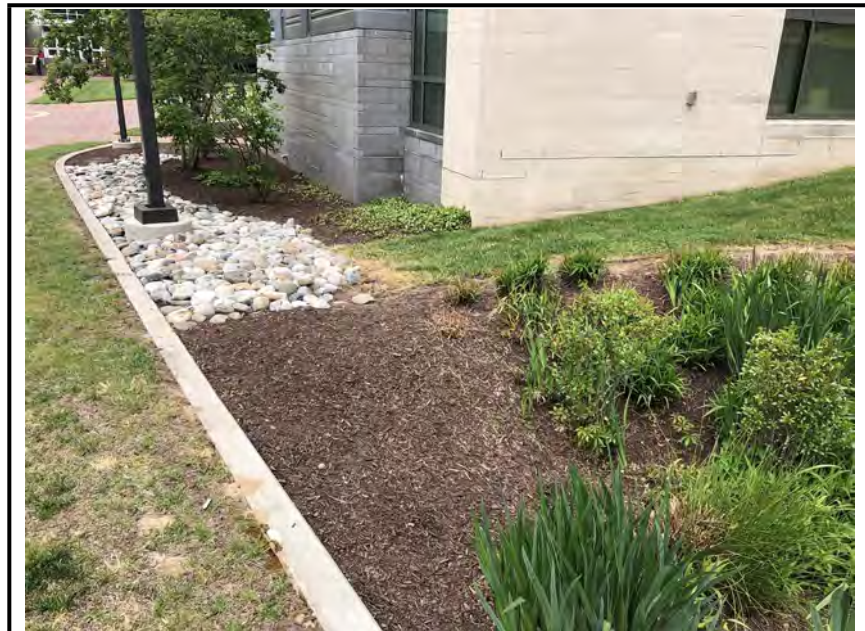
**Photo #4:** Curb lines the outside edge.

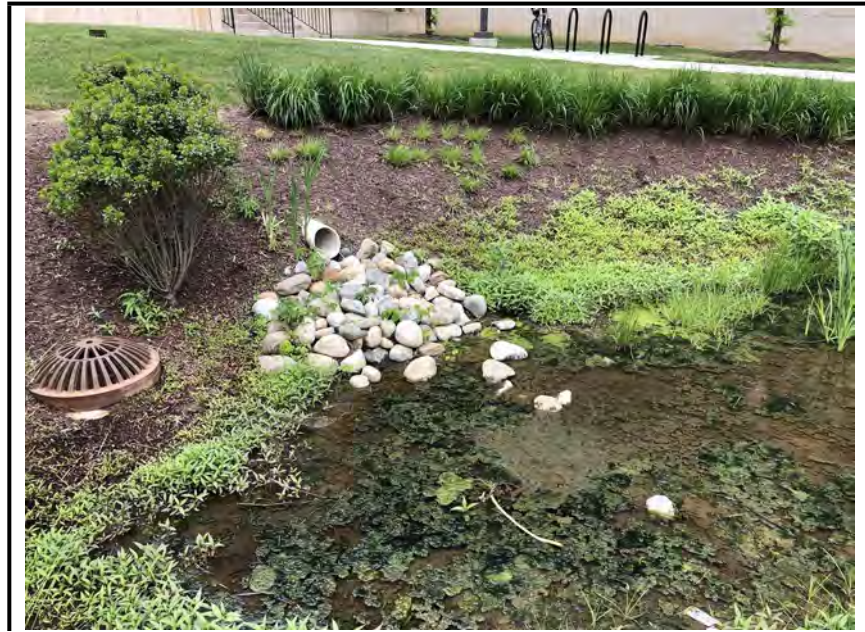
**Photo #3:** Algae and standing water next to the outflow structure.

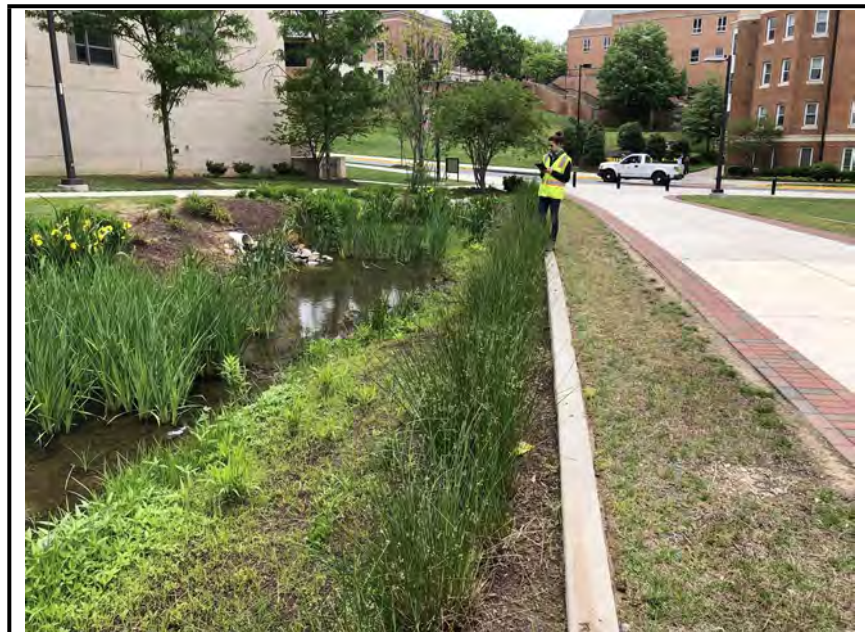
**Photo #4:** View of the facility.

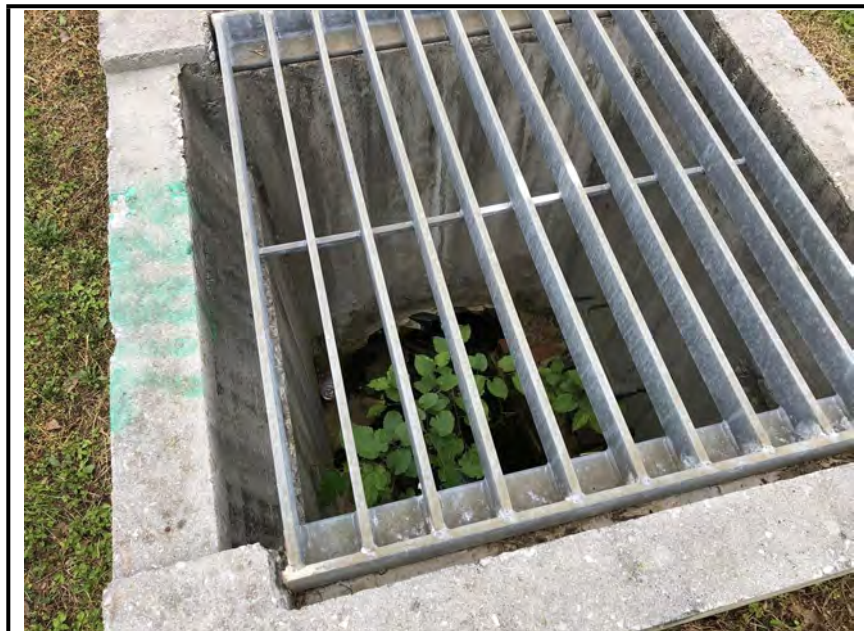
The facility outflows through infiltration and an overflow riser. There is a plant growing within the overflow riser.

Photo #2: Vegetation growing inside the outfall structure.

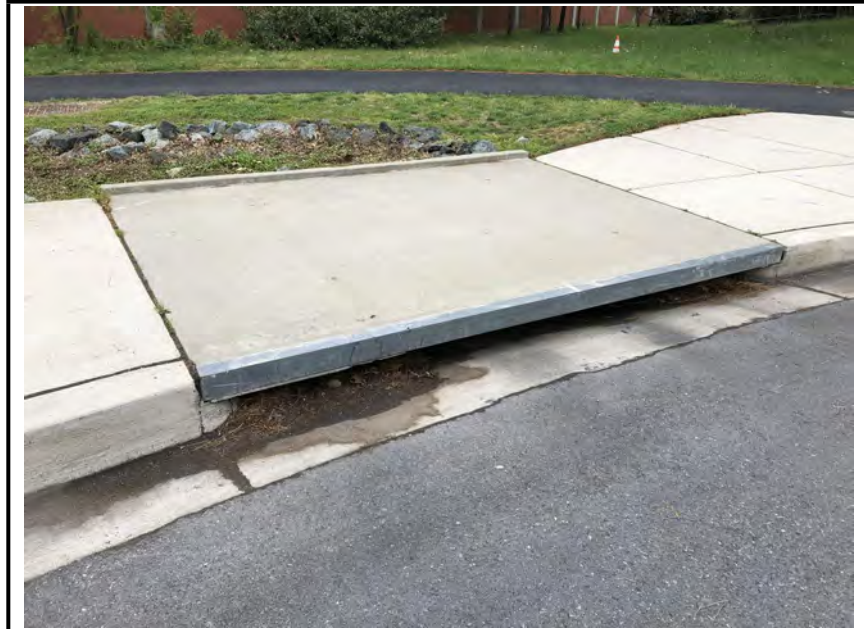
The bioretention filter area is covered by a layer of leaf debris. Trash is present within the facility. The side slopes of the bioretention area show signs of erosion. This facility is poor condition.

Photo #1: Inflow structure.

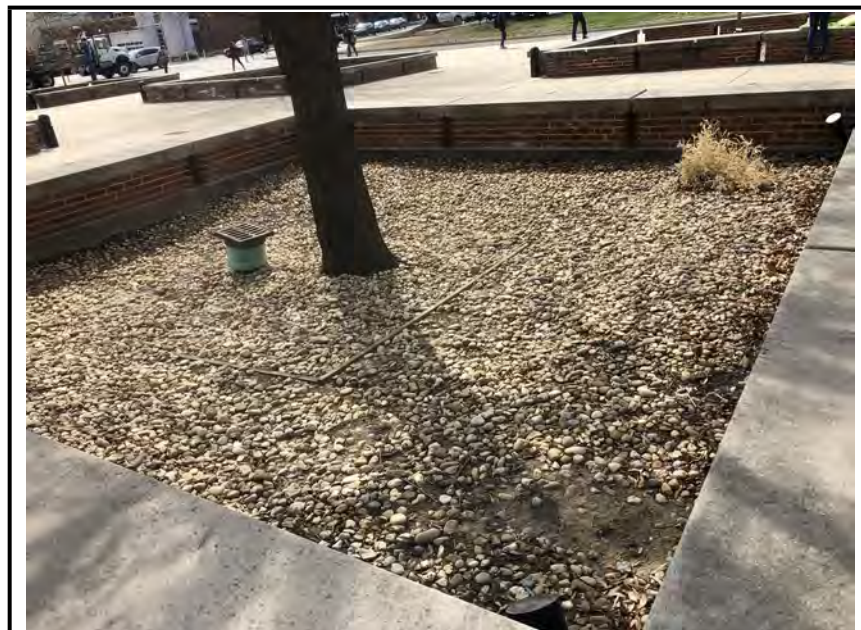
BMP SWF 134 is a shallow, gravel covered micro-bioretenion facility with no vegetation, except for one tree. The facility is 22 feet by 22 feet. At the time of inspection there was no standing water or algae present in the facility. Some erosion is apparent at the curb cut inflow areas. Aside from the lack of vegetation, this facility appears to be in fair condition. No MDE approved drawings were available, however it is assumed that the facility was designed according to Chapter 3 of the MDE Stormwater Manual. It does not meet the vegetation criteria of bioretention facilities. The facility also does not meet the pretreatment requirements of installing

a grass channel, grass filter strip, bottom sand layer, upper sand layer, or washed bank run as aggregate.

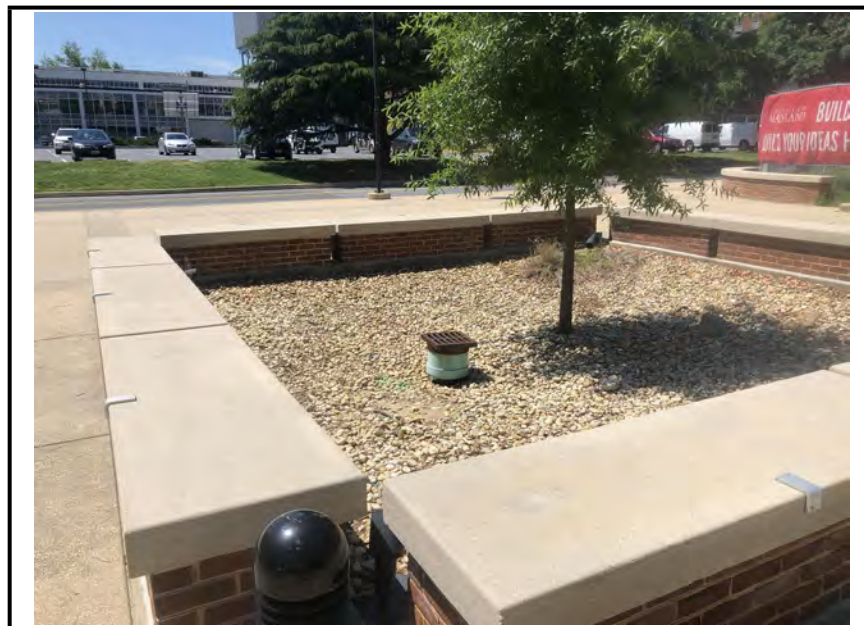
BMP SWF 135 is a shallow, gravel covered micro-bioretenion facility with no vegetation, except for one tree. The facility is 22 feet by 22 feet. At the time of inspection there was no standing water or algae present in the facility. There was trash present, and several weeds. The center surface of the facility is sunken down due to settling over time. Aside from the lack of vegetation, this facility appears to be in fair condition. No MDE approved drawings were available, however it is assumed that the facility was designed according to Chapter 3 of the MDE Stormwater Manual. It does not meet the vegetation criteria of bioretention facilities. The facility also does

not meet the pretreatment requirements of installing a grass channel, grass filter strip, bottom sand layer, upper sand layer, or washed bank run as aggregate.

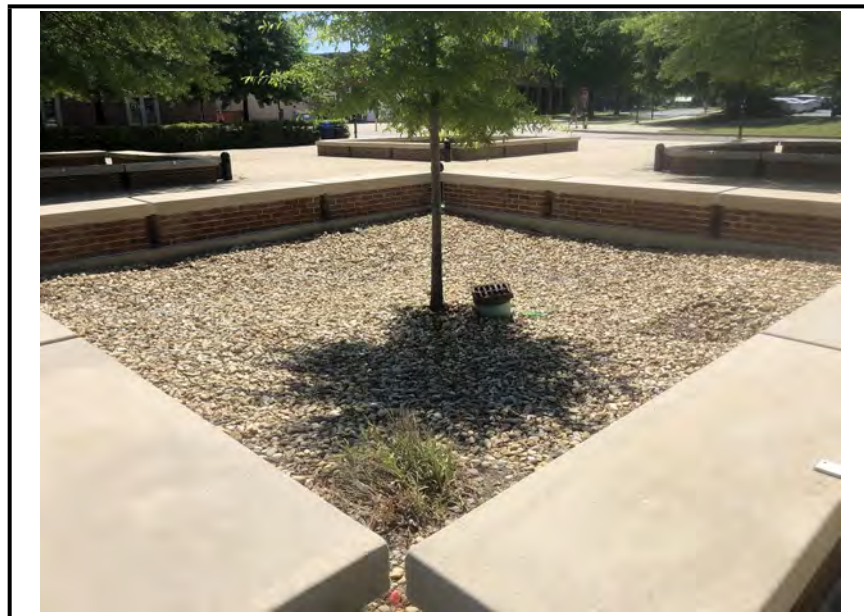
BMP SWF 136 is a shallow, gravel covered micro-bioretenion facility with no vegetation, except for one tree. The facility is 22 feet by 22 feet. At the time of inspection there was no standing water or algae present in the facility. Some erosion is apparent at the curb cut inflow areas. Aside from the lack of vegetation, this facility appears to be in fair condition. No MDE approved drawings were available, however it is assumed that the facility was designed according to Chapter 3 of the MDE Stormwater Manual. It does not meet the vegetation criteria of bioretention facilities. The facility also does not meet the pretreatment requirements of installing

a grass channel, grass filter strip, bottom sand layer, upper sand layer, or washed bank run as aggregate.

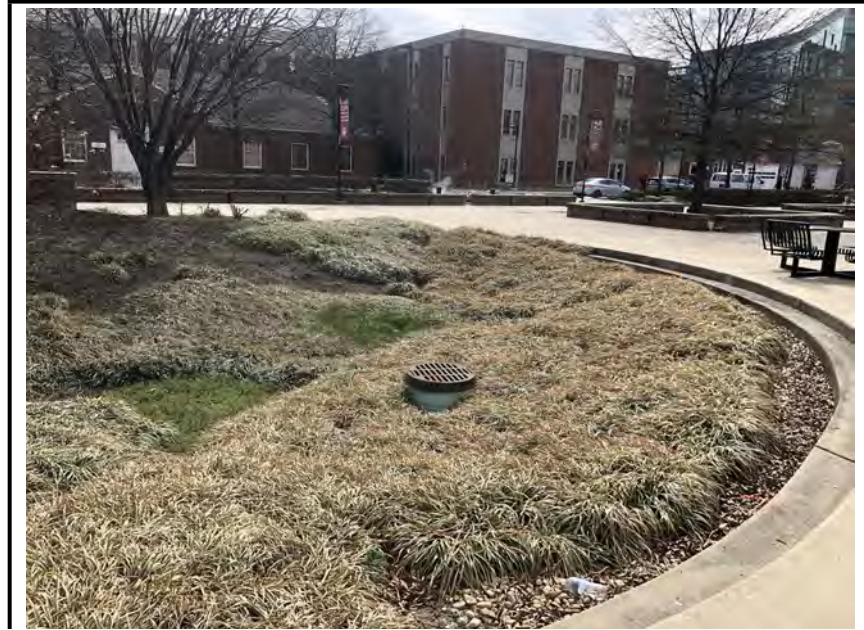
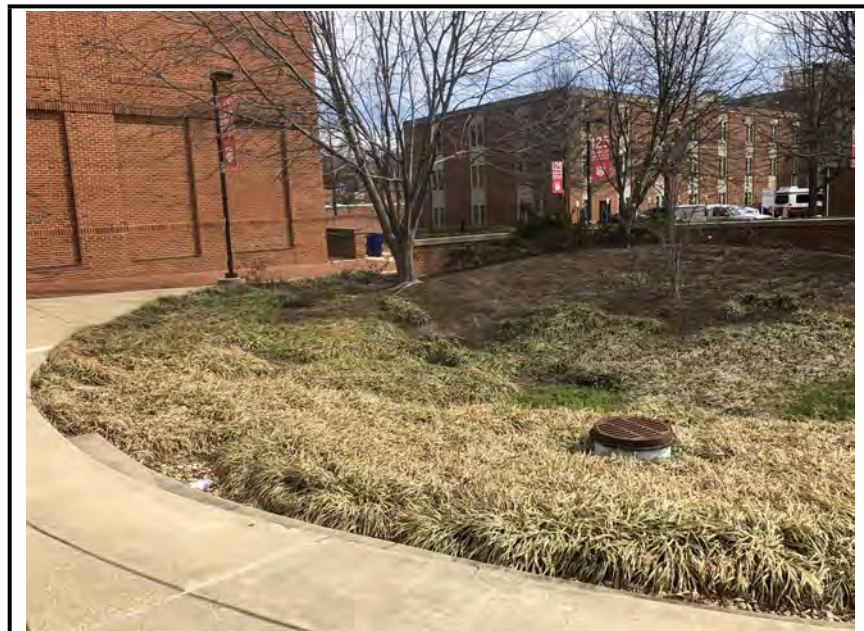
BMP SWF 142 is a circular bioretention facility with grasses and trees. The facility is 53 feet by 60 feet. At the time of inspection there was no standing water present in the facility. Some erosion is present where sheet flow enters the facility. Some trash and excess leaf debris are present throughout the facility. This facility appears to be in fair condition. No MDE approved drawings were available, however it is assumed that the facility was designed according to Chapter 3 of the MDE Stormwater Manual.

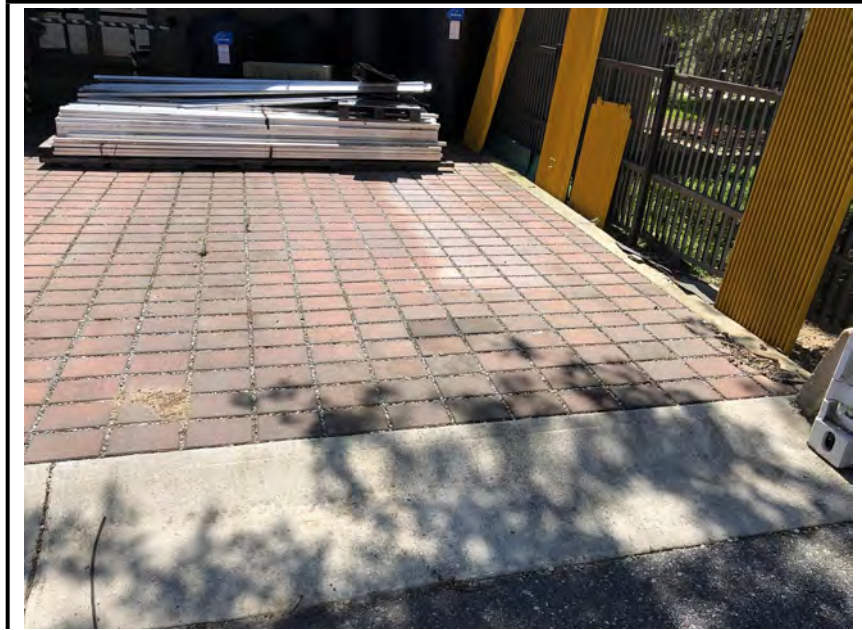
The permeable pavers are in fair condition. Some weeds are present between pavers. A tree is beginning to grow between the building foundation and the paver area. Equipment storage on the permeable pavers are blocking part of the facility area from receiving runoff. Buildup of weeds and sediment is occurring in the corner of the pavers near the parked trailer.

Photo #1: The facility surface.

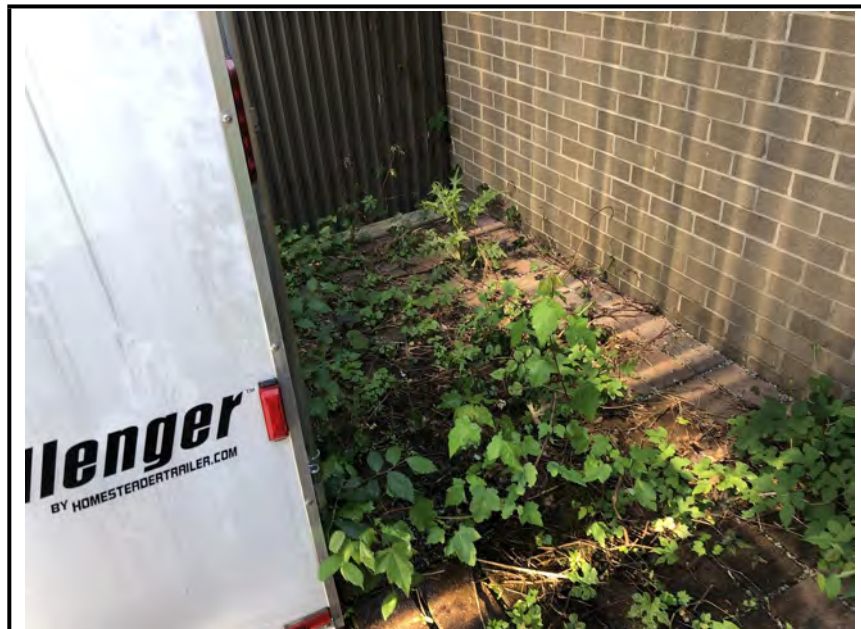
Photo #2: Vegetation growing from the facility surface.

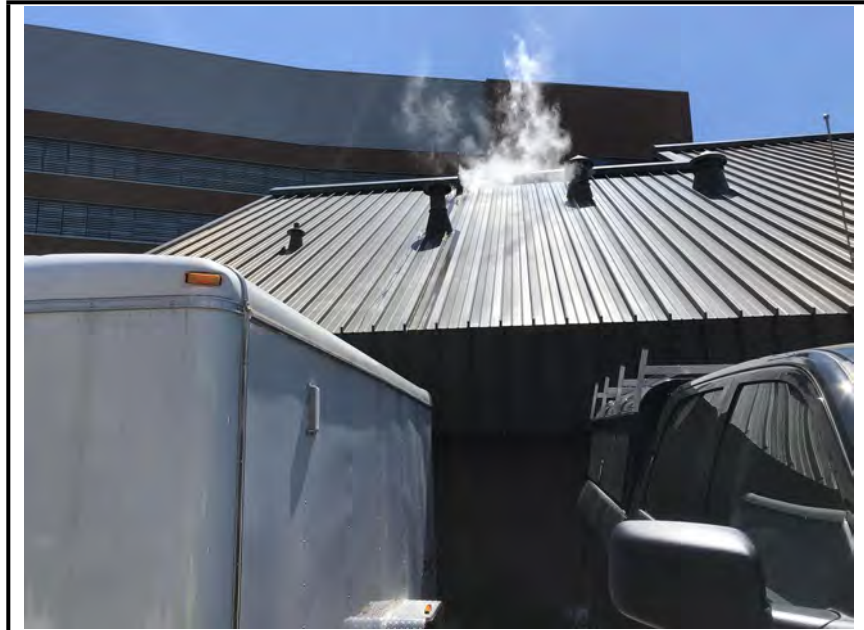
**Photo #3:** Steam from a vent that condenses on the roof and runs off onto the facility.

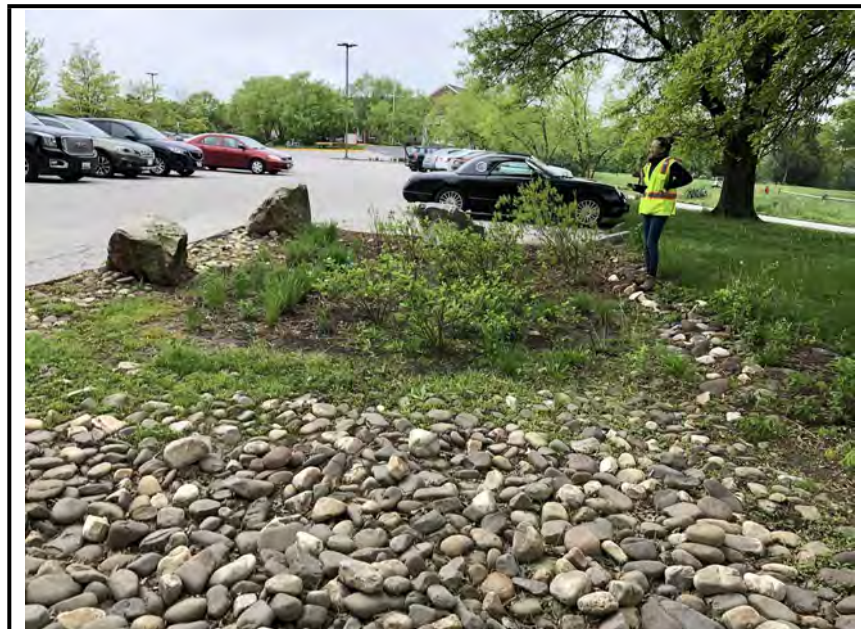
Photo #2: Pretreatment stage of the facility.

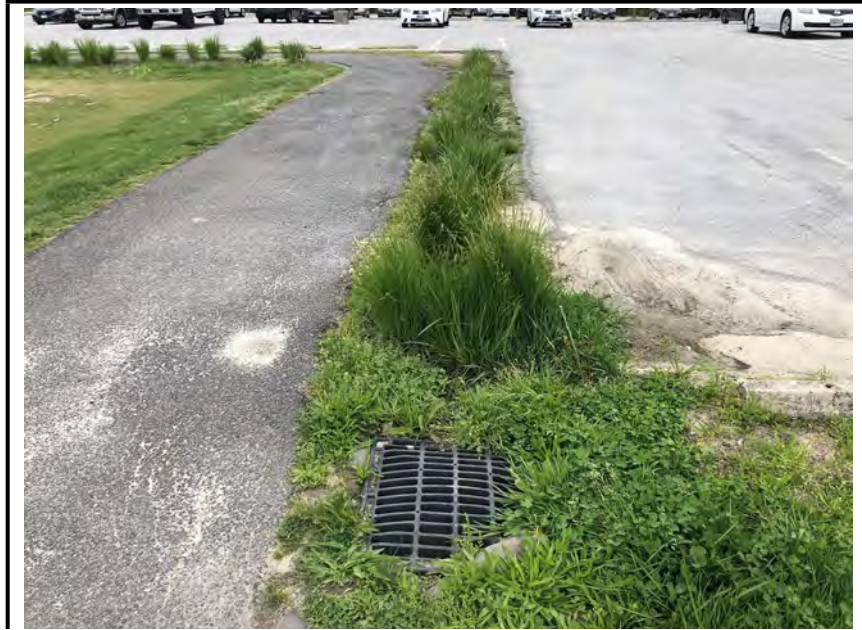
It is unclear if the intended drainage area enters the swale and therefore the facility. The pipe carrying water from the swale to the rain garden does not daylight at the discharge point. The outflow of the pipe could be clogged with grass or leaves, therefore backing up flow into the inlet. This facility is in fair condition.

**Photo #1:** The pretreatment swale.

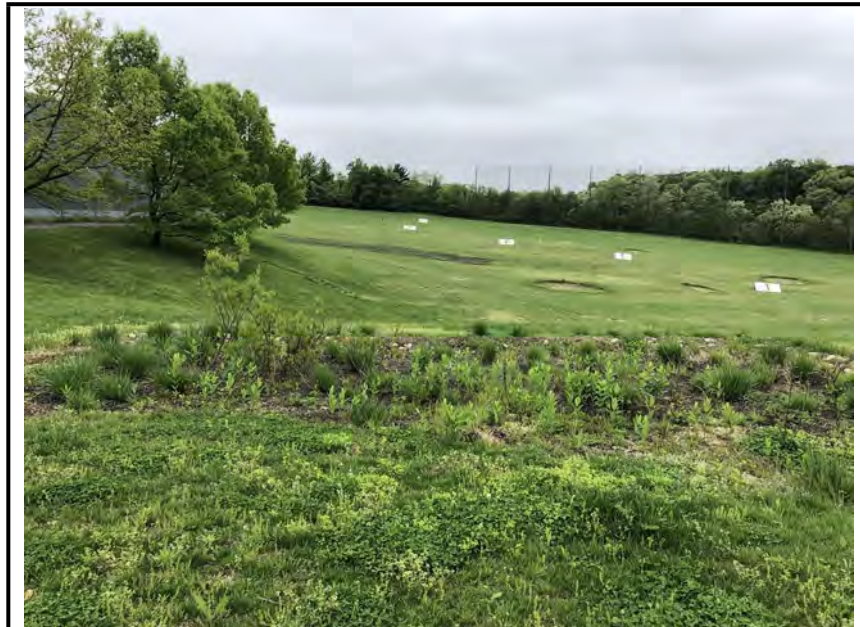
**Photo #2:** View into the facility.

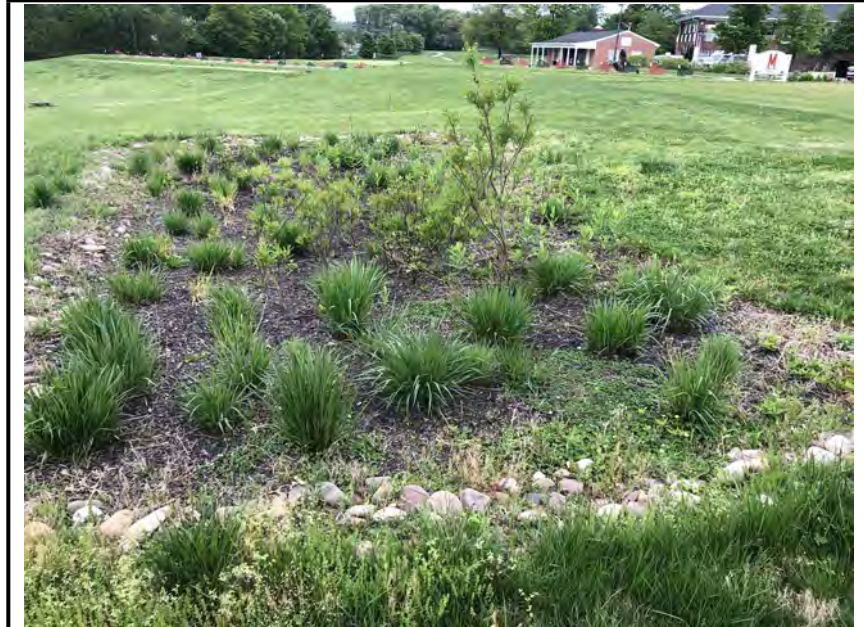
**Photo #3:** The vegetation within the facility.

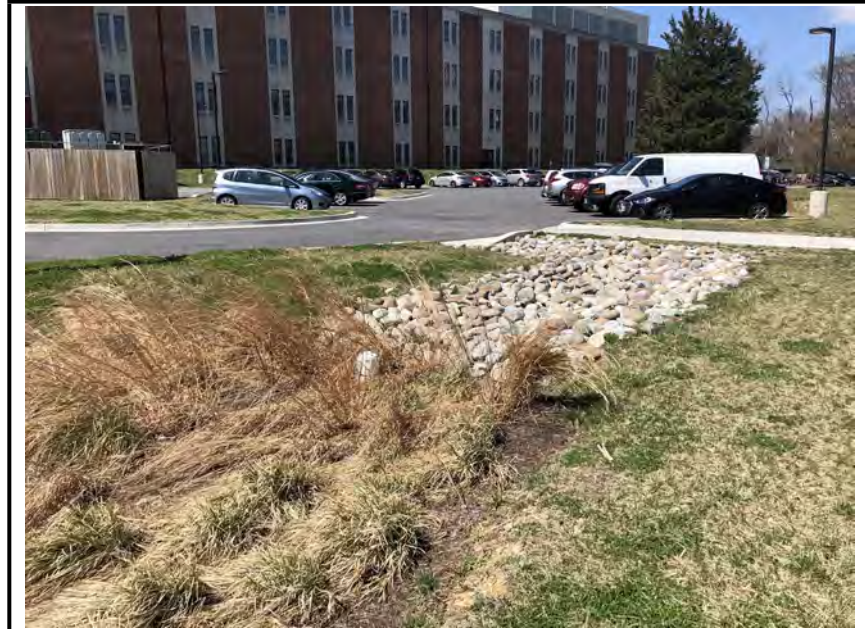
The bioretention facility is in overall good condition. The total drainage area of the facility is 25,448 square feet, including 16,263 square feet of impervious area. The ponding depth is designed to be 6 inches, with 2 feet of media depth. The total designed ESDv provided is 1,723 cubic feet, and a  $P_E$  of 1.3 inches is designed. There are grasses and vegetation covering much of the filter area. Some trash is present within the facility.

**Photo #3:** The riprap inflow channel.

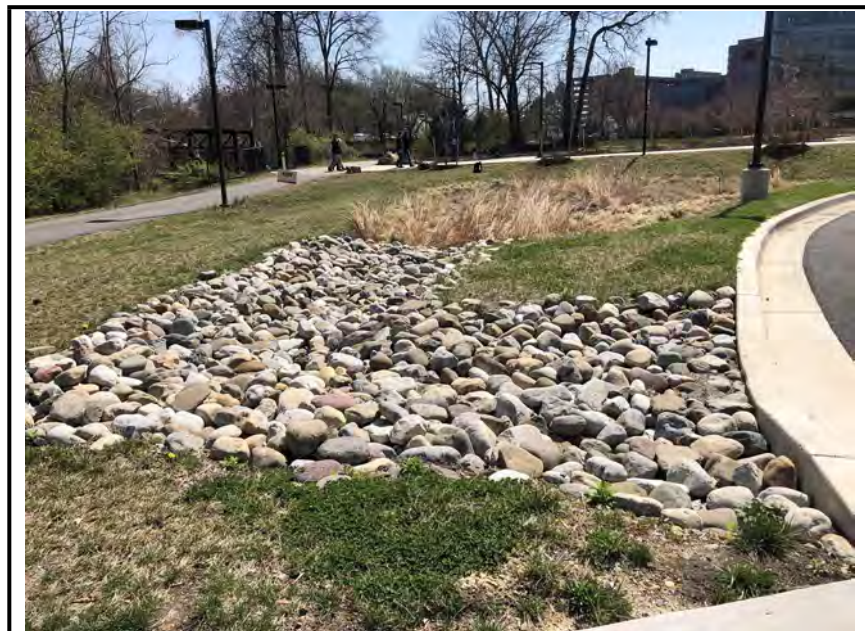
**Photo #4:** The riprap channel that serves as pretreatment.
