University of Maryland, College Park  
National Pollutant Discharge Elimination  
System MS4 Phase II  
FY2019 Annual Report  
General Discharge Permit #13-SF-5501

## **Stormwater Treatment Final Report & Recommendations**

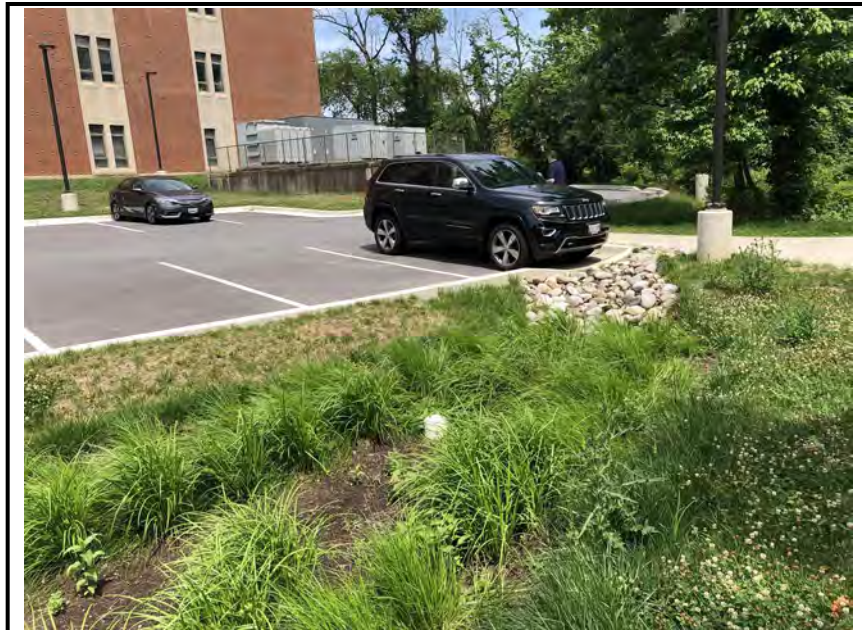
**Photo #3:** The riprap inflow that leads to the facility.

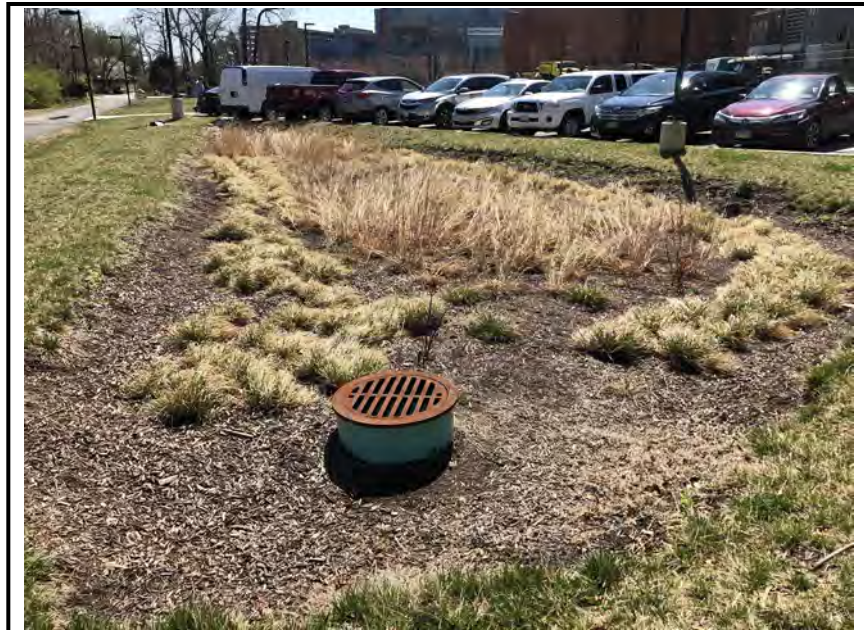
**Photo #3:** The riser outfall structure.

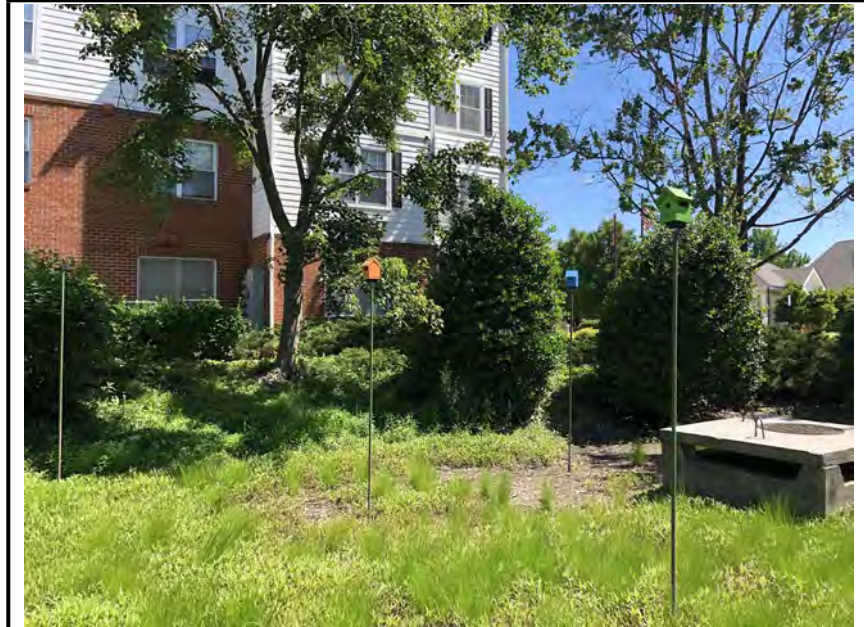
Photo #3: The outfall structure.

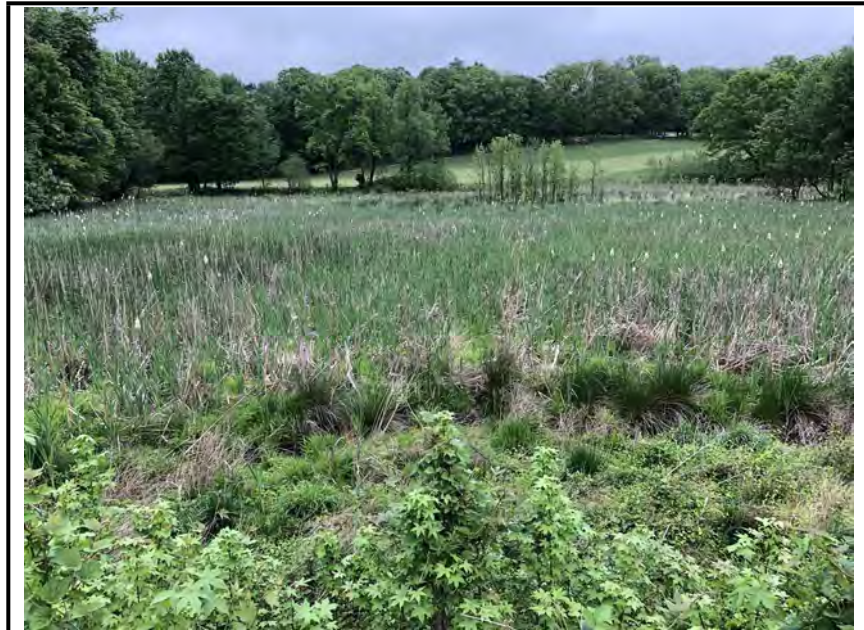
The wet pond is in overall poor condition. There are various smaller ponds throughout, with most of the facility area being dry. The pond area has been overrun by cattails, and other invasive species such as honeysuckle and poison ivy are growing along the edges of the pond. There are flow swale areas that have eroded throughout the pond area, carrying water away from the inflow points into smaller ponded areas. The side slopes of the facility show signs of erosion, with extremely steep side slopes in some areas. A walking path to a golf hole on the west side of the pond is creating erosion directly above one of the inflow culvert pipes. On the

Photo #1: View into the facility.

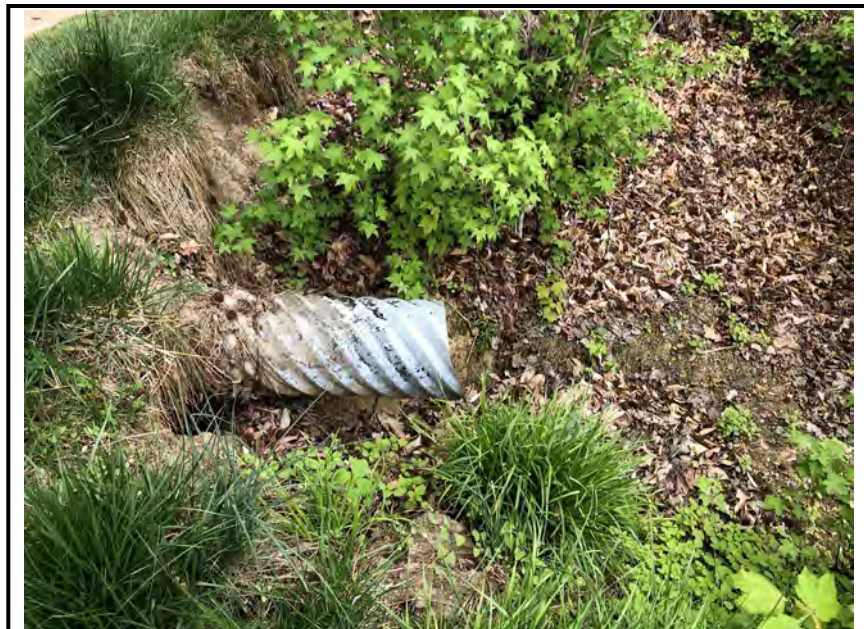
Photo #2: Erosion around inflow pipe.

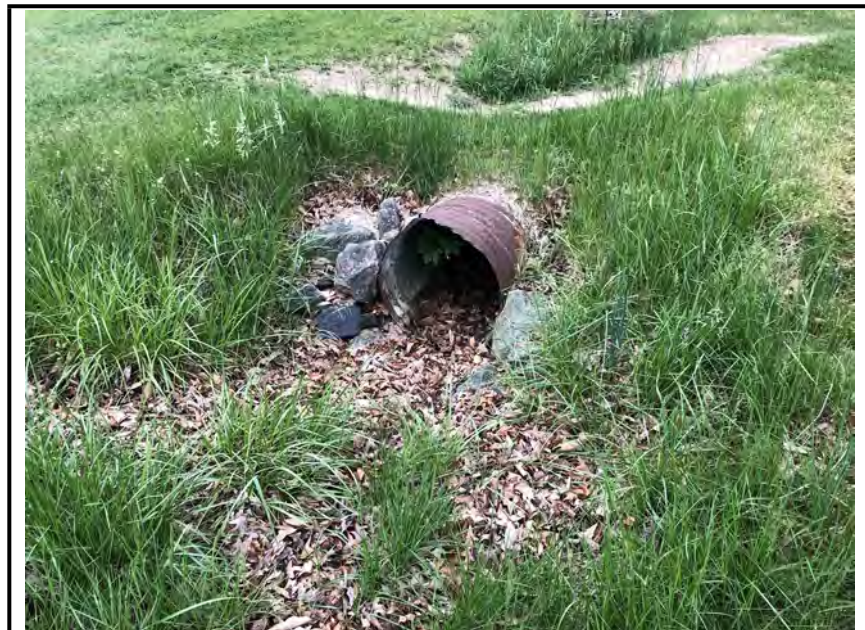
**Photo #4:** Erosion above inflow pipe.

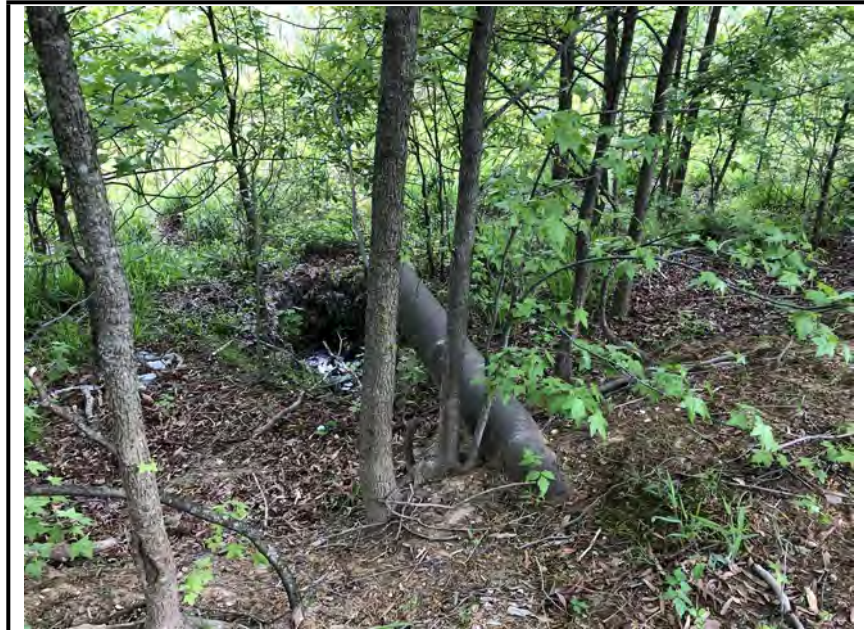
Photo #5: Erosion around inflow pipe.

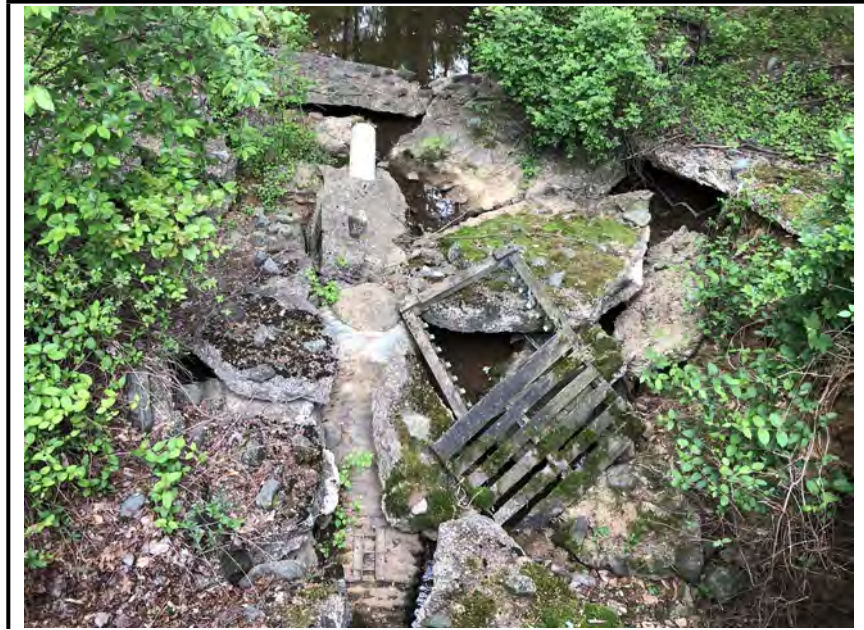
The wet pond outflow is through a dam that was reconstructed in 1972. The concrete dam is broken and has crumbling concrete. Water is seeping underneath the dam into the outflow stream.

Photo #7: Crumbling dam outflow.

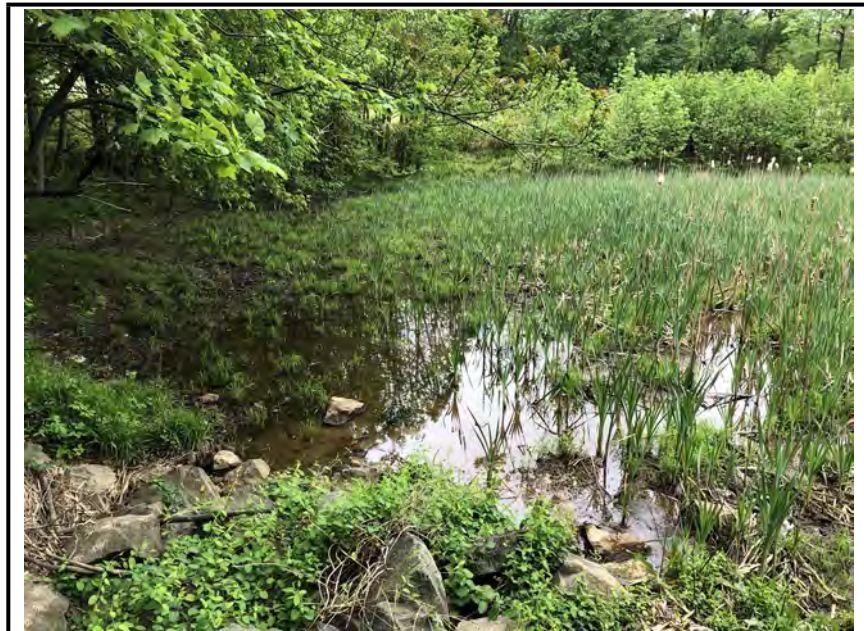
Photo #8: View into the facility.

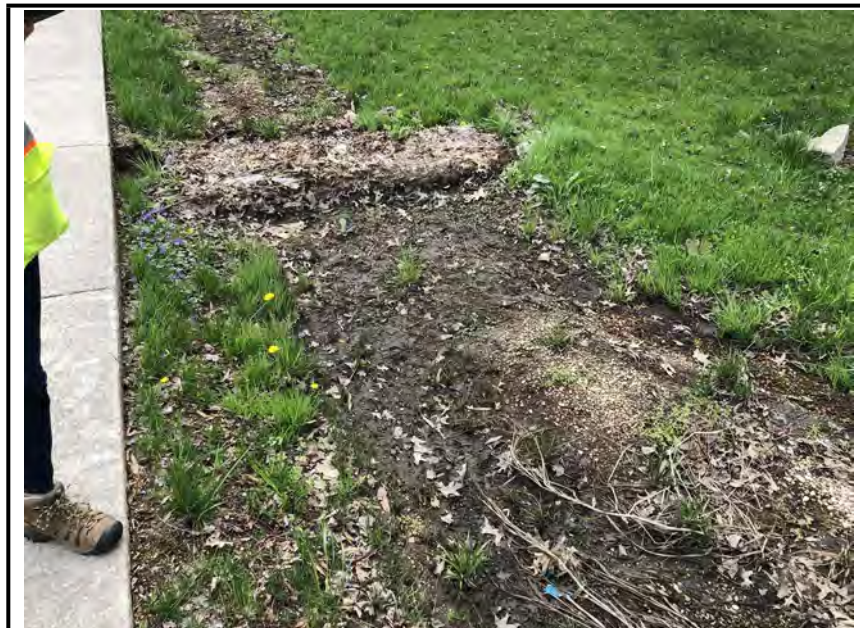
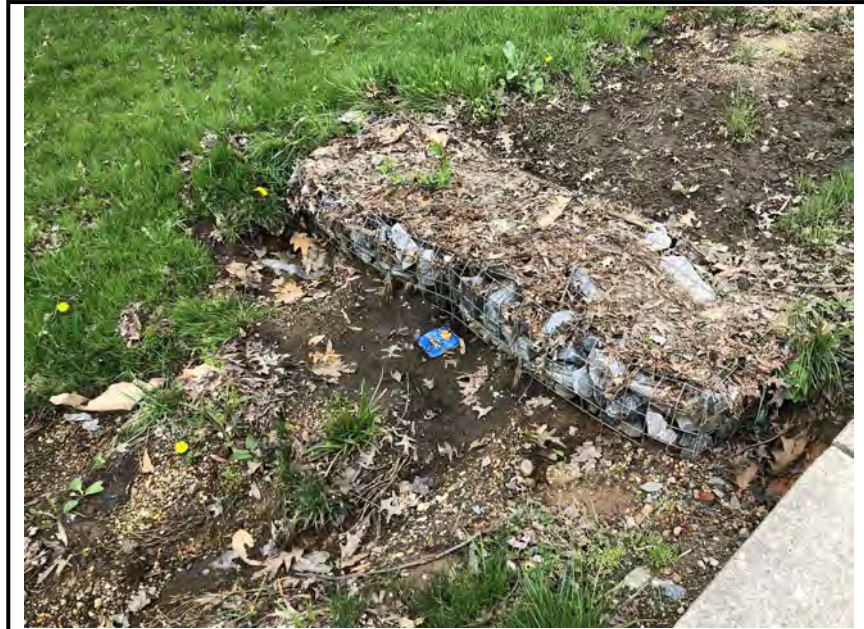
The facility area does not have any vegetation except for a few grass patches. The filter area appears to be clogged with sediment buildup and muck. The gabion basket weir in the middle of the facility is also clogged with leaves, and has plants growing within it. Due to the clogged weir, water is instead going around the weir, causing erosions around the weir.

Photo #2: Gabion weir.

**Photo #3:** Gabion weir.

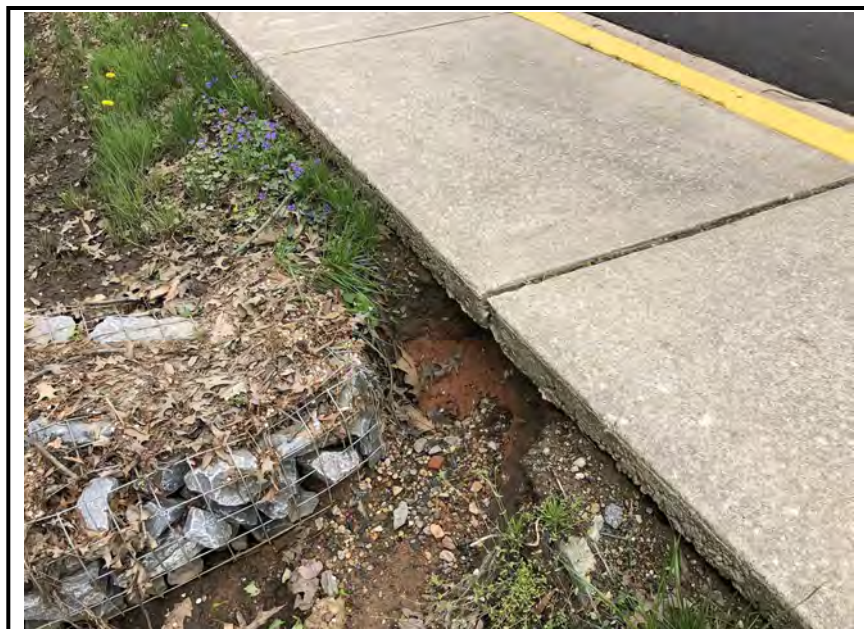
**Photo #4:** Gabion weir and undercut sidewalk.

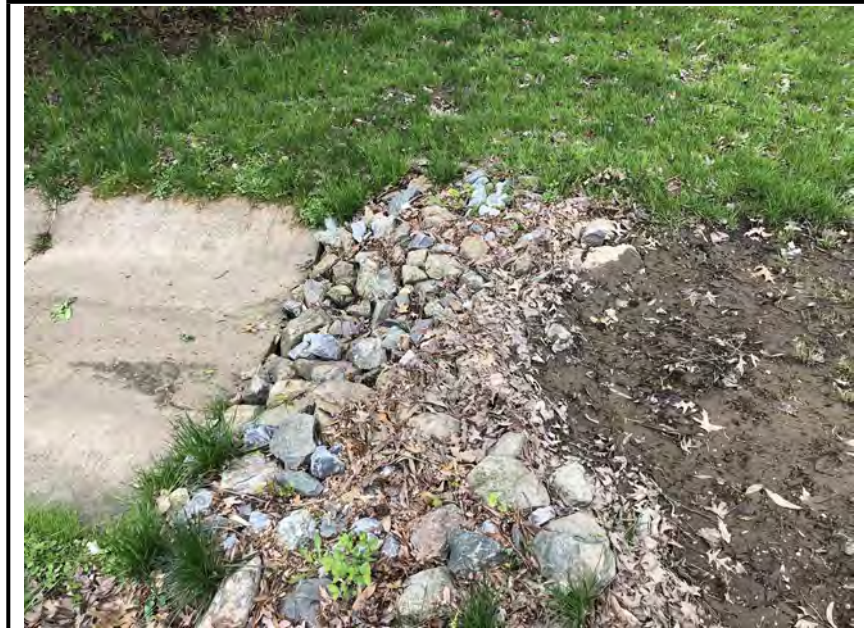
The facility discharges through infiltration, and a concrete channel to an at grade inlet. Before the concrete channel, there is an area of rip rap and sediment buildup.

**Photo #5:** Rip rap to outflow.

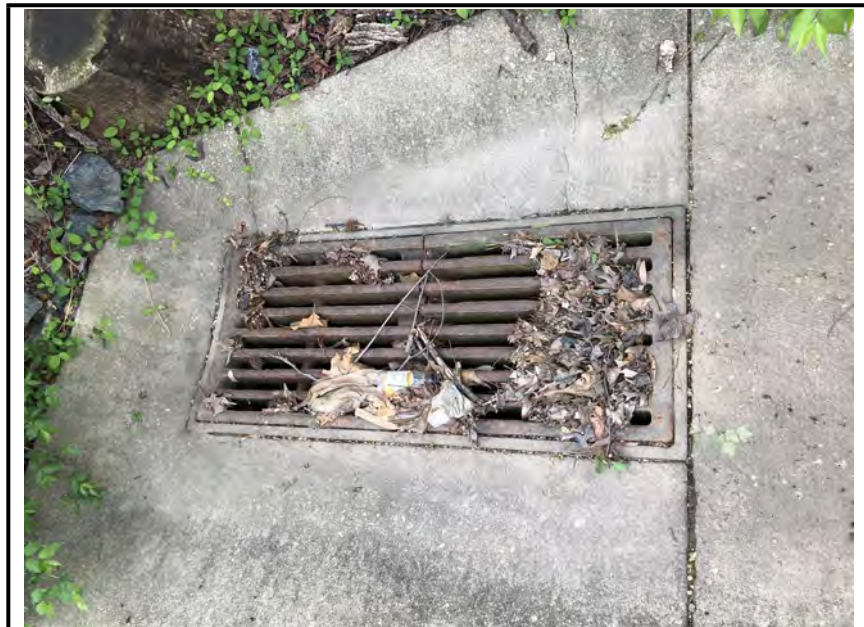
**Photo #6:** Outflow inlet clogged with leaves and trash.
