University of Maryland, College Park  
National Pollutant Discharge Elimination  
System MS4 Phase II  
FY2019 Annual Report  
General Discharge Permit #13-SF-5501

## **Stormwater Treatment Final Report & Recommendations**

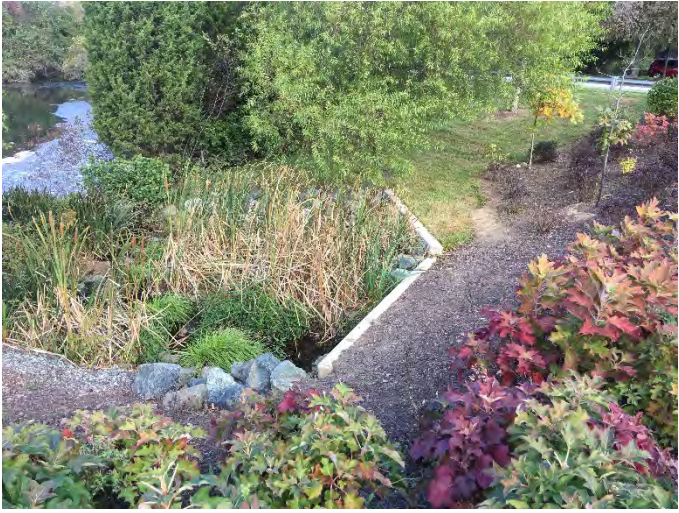
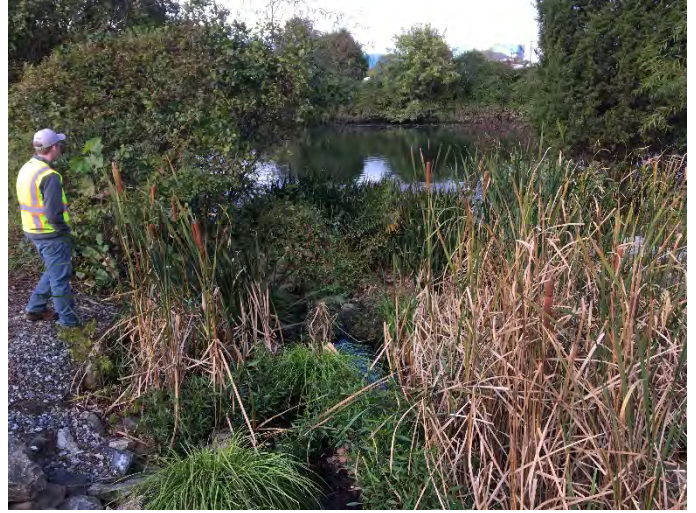
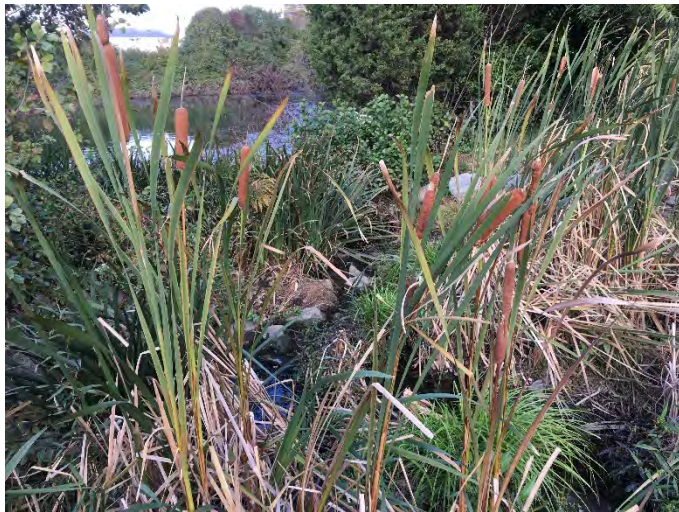
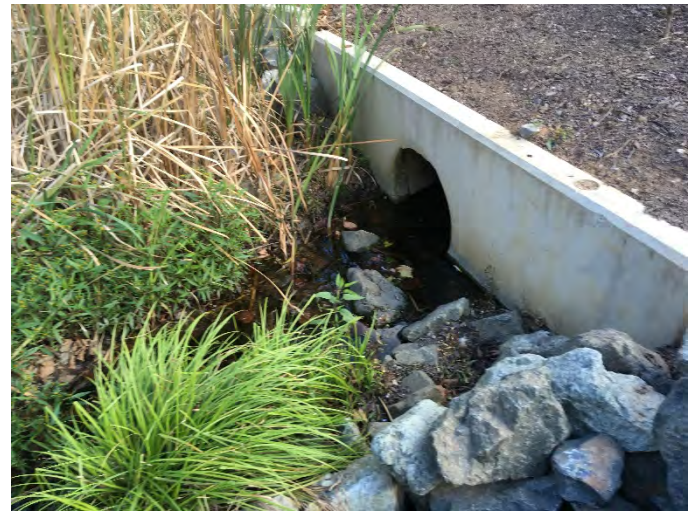
Gudelsky Pond could use some maintenance, particularly at the small forebay area on the east side of the pond where the two 30" pipes and one 15" pipe enters the pond. The forebay area is heavily silted with wetland plants growing and obstructing the inflow to the pond, as shown in Figures 9-12. The areas in front of the inflow pipes should be excavated to provide proper conveyance from the pipes.

Figures 9-12 – Photos of the silted in inflow at the point where the two 30" pipes and one 15" pipe enter Gudelsky Pond.

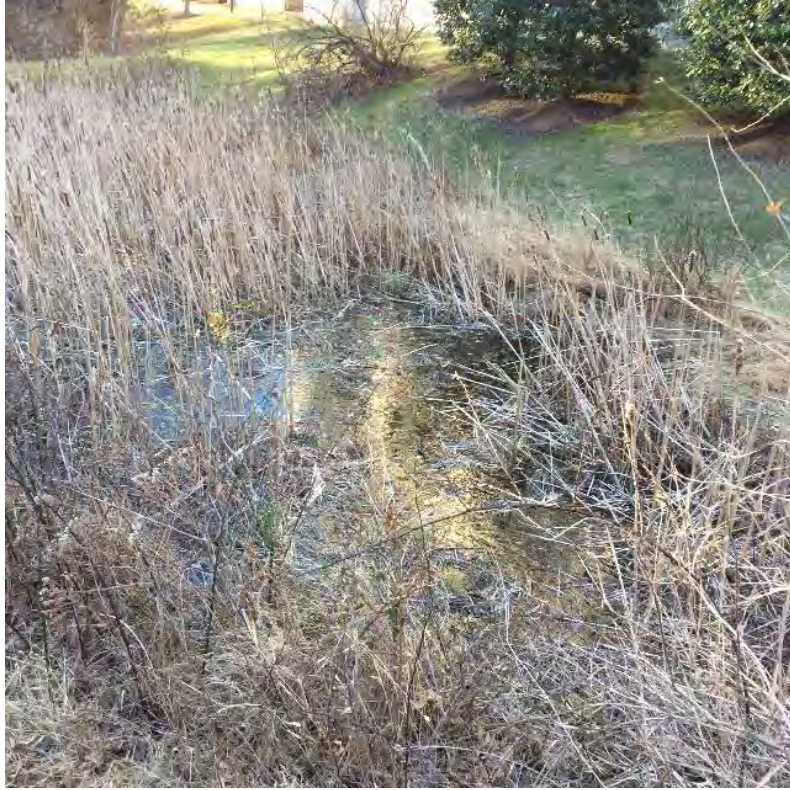
Ponding within BMP

The sand filter is considered failing and requires major maintenance to restore to functioning condition. Maintenance recommendations to restore the sand filter to functioning condition include: Removal of debris, unplanned and woody vegetation within a 10' buffer around the facility. Daylight 8" PVC inflow and repair and reset riprap at inflow. Removal of sediment and vegetation within the facility and dispose at an approved location. Excavation and reinstallation of the sand filter. Regrade the embankment to original design. If ENAKMAT 4010 device is compromised, reconstruct as designed. Removal of debris, unplanned and woody vegetation within a 15' from the downstream and upstream toe of the embankment and control structure. Recommend installing an underdrain and forebay to bring to approved MDE design standards. Facility may not be feasible in current location due to low grade and adjacent wetland. Site is located on type C soils.

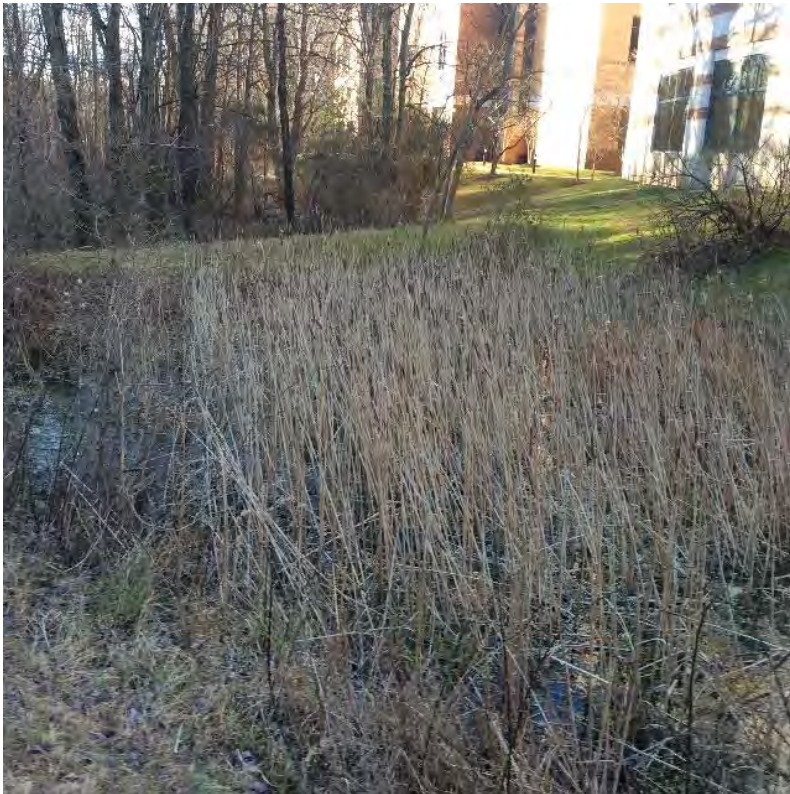
Cattails within BMP

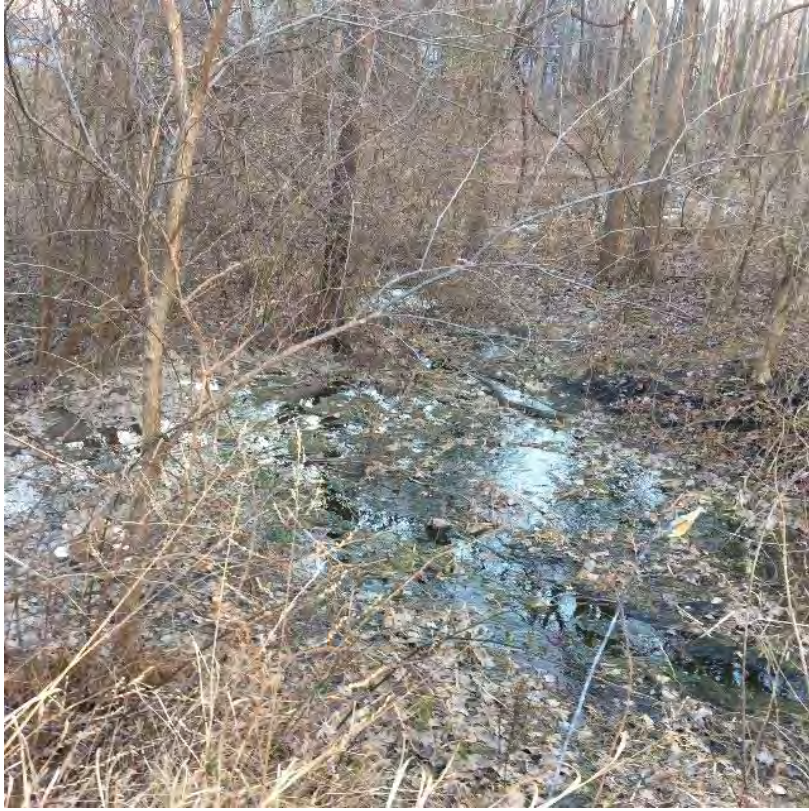
Downstream Condition

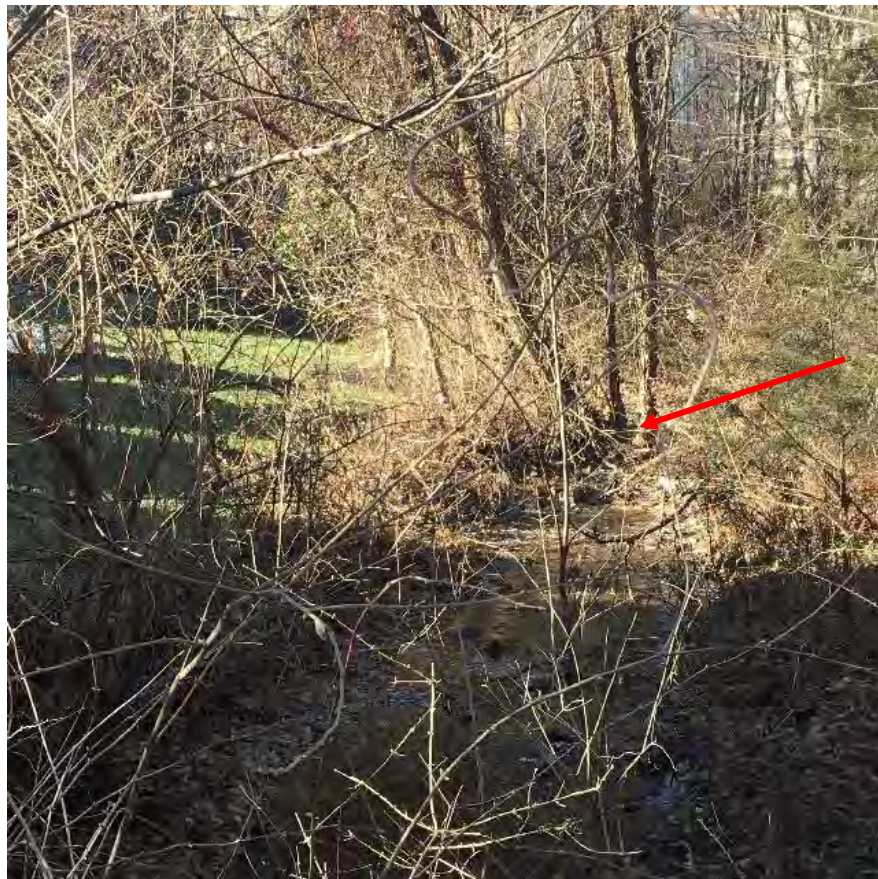
Overall, tree growth at outfall

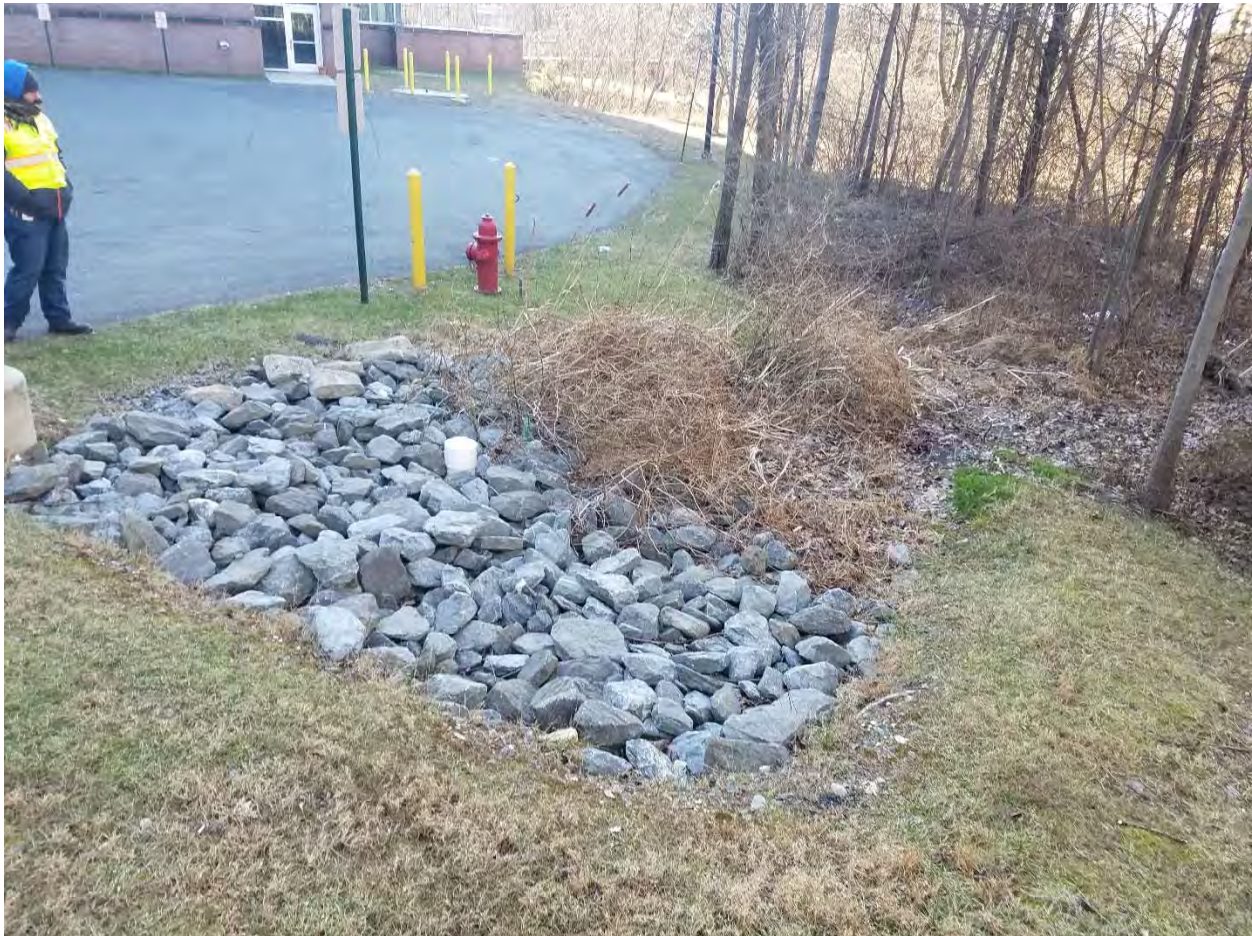
<b>Date of Inspection:</b>	01/11/2019 11:10 AM	<b>Inspector Initials</b>	SAL,JK,CAB
<b>BMP ID</b>	USG19BMP00005	<b>Inspection Firm</b>	MES
<b>BMP Type:</b>	Infiltration Trench	<b>Underground BMP?</b>	No
<b>Rating:</b>	A - Functioning, only needs routine maintenance	<b>Overall Inspection Comment</b>	Inflow pipe designed to drain sub-grade into infiltration trench. Debris, sediment, and overgrown vegetative growth at overflow. BMP does not receive sheetflow from surrounding impervious. BMP is performing as designed.

- **BMP Access** - Good
- **Debris & Sediment** - Fair
- **Vegetation** - Fair
- **BMP Contamination** - Good
- **Inflow Condition** - Not Rated
  - Inflow pipe buried under riprap, no sheetflow to the BMP
- **Forebay** - Not Rated
  - Not Part of Design
- **Conveyance Stability** - Good
- **Downstream Condition** - Fair

No remedial action necessary as the infiltration trench is in good functioning condition. Routine maintenance recommendations include: Removal of debris, sediment, and unplanned vegetation at the overflow and within a 10' buffer around the facility.

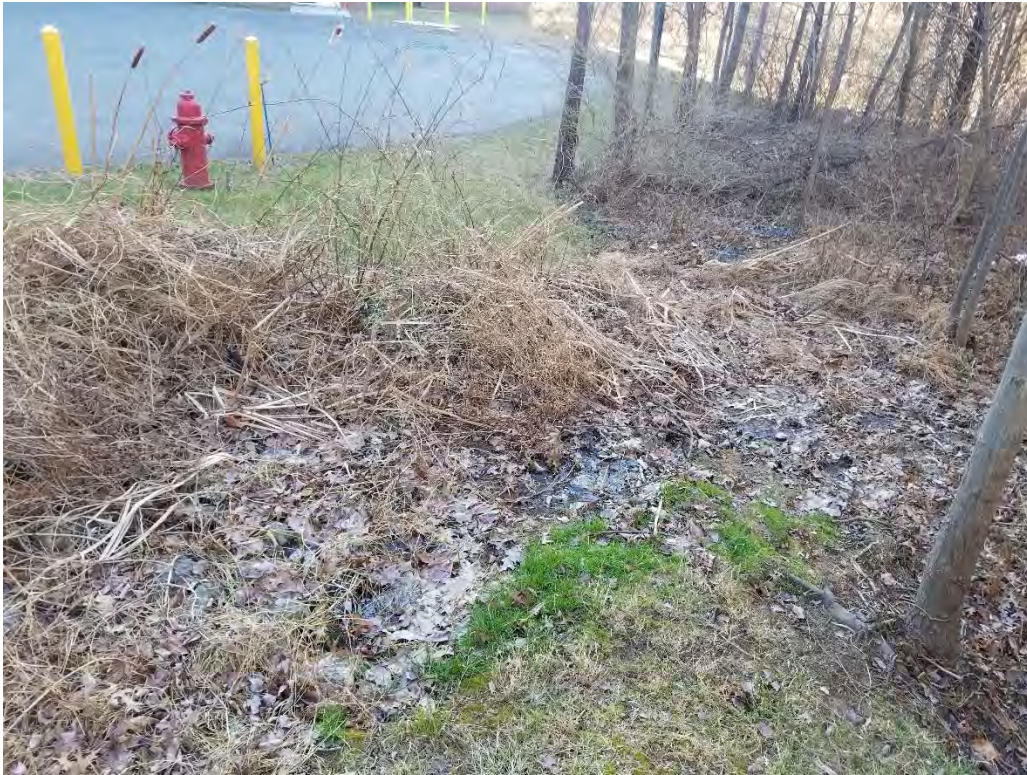
Vegetative growth at outfall

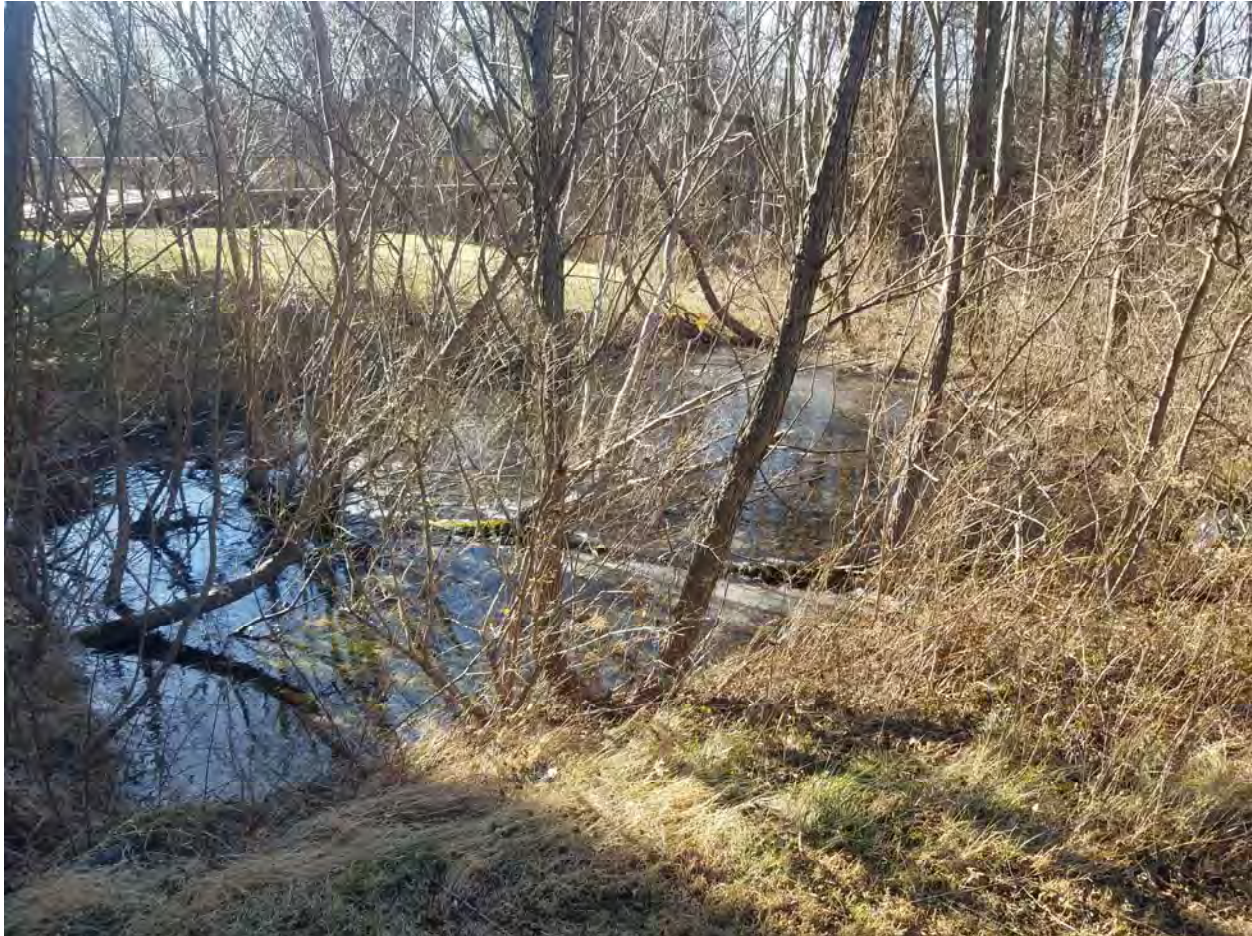
<b>Date of Inspection:</b>	01/11/2019 11:05 AM	<b>Inspector Initials</b>	SAL,JK,CAB
<b>BMP ID</b>	USG19BMP00006	<b>Inspection Firm</b>	MES
<b>BMP Type:</b>	Infiltration Trench	<b>Underground BMP?</b>	No
<b>Rating:</b>	C - Failing, needs major maintenance	<b>Overall Inspection Comment</b>	Ponding within BMP, Observation well submerged, Tree growth within BMP. Remove unwanted vegetation, excavate and restore BMP to original design.

- **BMP Access** - Good
- **Debris & Sediment** - Poor
- **Vegetation** - Poor
  - Tree growth around infiltration trench
- **BMP Contamination** - Good
- **Inflow Condition** - Fair
- **Forebay** - Not Rated
  - Not Part of Design
- **Conveyance Stability** - Poor
  - BMP is ponding and not infiltrating
- **Downstream Condition** - Good

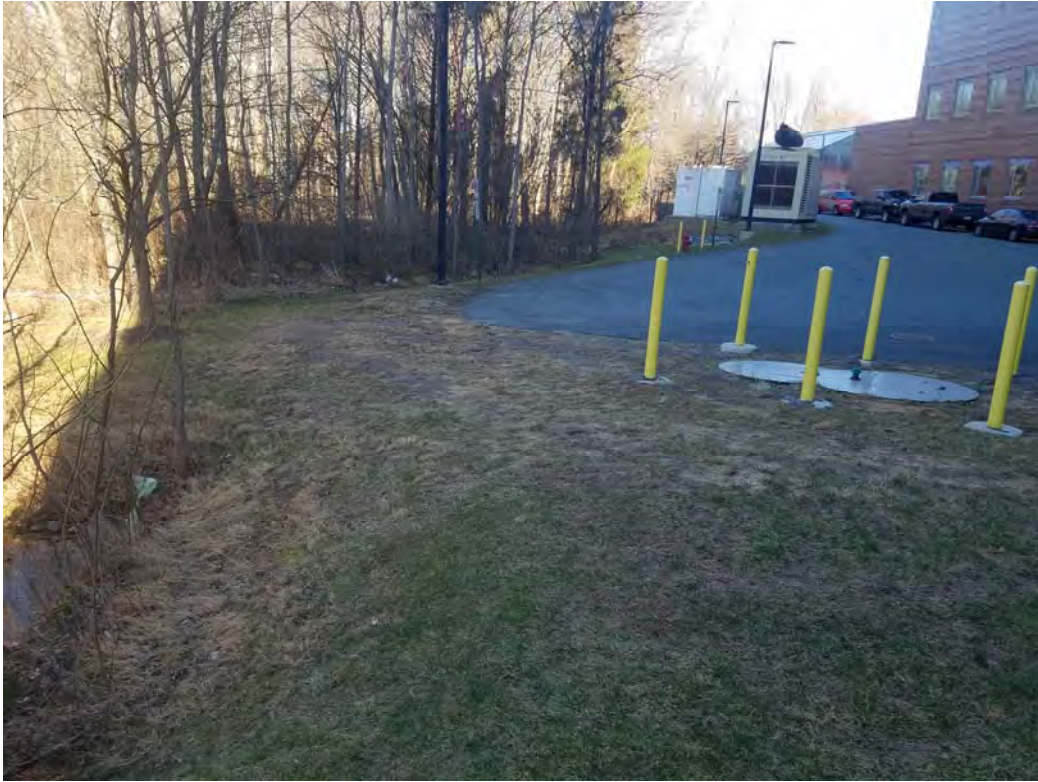
Inflow sheetflow, requires reseeding

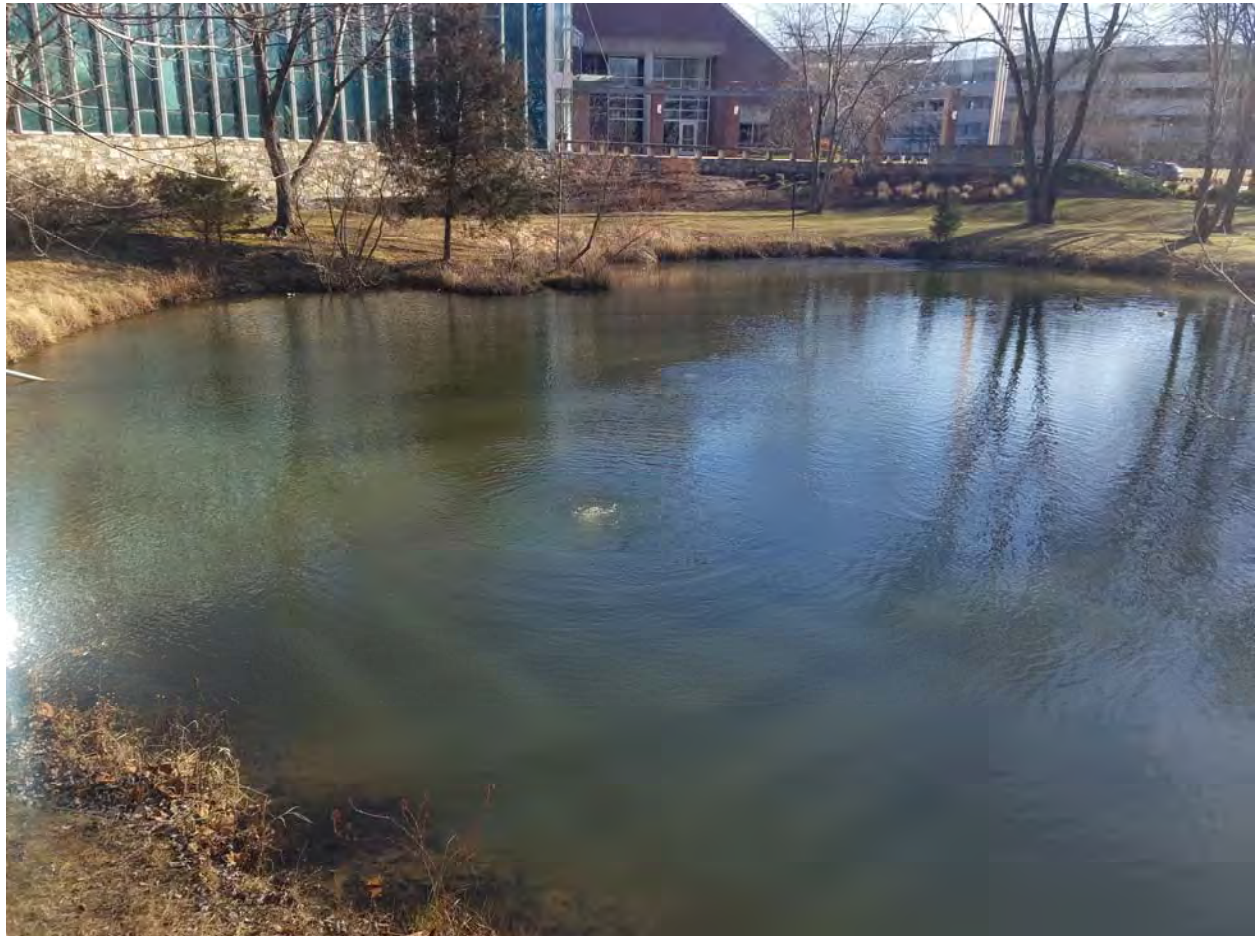
<b>Date of Inspection:</b>	01/11/2019 12:16 PM	<b>Inspector Initials</b>	SAL,JK,CAB
<b>BMP ID</b>	USG19BMP00007	<b>Inspection Firm</b>	MES
<b>BMP Type:</b>	Retention Pond (Wet Pond)	<b>Underground BMP?</b>	No
<b>Rating:</b>	B - Functioning, needs minor maintenance	<b>Overall Inspection Comment</b>	BMP may require sediment removal to return to full capacity, erosion at upstream embankment toe, riprap weir needs minor repair, inflow pipe requires minor sediment removal. BMP functioning as designed.

- **BMP Access** - Good
- **Debris & Sediment** - Fair
- **Vegetation** - Not Rated
  - Outside of growing season
- **BMP Contamination** - Good
- **Inflow Condition** - Fair
- **Forebay** - Not Rated
  - Not Part of Design
- **Conveyance Stability** - Fair
- **Downstream Condition** - Good

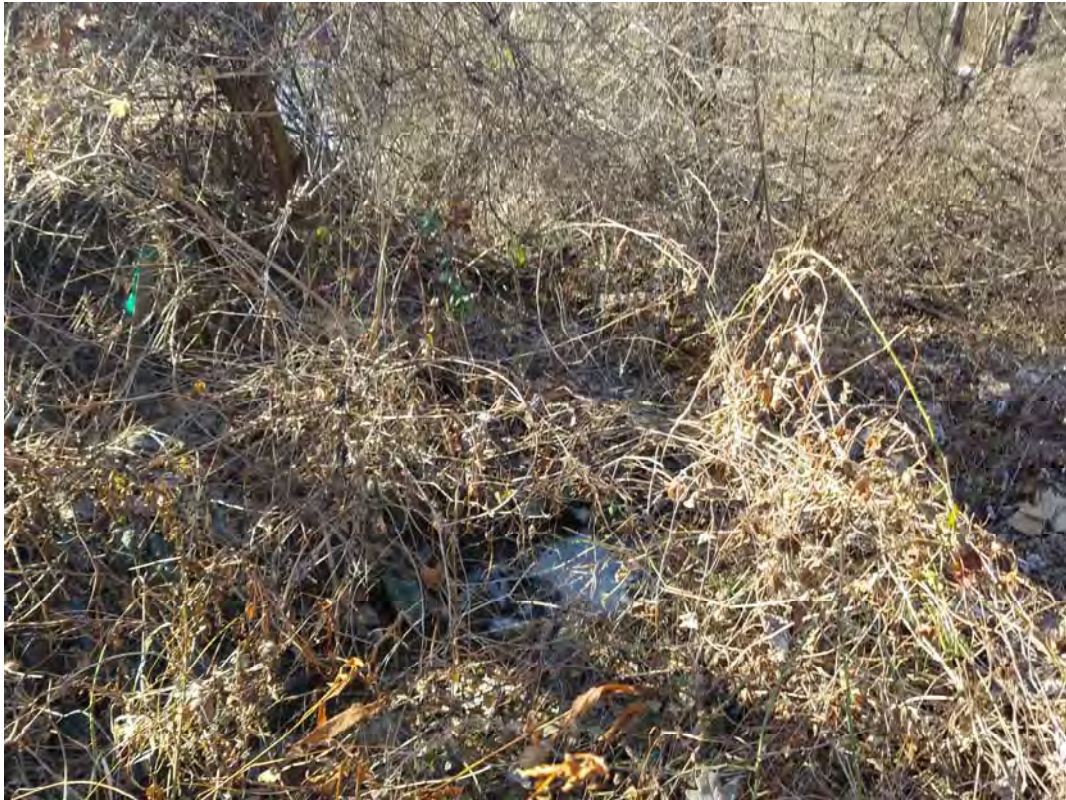
Downstream Condition

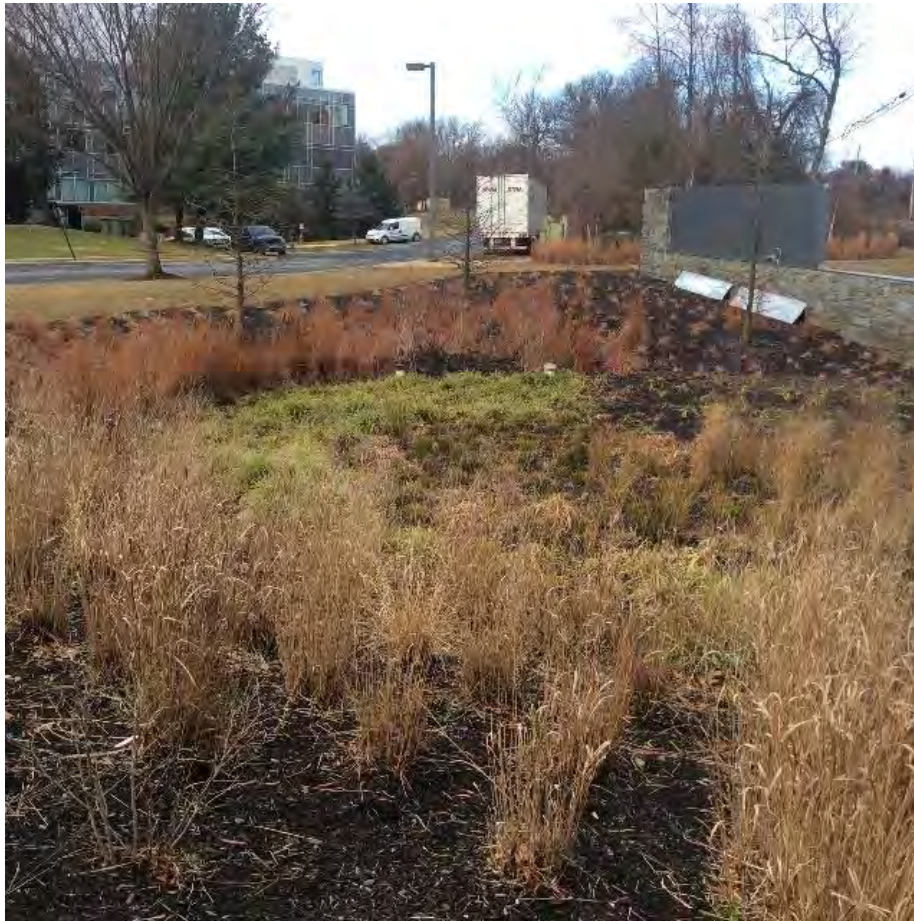
<b>Date of Inspection:</b>	02/05/2019 12:18 PM	<b>Inspector Initials</b>	SAL,JW,TF,SL
<b>BMP ID</b>	USG19BMP00012	<b>Inspection Firm</b>	MES
<b>BMP Type:</b>	Micro-Bioretenion	<b>Underground BMP?</b>	No
<b>Rating:</b>	B - Functioning, needs minor maintenance	<b>Overall Inspection Comment</b>	Erosive flow within BMP causing channel to form and plants being disturbed. Repair erosion and replant disturbed plants. Low point of BMP is at university sign placed within BMP. BMP is functioning as designed

The micro-bioretention is considered functioning but could use minor and routine maintenance. Maintenance recommendations include: Repair and stabilization of eroded areas within facility. Restore the facility to design grade. Replanting of any disturbed bioretention plants. Removal of any debris, sediment, and unplanned vegetation within BMP and at the inflows.

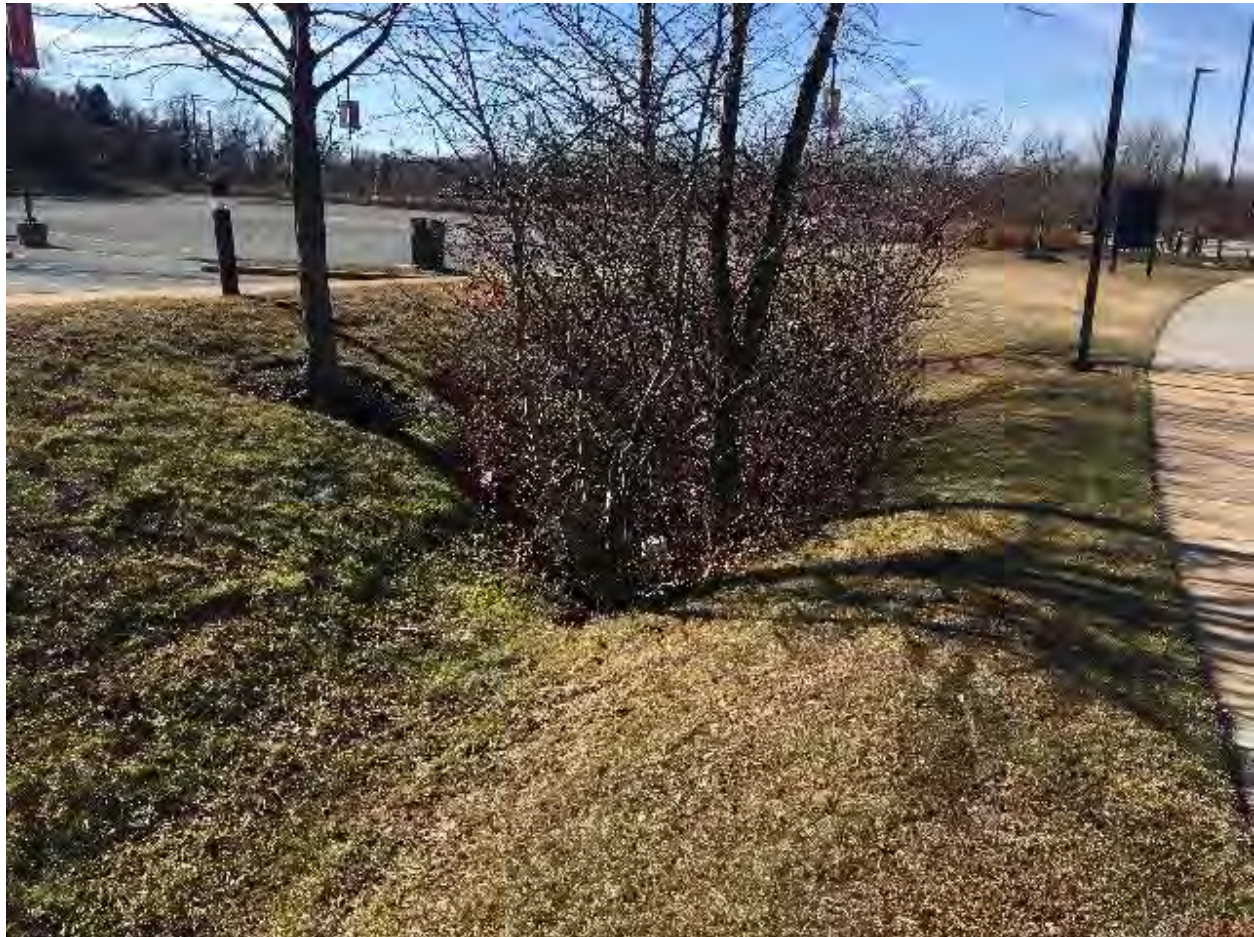
### Overall Photo

<b>Date of Inspection:</b>	01/11/2019 3:08 PM	<b>Inspector Initials</b>	SAL,JK,CAB
<b>BMP ID</b>	USG19BMP00018	<b>Inspection Firm</b>	MES
<b>BMP Type:</b>	Bioretention	<b>Underground BMP?</b>	No
<b>Rating:</b>	B - Functioning, needs minor maintenance	<b>Overall Inspection Comment</b>	Overgrown vegetation within BMP. Remove unwanted vegetation and replace with MDE approved bioretention plants. BMP is in good condition and functioning as designed

- **BMP Access** - Good
- **Debris & Sediment** - Good
- **Vegetation** - Poor
  - Overgrown vegetation within BMP
- **BMP Contamination** - Good
- **Inflow Condition** - Good
- **Forebay** - Not Rated
  - Not Part of Design
- **Conveyance Stability** - Good
- **Downstream Condition** - Not Rated
  - Site outfalls to existing stormwater network

The bioretention is considered functioning but could use minor and routine maintenance. Maintenance recommendations include: Removal of debris, sediment, and unplanned vegetation within facility. Replanting of MDE approved bioretention plants where necessary.

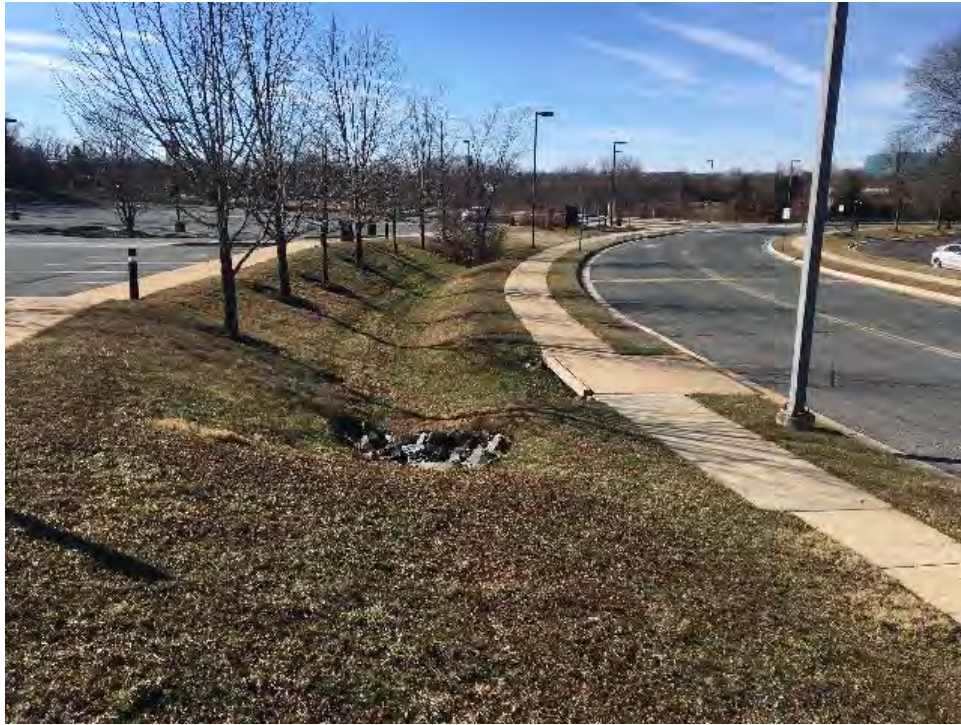
Inflow - COG Open Back, Grass Swale Conveyance

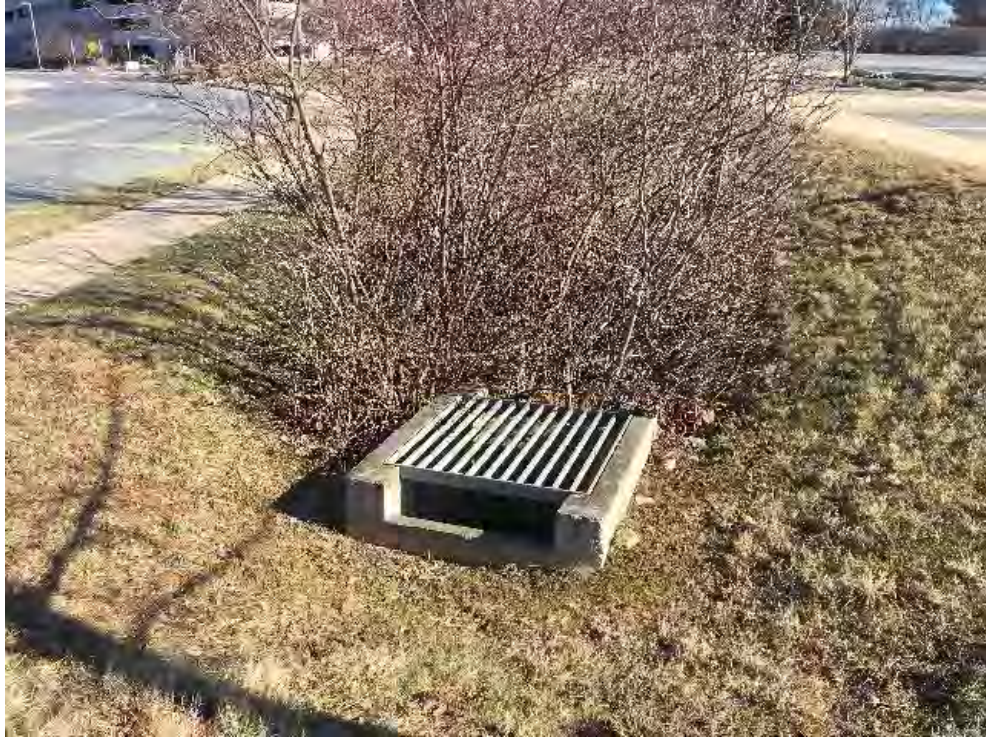
Overall - Facing West, Overflow Device

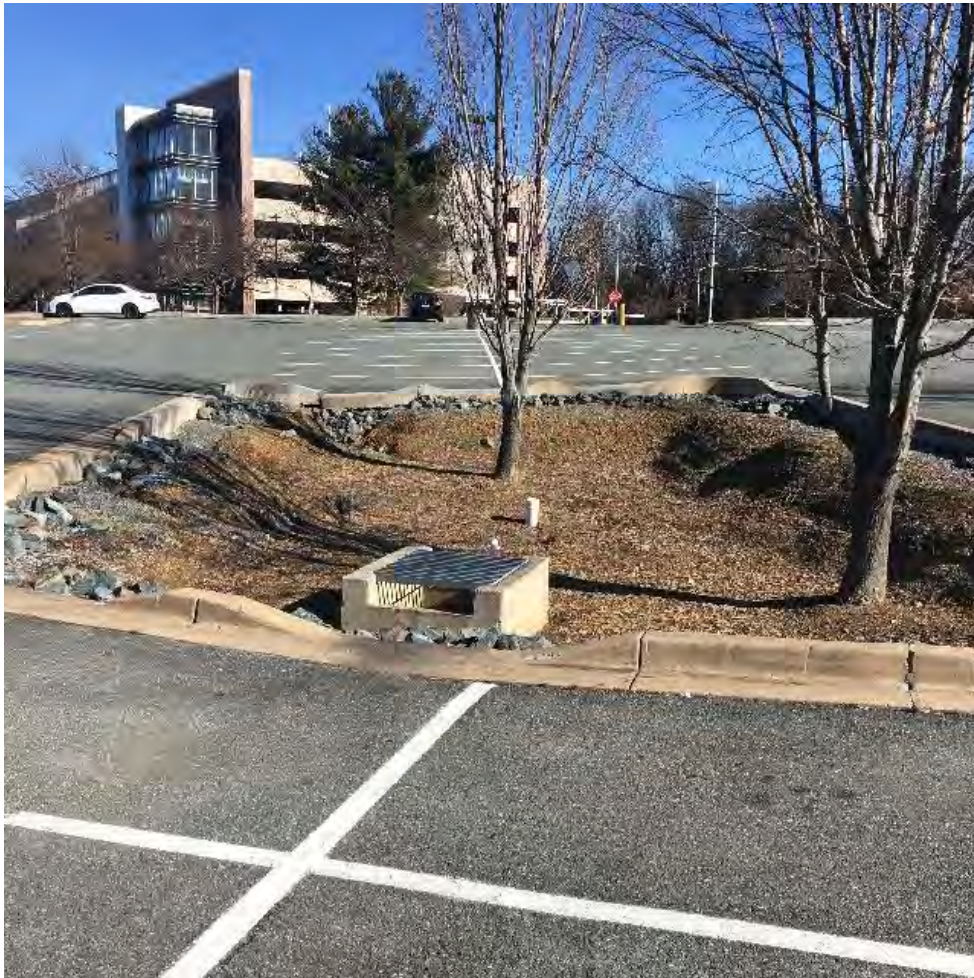
### Overall Photo

<b>Date of Inspection:</b>	01/15/2019 2:39 PM	<b>Inspector Initials</b>	SAL,JK,CAB
<b>BMP ID</b>	USG19BMP00019	<b>Inspection Firm</b>	MES
<b>BMP Type:</b>	Bioretention	<b>Underground BMP?</b>	No
<b>Rating:</b>	C - Failing, needs major maintenance	<b>Overall Inspection Comment</b>	Major erosion at inflows - undermining of western curb, Vegetation Removed from BMP 2013. Repair erosion, replace bioretention plants, remove tree, and remediate BMP to current MDE standards. +/-12" ponding depth in BMP

- **BMP Access** - Good
- **Debris & Sediment** - Good
- **Vegetation** - Poor
  - Non-Woody Vegetation Removed 2013, Maple trees show evidence of distressed health
- **BMP Contamination** - Good
- **Inflow Condition** - Poor
  - Undermining of curbing at west curb opening. Erosion at Gravel Curtain Drain
- **Forebay** - Not Rated
  - Not Part of Design
- **Conveyance Stability** - Fair
- **Downstream Condition** - Not Rated
  - Site outfalls to existing stormwater network

The bioretention is considered failing and requires major maintenance to restore to functioning condition. Maintenance recommendations to restore the bioretention to a functioning condition include: Regrade and restore bioretention to design criteria. Replanting of MDE approved bio-wetland plants. MES recommends removing the maple tree and replace with other MDE approved bioretention plants. Restore parking lot curb along perimeter/inflows of the bioretention facility. Perform additional maintenance as directed by project engineer to restore structural integrity of the surrounding parking lot.

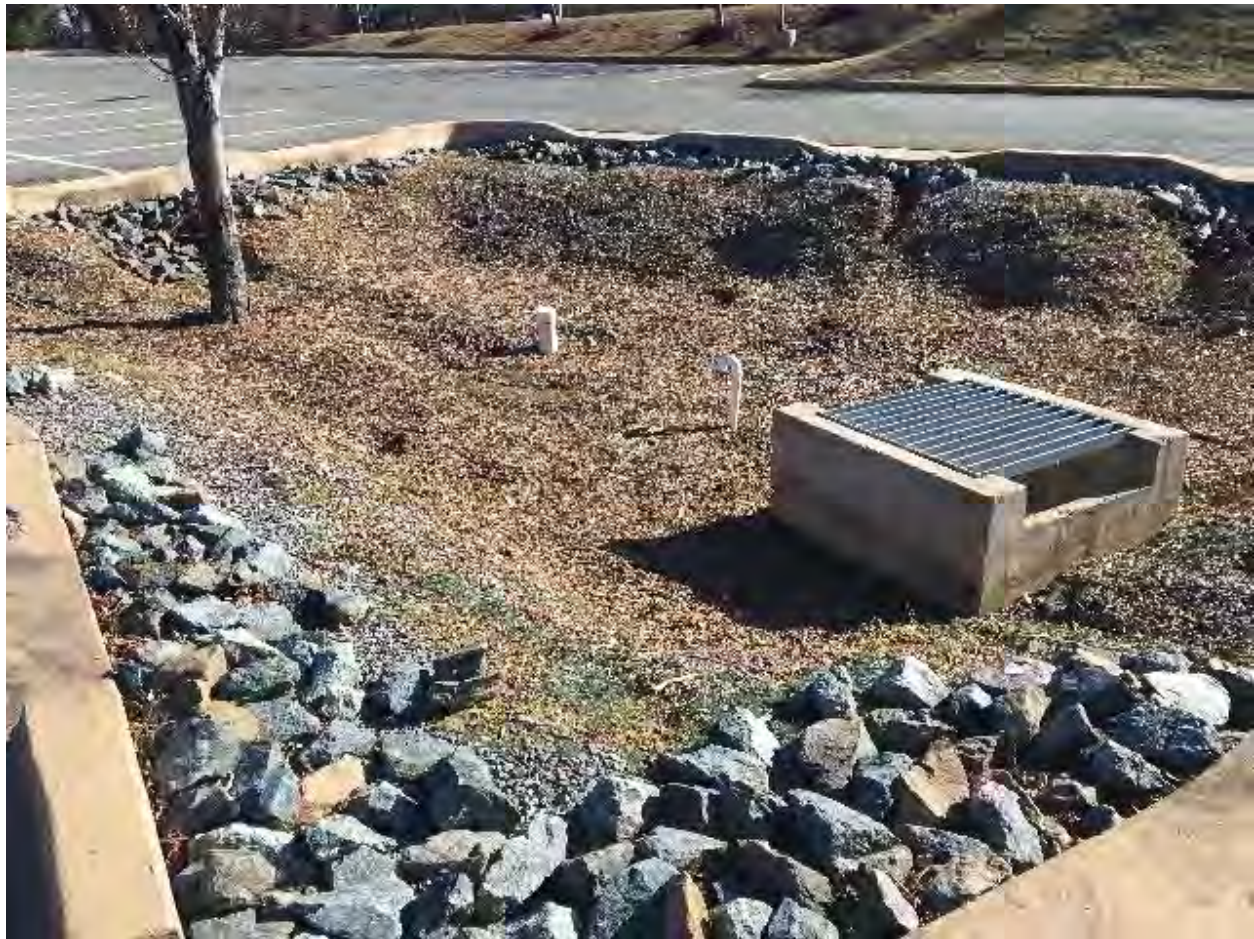
### Overall Photo

<b>Date of Inspection:</b>	01/11/2019 2:09 PM	<b>Inspector Initials</b>	SAL,JK,CAB
<b>BMP ID</b>	USG19BMP00020	<b>Inspection Firm</b>	MES
<b>BMP Type:</b>	Bioretention	<b>Underground BMP?</b>	No
<b>Rating:</b>	C - Failing, needs major maintenance	<b>Overall Inspection Comment</b>	Erosion at curb cut inflow and gravel curtain drain, excessive ponding potential at overflow device, vegetation removed 2013. Repair erosion, replace bioretention plants, remove tree, and remediate BMP to current MDE standards. +/-12" ponding depth in BMP

- **BMP Access** - Good
- **Debris & Sediment** - Good
- **Vegetation** - Poor
  - Non-Woody Vegetation Removed 2013, Maple trees show evidence of distressed health
- **BMP Contamination** - Good
- **Inflow Condition** - Poor
  - Erosion at inflows of curb cuts surrounding the BMP. Evidence of parking lot integrity being undermined. Erosion at gravel curtain drain
- **Forebay** - Not Rated
  - Not Part of Design
- **Conveyance Stability** - Poor
  - Erosive channel along embankment
- **Downstream Condition** - Not Rated
  - Site outfalls to existing stormwater network

The bioretention is considered failing and requires major maintenance to restore to functioning condition. Maintenance recommendations to restore the bioretention to a functioning condition include: Regrade and restore bioretention to design criteria. Replanting of MDE approved bio-wetland plants. MES recommends removing the maple tree and replace with other MDE approved bioretention plants. Restore parking lot curb along perimeter/inflows of the bioretention facility. Perform additional maintenance as directed by project engineer to restore structural integrity of the surrounding parking lot.

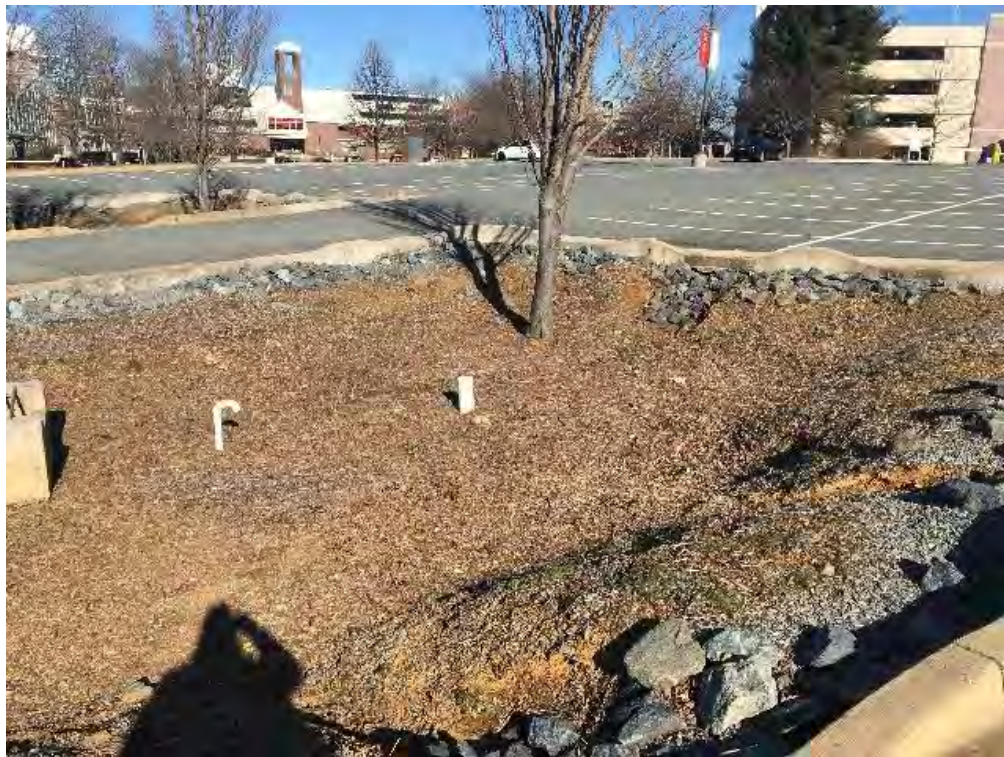
Vegetation Removed

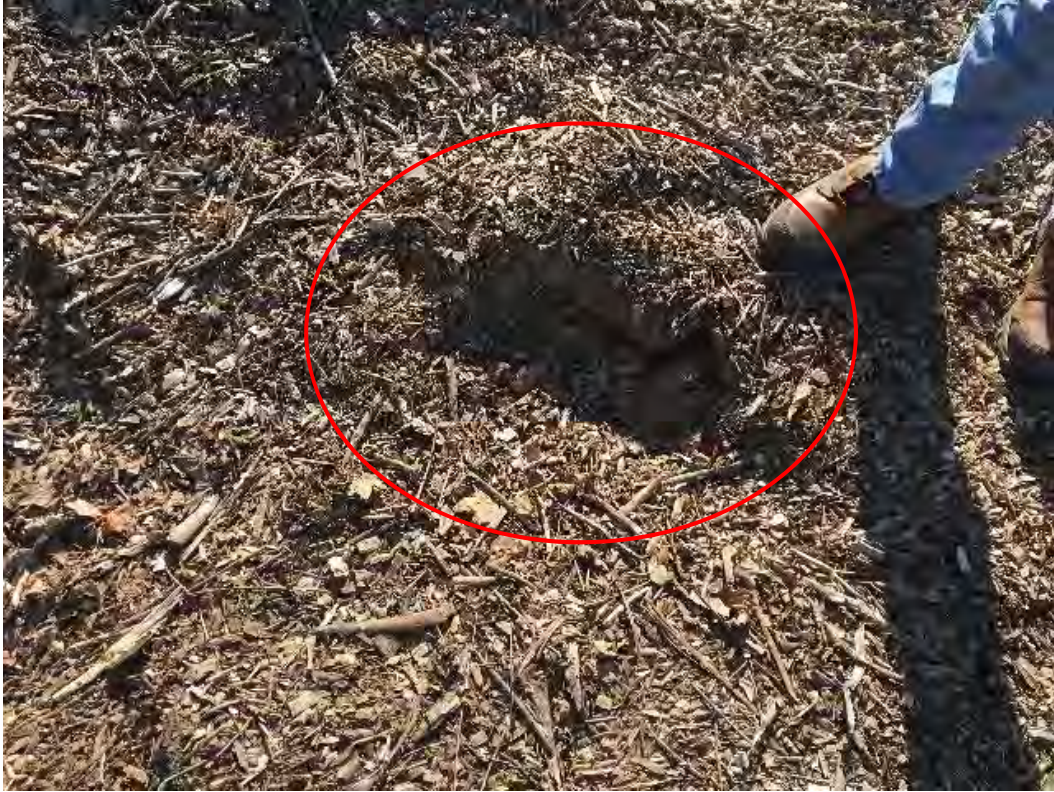
Sinking of Biomediation

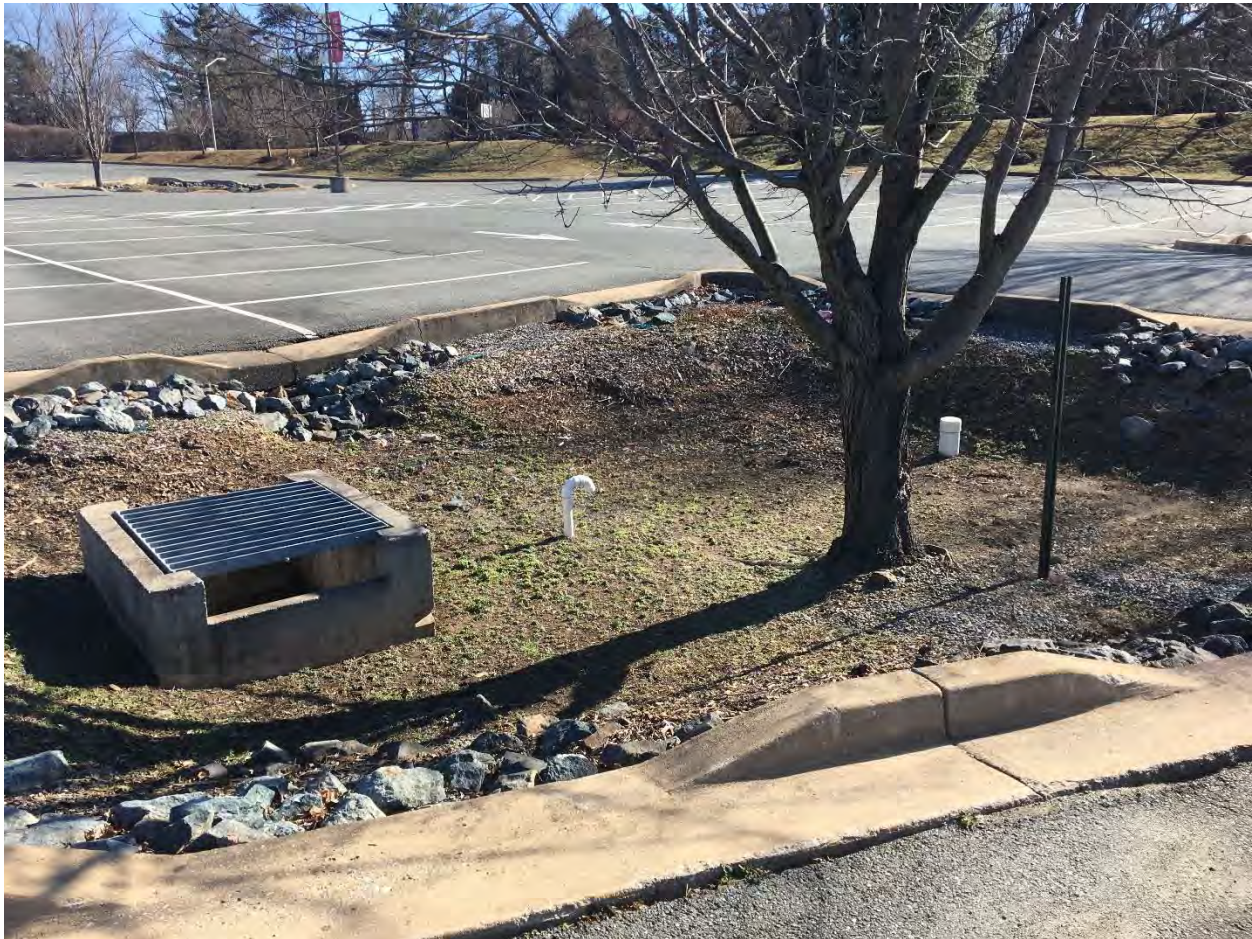
### Overall Photo

<b>Date of Inspection:</b>	01/11/2019 12:23 PM	<b>Inspector Initials</b>	SAL,JK,CAB
<b>BMP ID</b>	USG19BMP00021	<b>Inspection Firm</b>	MES
<b>BMP Type:</b>	Bioretention	<b>Underground BMP?</b>	No
<b>Rating:</b>	C - Failing, needs major maintenance	<b>Overall Inspection Comment</b>	Erosion at curb cut inflow and gravel curtain drain, excessive ponding potential at overflow device, vegetation removed 2013. Repair erosion, replace bioretention plants, remove tree, and remediate BMP to current MDE standards. +/-12" ponding depth in BMP

- **BMP Access** - Good
- **Debris & Sediment** - Fair
- **Vegetation** - Poor
  - BMP Vegetation Removed 2013, Maple trees show evidence of distressed health
- **BMP Contamination** - Good
- **Inflow Condition** - Poor
  - Erosion at inflows of curb cuts surrounding the BMP. Evidence of parking lot integrity being undermined. Erosion at gravel curtain drain
- **Forebay** - Poor
  - Erosion of Curtain Drain Pretreatment
- **Conveyance Stability** - Fair
- **Downstream Condition** - Not Rated
  - Site outfalls to existing stormwater network

The bioretention is considered failing and requires major maintenance to restore to functioning conditions. Maintenance recommendations to restore the bioretention to functioning conditions include: Removal of debris, unplanned and woody vegetation within facility. Replanting of MDE approved bioorientation plants according to design. Repair of eroded areas at the inflows and gravel curtain drain. Investigation of underdrain for potential clogging and removal of sediment if necessary. Removal of any sediment build up on surface of facility or addition of mulch to meet MDE ponding depth requirement.
