University of Maryland, College Park  
National Pollutant Discharge Elimination  
System MS4 Phase II  
FY2019 Annual Report  
General Discharge Permit #13-SF-5501

## **Stormwater Treatment Final Report & Recommendations**

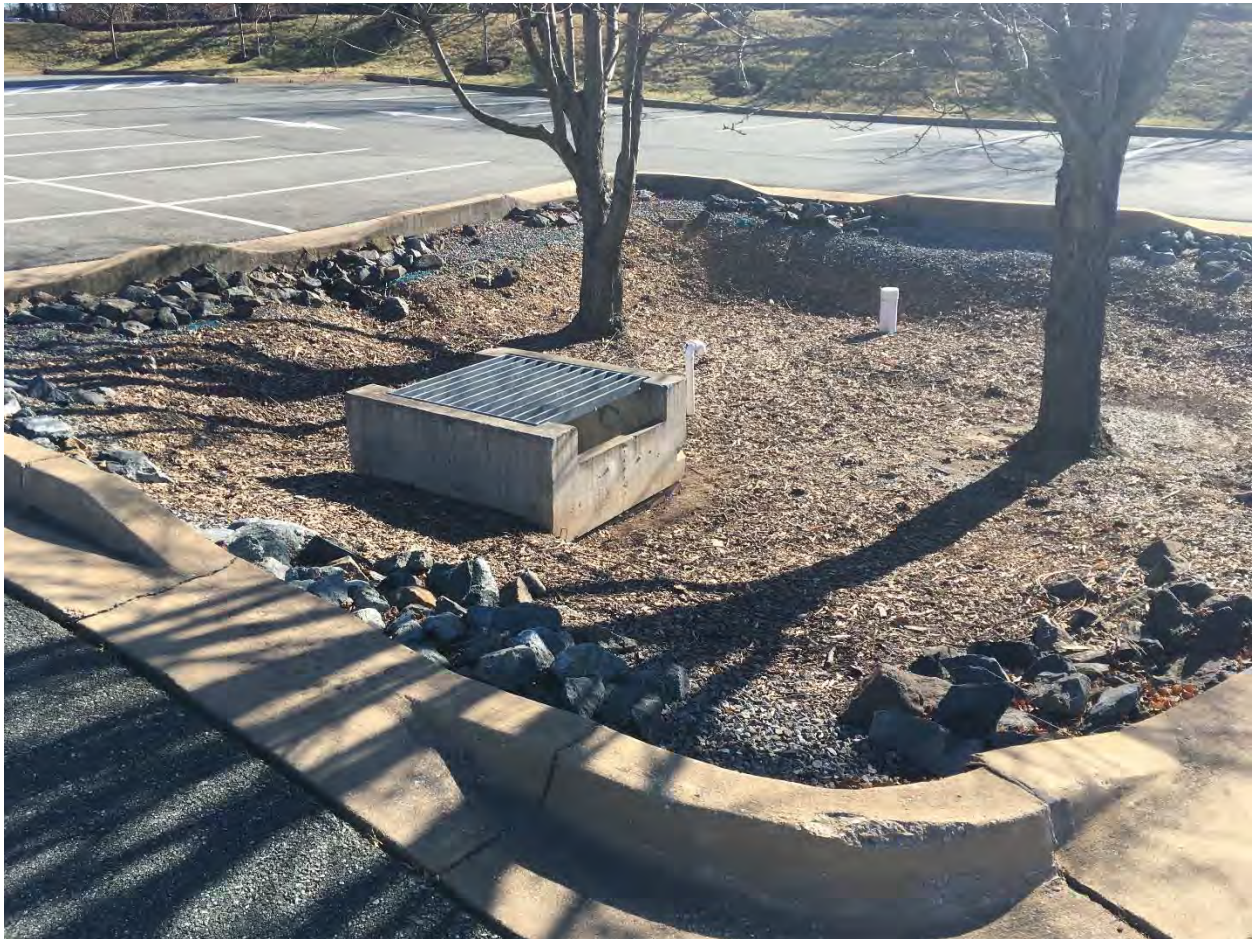
### Overall Photo

<b>Date of Inspection:</b>	01/11/2019 1:48 PM	<b>Inspector Initials</b>	SAL,JK,CAB
<b>BMP ID</b>	USG19BMP00022	<b>Inspection Firm</b>	MES
<b>BMP Type:</b>	Bioretention	<b>Underground BMP?</b>	No
<b>Rating:</b>	C - Failing, needs major maintenance	<b>Overall Inspection Comment</b>	Erosion at curb cut inflow and gravel curtain drain, excessive ponding potential at overflow device, vegetation removed 2013. Repair erosion, replace bioretention plants, remove tree, and remediate BMP to current MDE standards. +/-12" ponding depth in BMP

- **BMP Access** - Good
- **Debris & Sediment** - Good
- **Vegetation** - Poor
  - Non-Woody Vegetation Removed 2013, Maple trees show evidence of distressed health
- **BMP Contamination** - Good
- **Inflow Condition** - Poor
  - Erosion at inflows of curb cuts surrounding the BMP. Evidence of parking lot integrity being undermined. Erosion at gravel curtain drain
- **Forebay** - Not Rated
  - Gravel Curtain Drain Eroded and Riprap added
- **Conveyance Stability** - Fair
- **Downstream Condition** - Not Rated
  - Site outfalls to existing stormwater network

The bioretention is considered failing and requires major maintenance to restore to functioning condition. Maintenance recommendations to restore the bioretention to a functioning condition include: Regrade and restore bioretention to design criteria. Replanting of MDE approved bio-wetland plants. MES recommends removing the maple tree and replace with other MDE approved bioretention plants. Restore parking lot curb along perimeter/inflows of the bioretention facility. Perform additional maintenance as directed by project engineer to restore structural integrity of the surrounding parking lot.

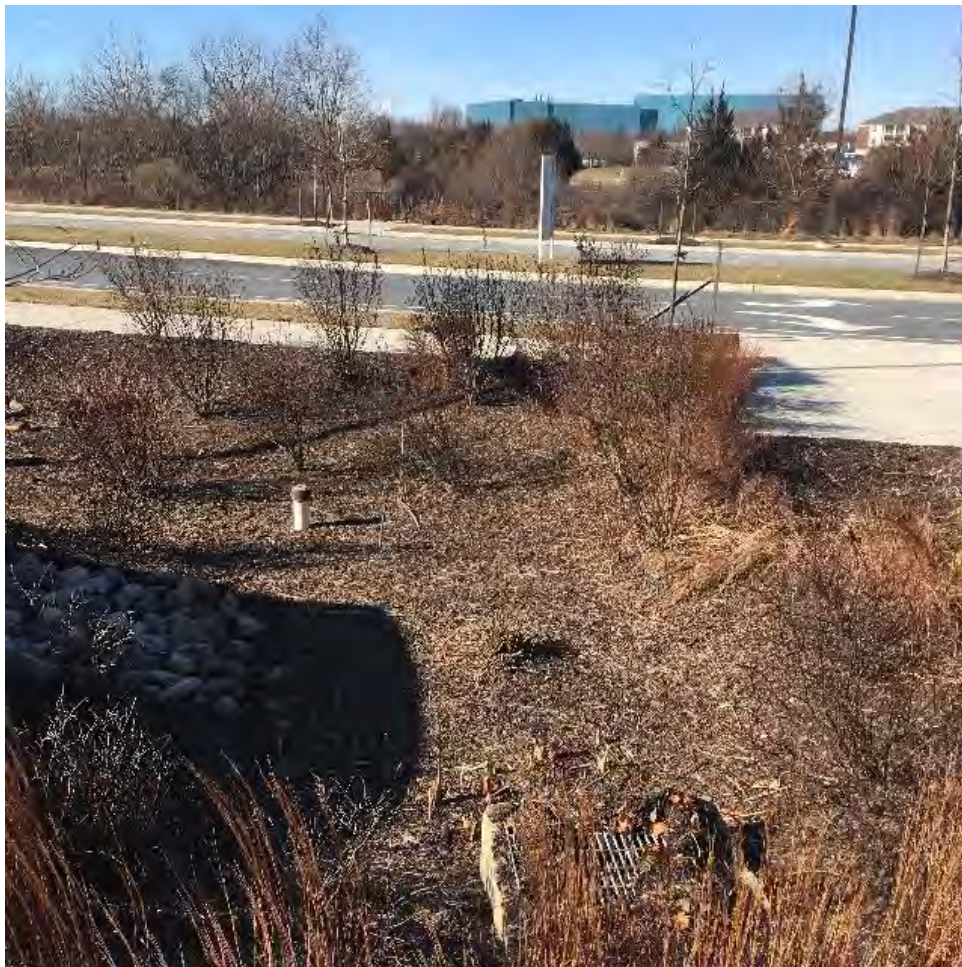
### Overall Photo

<b>Date of Inspection:</b>	01/11/2019 12:06 PM	<b>Inspector Initials</b>	SAL,JK,CAB
<b>BMP ID</b>	USG19BMP00023	<b>Inspection Firm</b>	MES
<b>BMP Type:</b>	Micro-Bioretenention	<b>Underground BMP?</b>	No
<b>Rating:</b>	B - Functioning, needs minor maintenance	<b>Overall Inspection Comment</b>	Erosive flow within BMP at southern inflow, Overflow device buried under mulch. Repair erosion, replace bioretention plants as needed, and uncover overflow device. BMP functioning as designed

- **BMP Access** - Good
- **Debris & Sediment** - Fair
- **Vegetation** - Fair
- **BMP Contamination** - Good
- **Inflow Condition** - Fair
- **Forebay** - Not Rated
  - Not Part of Design
- **Conveyance Stability** - Fair
- **Downstream Condition** - Not Rated
  - Site outfalls to existing stormwater network

The micro-bioretenion is considered functioning but could use minor and routine maintenance. Maintenance recommendations include: Removal of debris, sediment, and unplanned vegetation around the facility and at the inflow. Removal of sediment, and debris at the overflow device. Replace bioretention plants as needed.

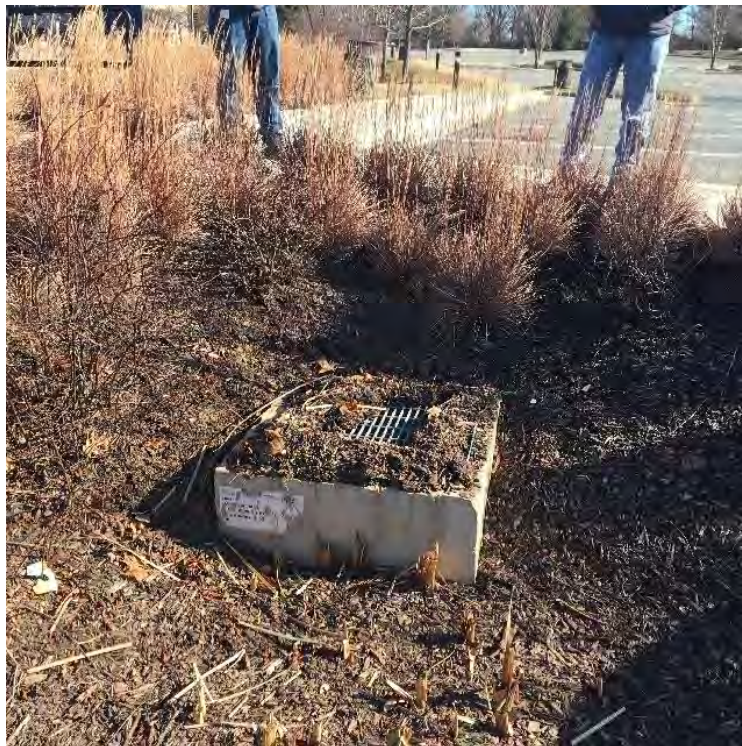
Overflow Device, Mulch on Inlet

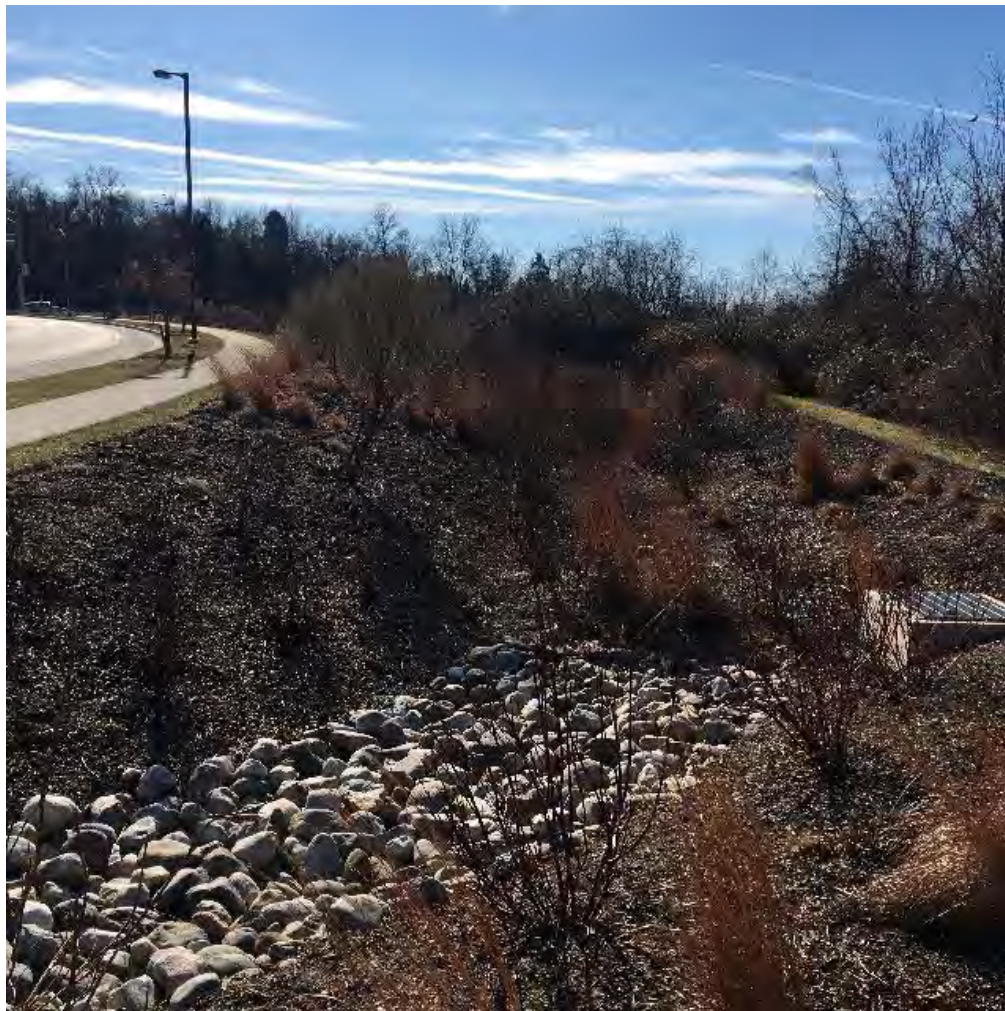
### Overall Photo

<b>Date of Inspection:</b>	01/11/2019 3:21 PM	<b>Inspector Initials</b>	SAL,JK,CAB
<b>BMP ID</b>	USG19BMP00024	<b>Inspection Firm</b>	MES
<b>BMP Type:</b>	Micro-Bioretenion	<b>Underground BMP?</b>	No
<b>Rating:</b>	A - Functioning, only needs routine maintenance	<b>Overall Inspection Comment</b>	BMP in good condition, minor sediment within inflow protection. BMP functioning as designed.

- **BMP Access** - Good
- **Debris & Sediment** - Good
- **Vegetation** - Not Rated
  - Outside of Growing Season
- **BMP Contamination** - Good
- **Inflow Condition** - Good
- **Forebay** - Not Rated
  - Not Part of Design
- **Conveyance Stability** - Good
- **Downstream Condition** - Not Rated
  - Site outfalls to existing stormwater network

No remedial action needed as the micro-bioretenion is in good functioning condition. Routine maintenance recommendations include: Removal of sediment within the facility. Repair any erosion at facility inflows. Removal of any unplanned and invasive vegetation inside the facility.

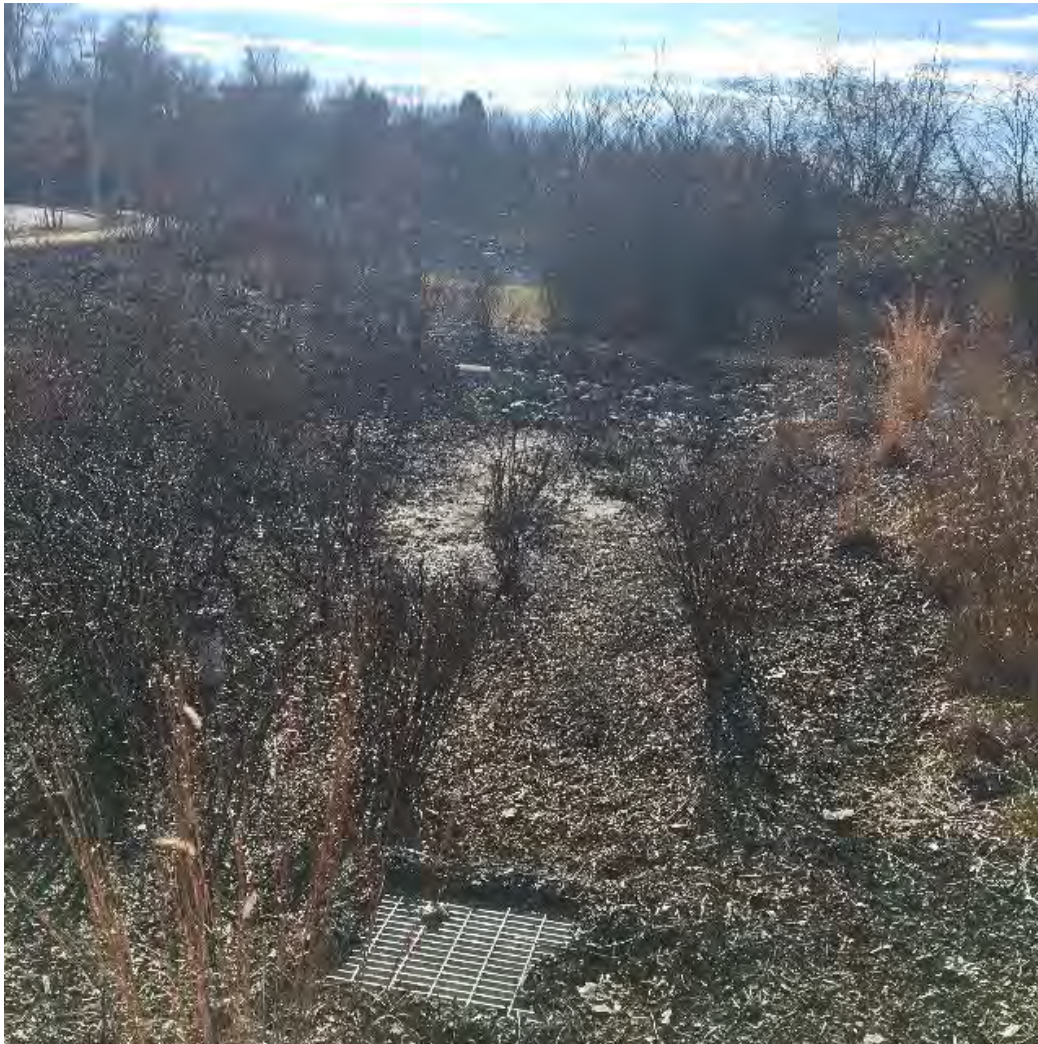
### Overall Photo

<b>Date of Inspection:</b>	01/11/2019 4:11 PM	<b>Inspector Initials</b>	SAL,JK,CAB
<b>BMP ID</b>	USG19BMP00025	<b>Inspection Firm</b>	MES
<b>BMP Type:</b>	Micro-Bioretention	<b>Underground BMP?</b>	No
<b>Rating:</b>	A - Functioning, only needs routine maintenance	<b>Overall Inspection Comment</b>	BMP in good condition, minor sediment within inflow protection. BMP functioning as designed.

- **BMP Access** - Good
- **Debris & Sediment** - Fair
- **Vegetation** - Not Rated
  - Outside Growing Season
- **BMP Contamination** - Good
- **Inflow Condition** - Good
- **Forebay** - Not Rated
  - Not Part of Design
- **Conveyance Stability** - Good
- **Downstream Condition** - Not Rated
  - BMP outflows into Stormdrain System

No remedial action needed as the micro-bioretenion is in good functioning condition. Routine maintenance recommendations include: Removal of sediment within the facility. Repair any erosion at facility inflows. Removal of any unplanned and invasive vegetation inside the facility.

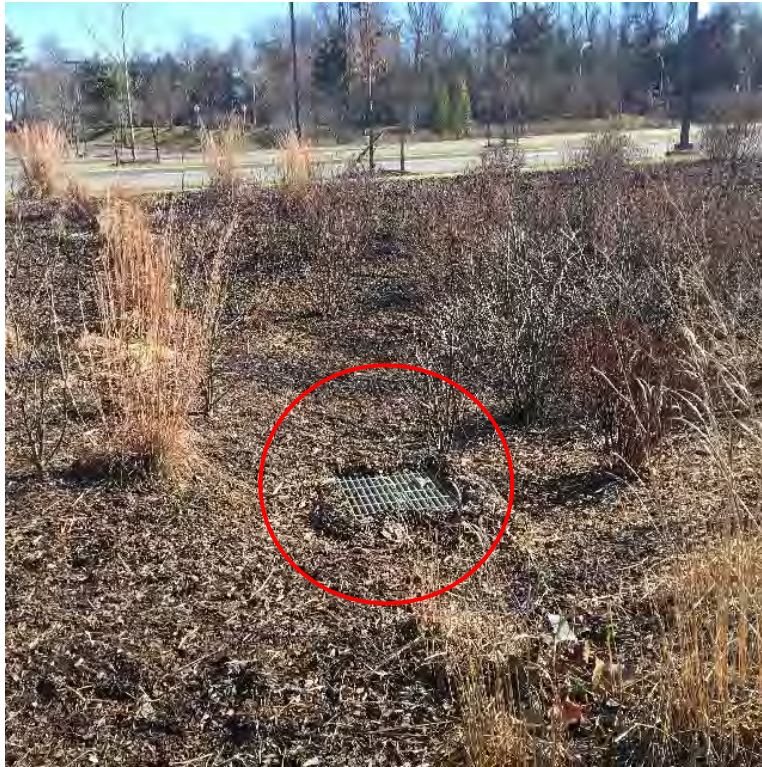
Overflow Device

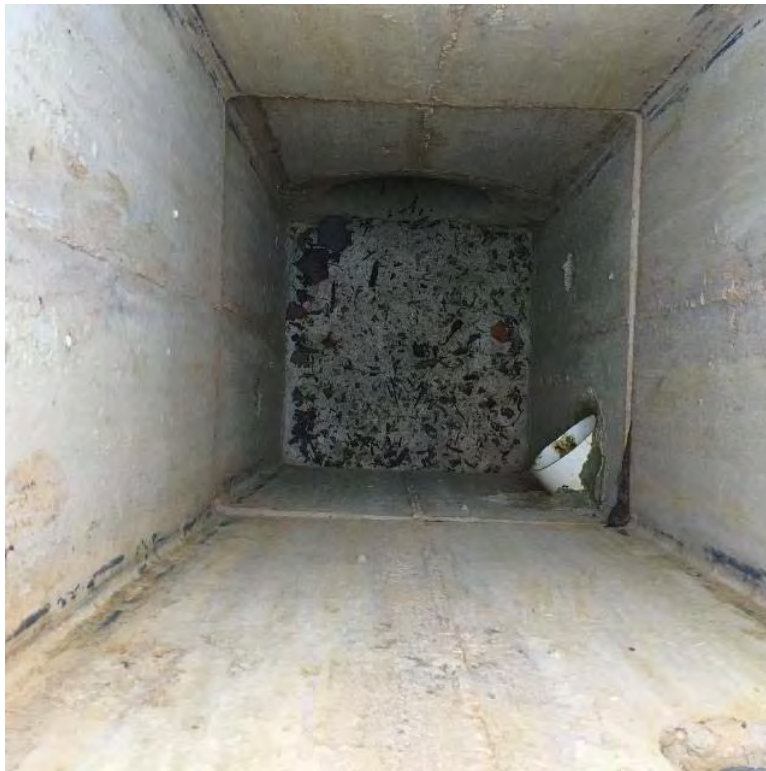
Principal Spillway

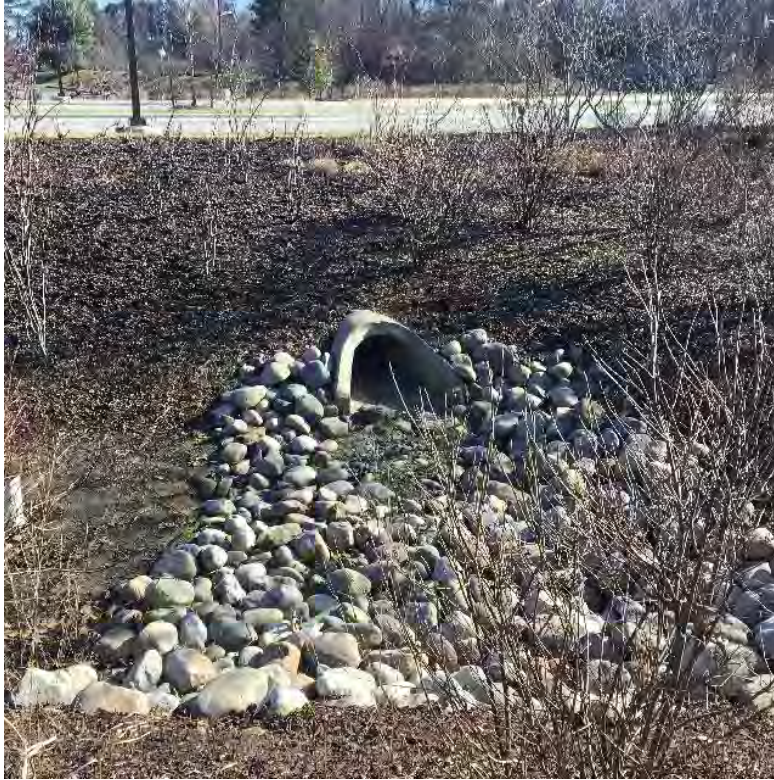
Inflow - from COG

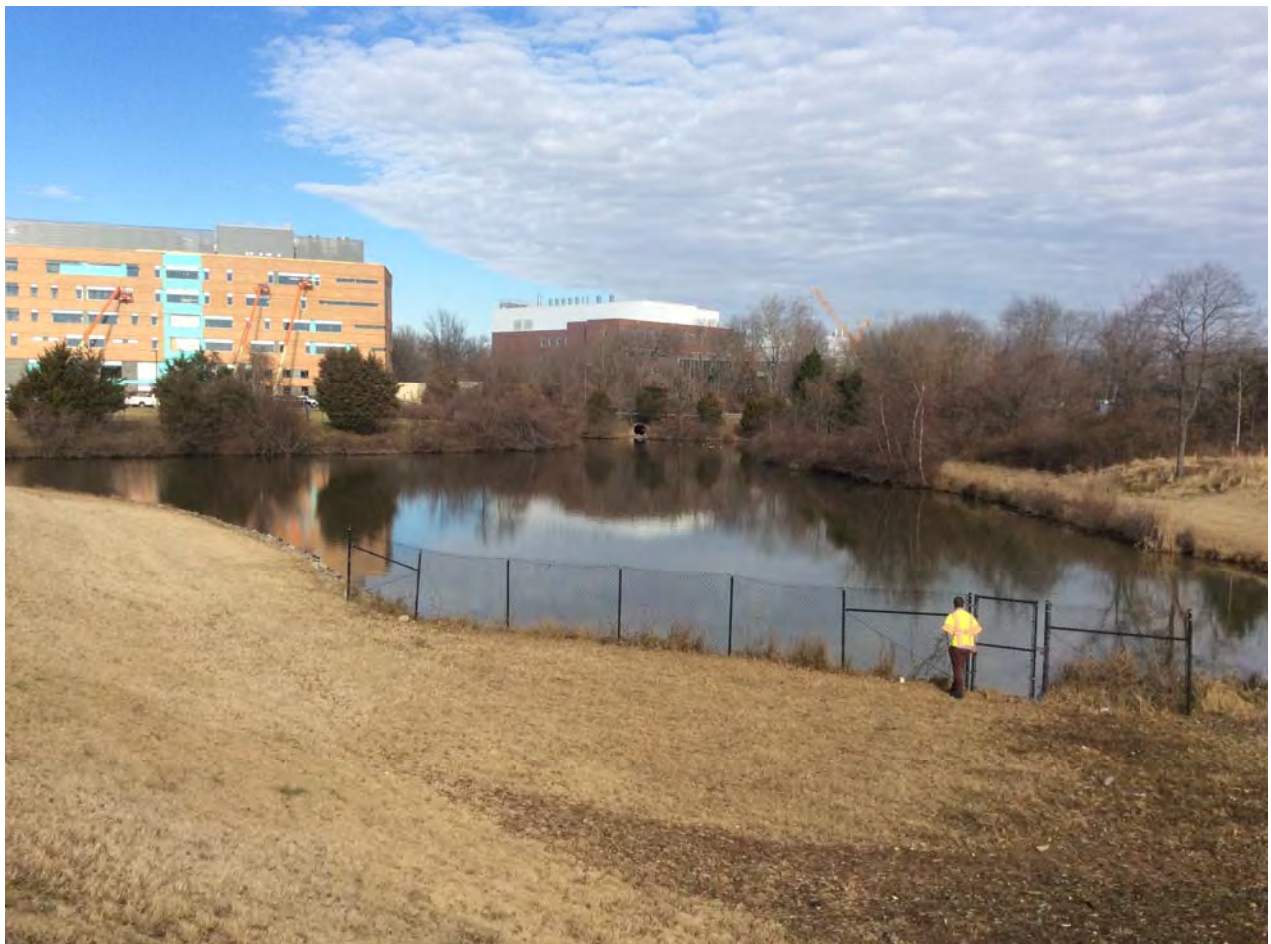
## Overall Photo

<b>Date of Inspection:</b>	01/08/2019 3:50 PM	<b>Inspector Initials</b>	SAL,JW,TF,SL
<b>BMP ID</b>	USG19BMP00026	<b>Inspection Firm</b>	MES
<b>BMP Type:</b>	Retention Pond (Wet Pond)	<b>Underground BMP?</b>	No
<b>Rating:</b>	A - Functioning, only needs routine maintenance	<b>Overall Inspection Comment</b>	Pond in good condition, Forebay is undersized for pond inflow and filled with cattails, ponding at emergency spillway base, left valve appears closed, unable to test valves due to confined space. Functioning as designed.

- **BMP Access** - Good
- **Debris & Sediment** - Good
- **Vegetation** - Fair
  - Plant growth in forebay and in emergency spillway
- **BMP Contamination** - Good
- **Inflow Condition** - Good
- **Forebay** - Poor
  - Forebay is undersized and filled unwanted vegetation
- **Conveyance Stability** - Good
- **Downstream Condition** - Good

No remedial action necessary as the pond is in good functioning condition. Routine maintenance recommendations include: Removal of debris, cattails and other unplanned vegetation at the forebay and remaining inflows. Removal of debris and unplanned vegetation at pond outfall, 15' downstream of the control structure and emergency spillway.

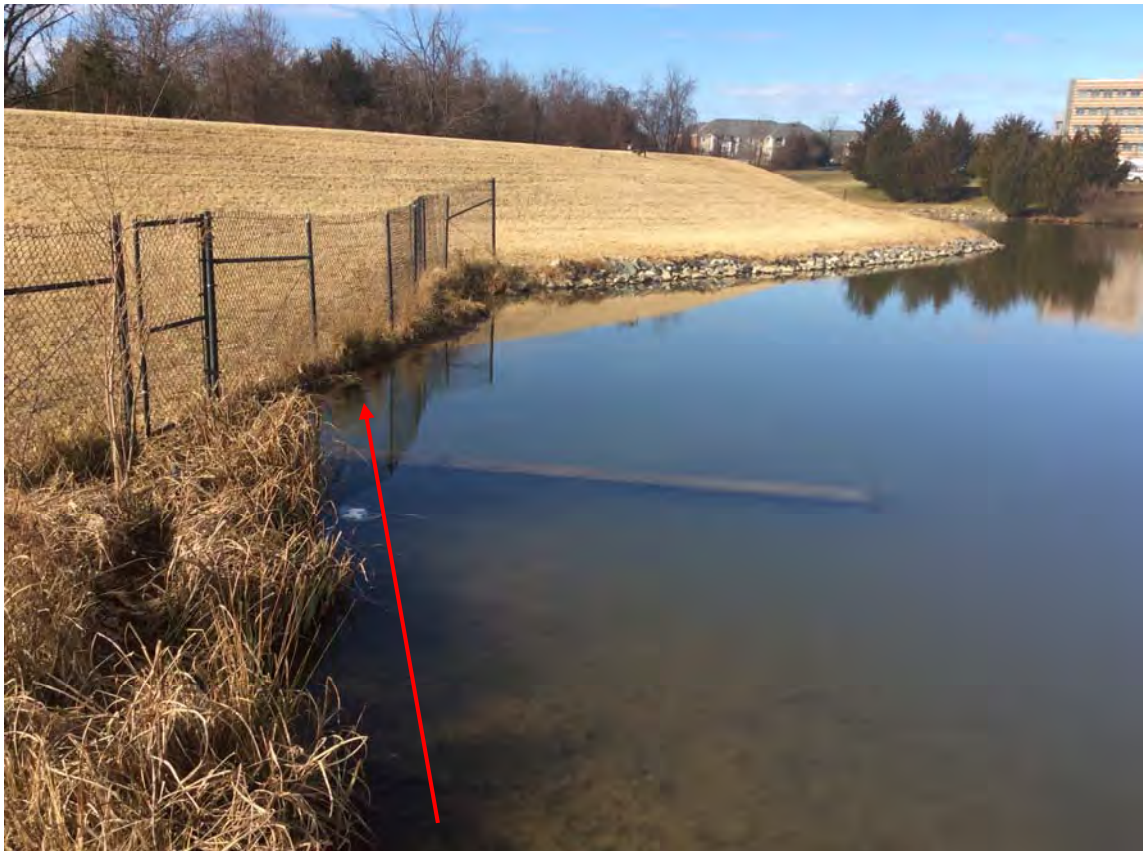
Low flow Device, Submerged

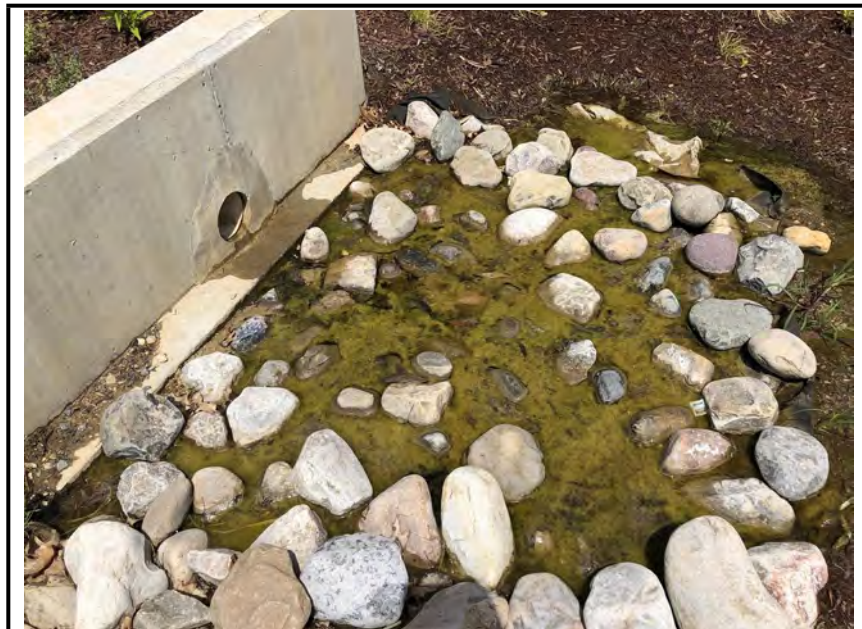
**Photo #4:** Standing water at inflow.

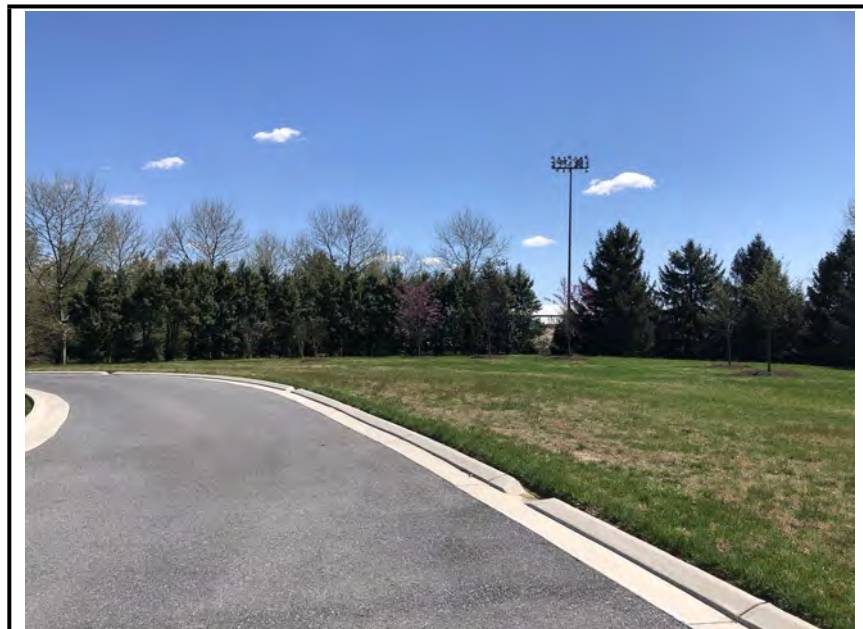
**Photo #2:** Curb cuts along the driveway.

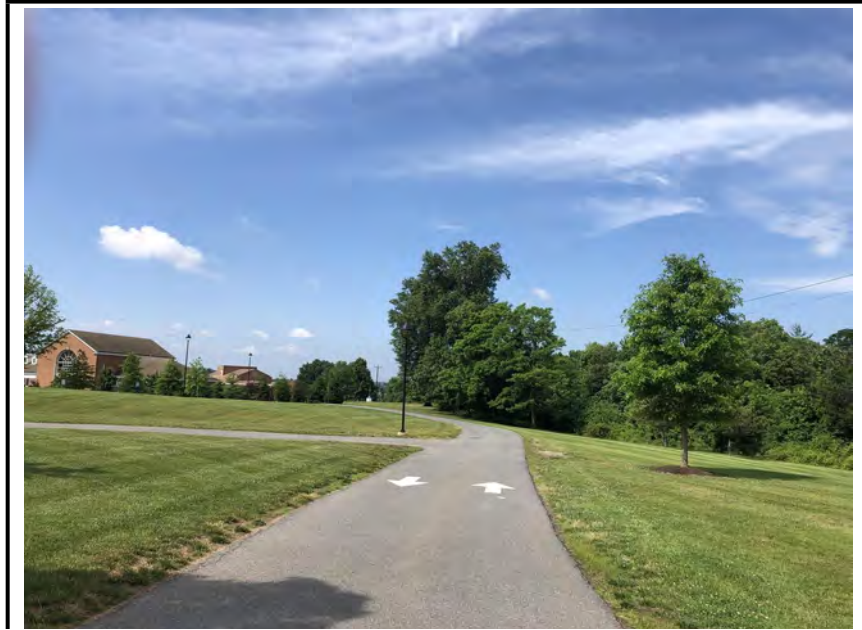
This BMP is sheet flow to a conservation area and is a non-structural practice. The grass adjacent to the parking lot is in good condition. Some of the grass areas of the disconnect drainage area are greater than 5% slope. These areas do not pass MDE design criteria, unless MDE approved and made an exception within the original design plans. Areas with a slope less than 5% are in good condition and meet MDE criteria.

**Photo #1:** The driveway behind University House.

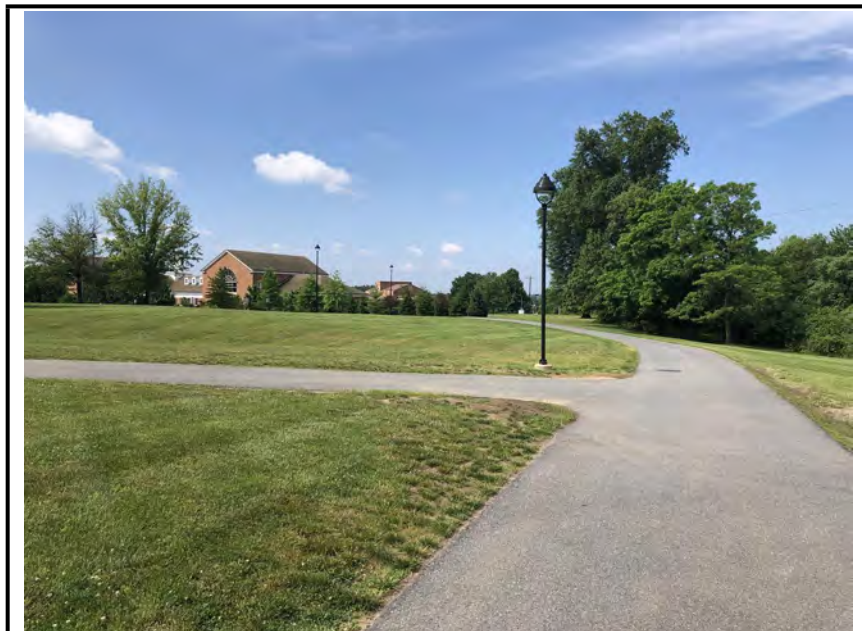
**Photo #2:** A section of the non-structural practice.

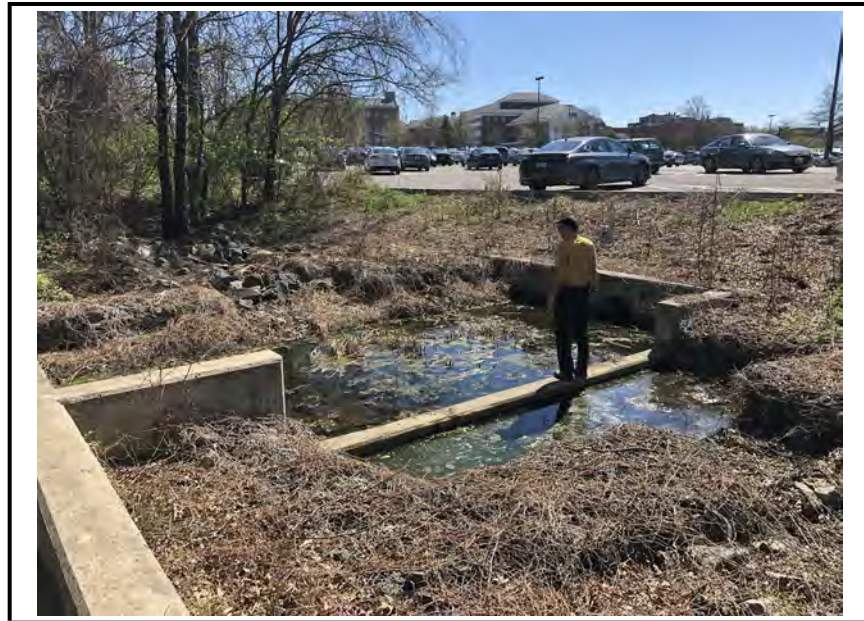
The filter area is clogged with leaves, debris, and muck, and is not infiltrating water through the sand layer. A ½" layer of mud and silt is located throughout the sand filter area. Standing water is present on the surface of the sand filter due to an uneven filter surface elevation. Trash is present throughout filter area and pretreatment area. Algae is present in pretreatment area and within the flowsplitter. All observation wells are filled with standing water up to the filter surface and have broken caps. The channel adjacent to the flowsplitter is filled with leaves, branches, and debris. Leaves and branches are being dumped adjacent to the sand filter, causing the facility to become filled with debris and resulting in stagnant water. The sand filter is in overall poor condition and is failing to treat the stormwater runoff it receives.

**Photo #1:** Flowsplitter, algae, vines, and debris present.

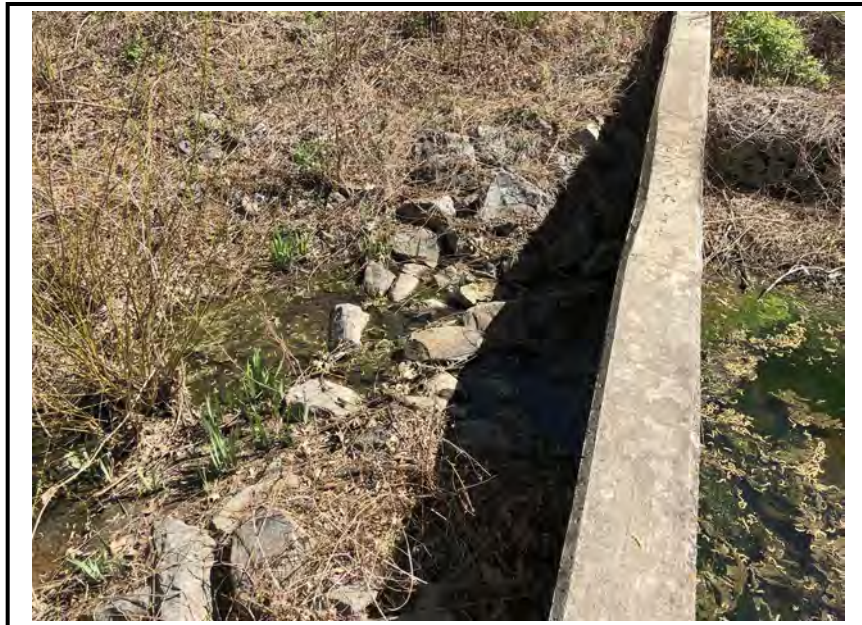
**Photo #3:** Outfall of flowsplitter, algae, debris present.

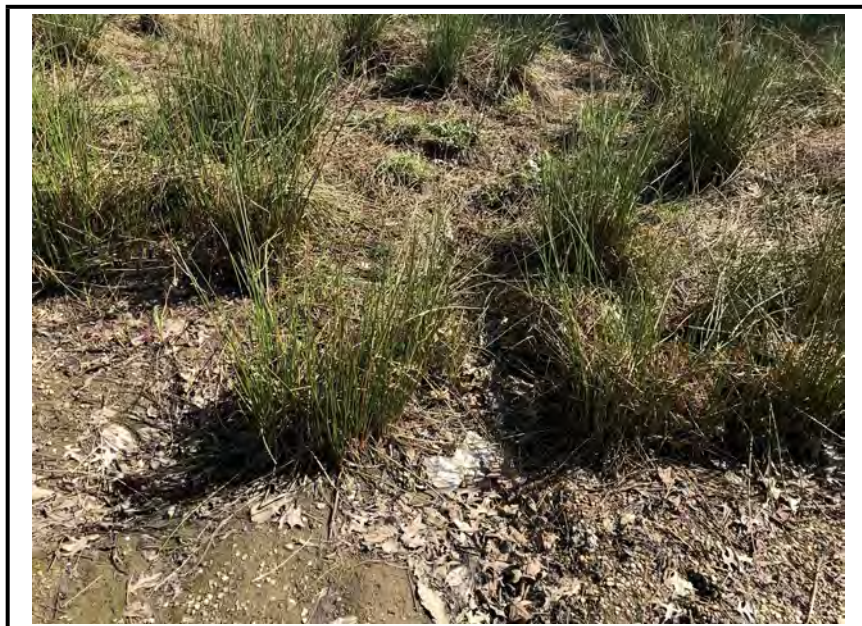
**Photo #4:** Pretreatment area, leaves, trash, and debris present.

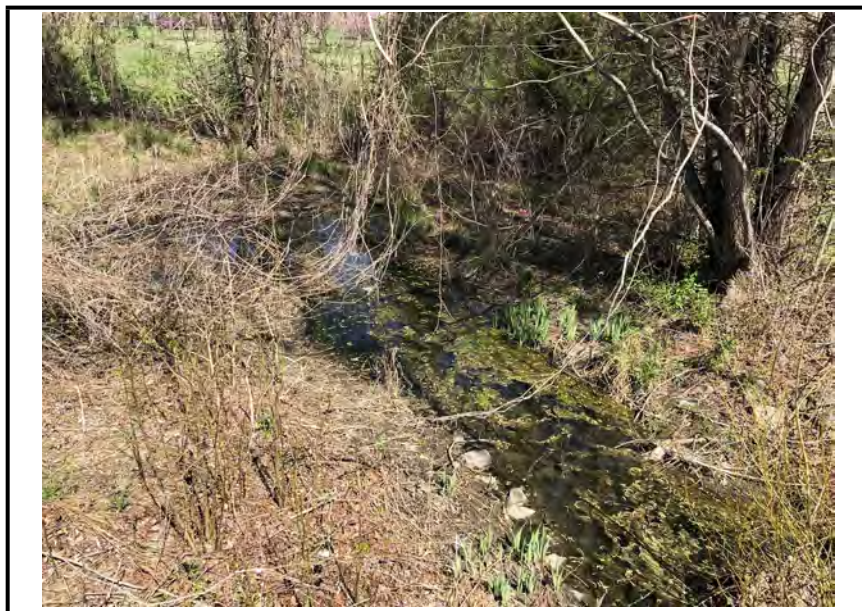
Photo #6: Pretreatment area.

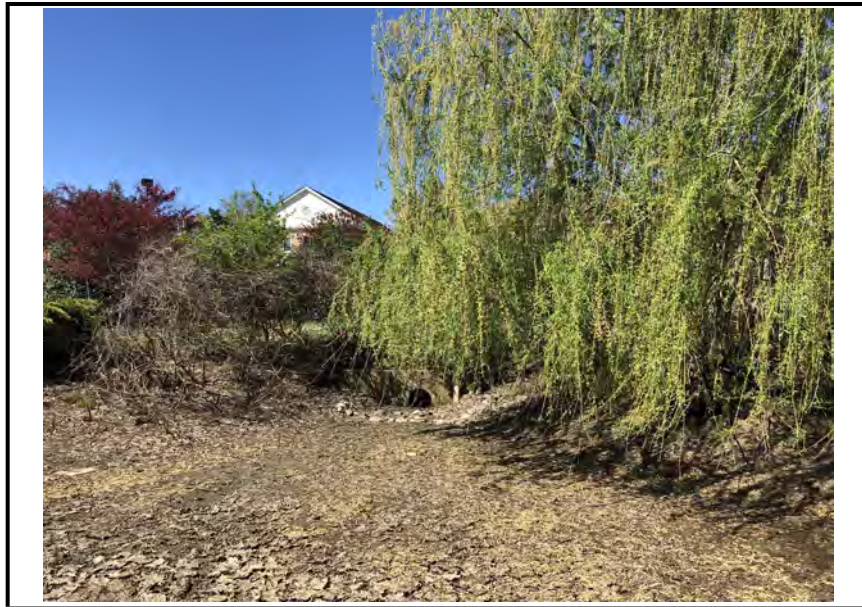
**Photo #7:** Sand filter area, facing west.

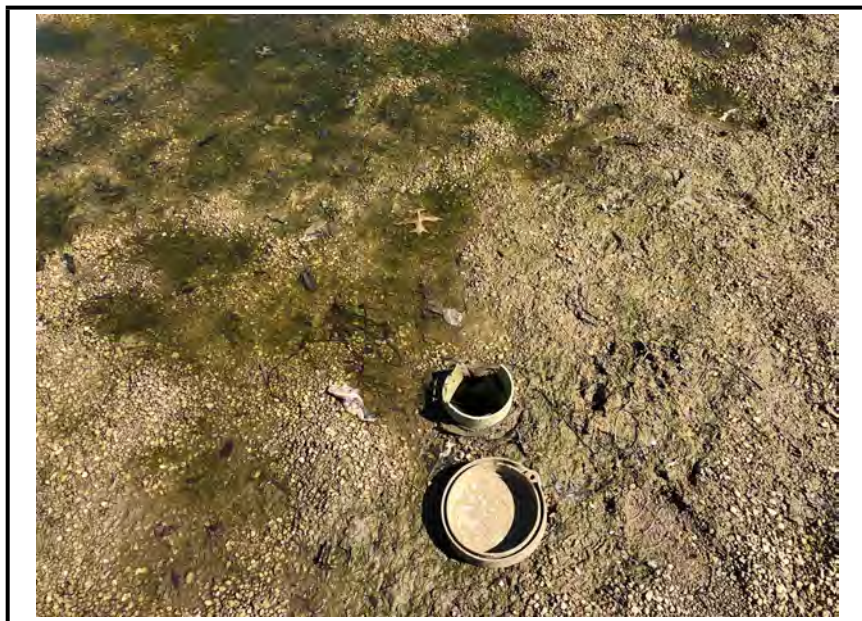
**Photo #8:** Cleanout, full of water, algae present.

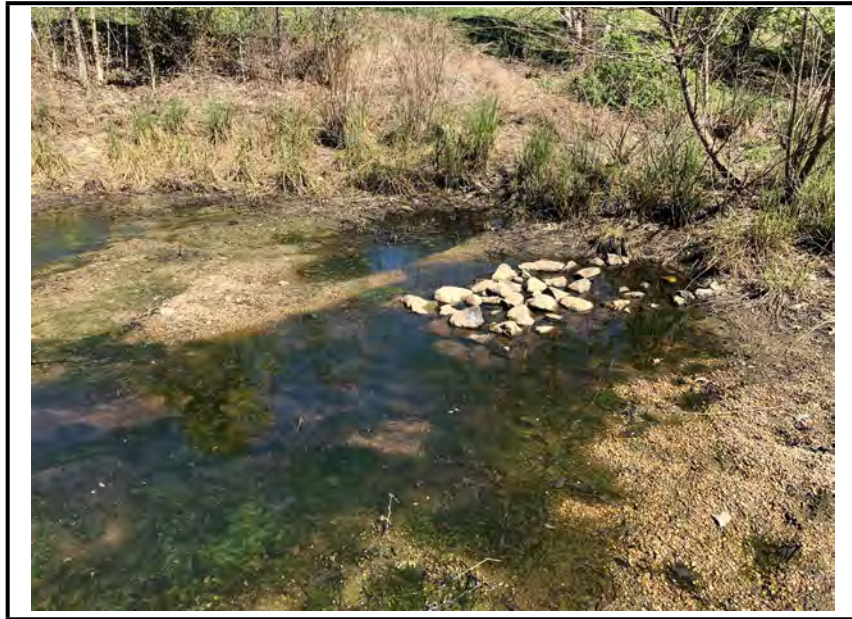
**Photo #9:** Pretreatment area, ponding and algae present.

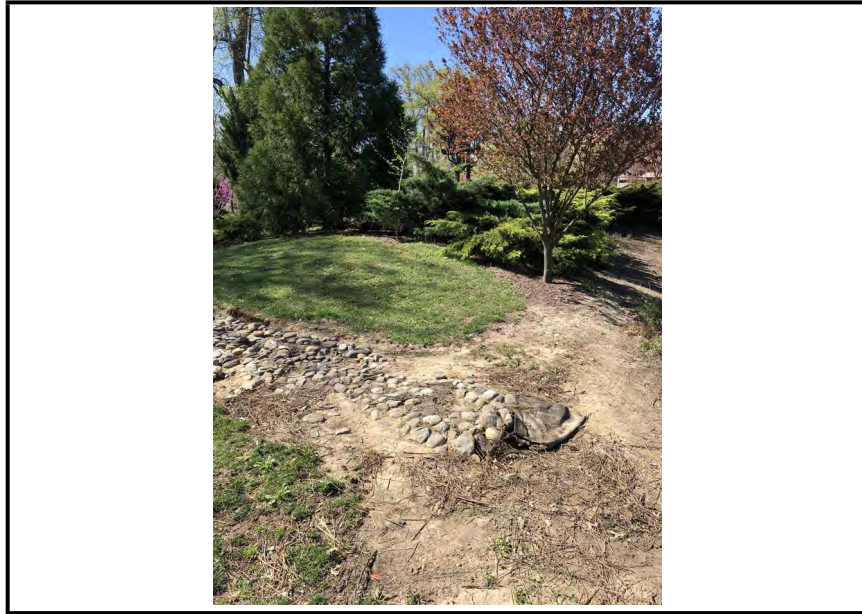
**Photo #11:** Overflow spillway, erosion present.

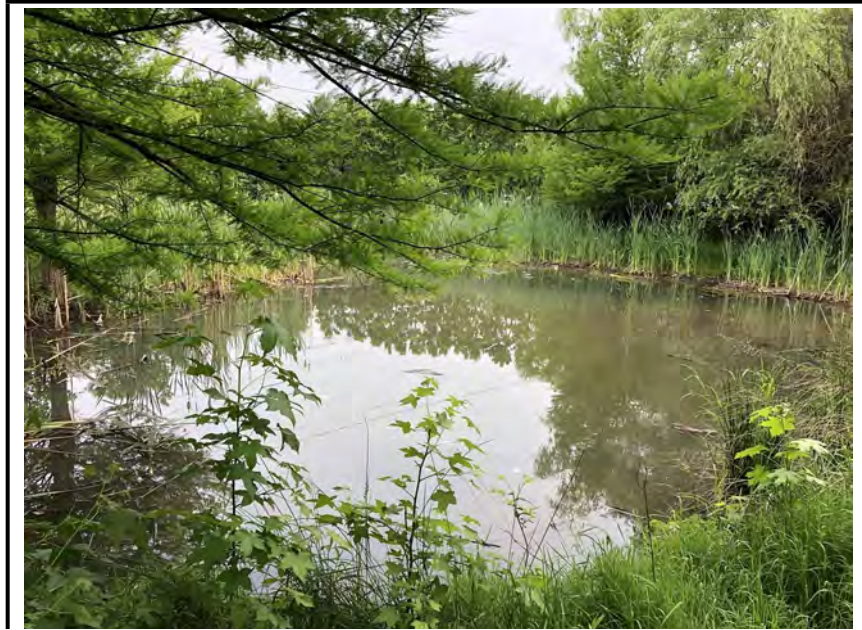
Overall this facility is in fair condition. The water is not stagnant, and the facility has become a thriving habitat for wildlife. Vegetation including cattails and trees are present within the facility and should be more frequently landscaped. Additional riprap is required at the second inflow point.

**Photo #1:** View into the facility.

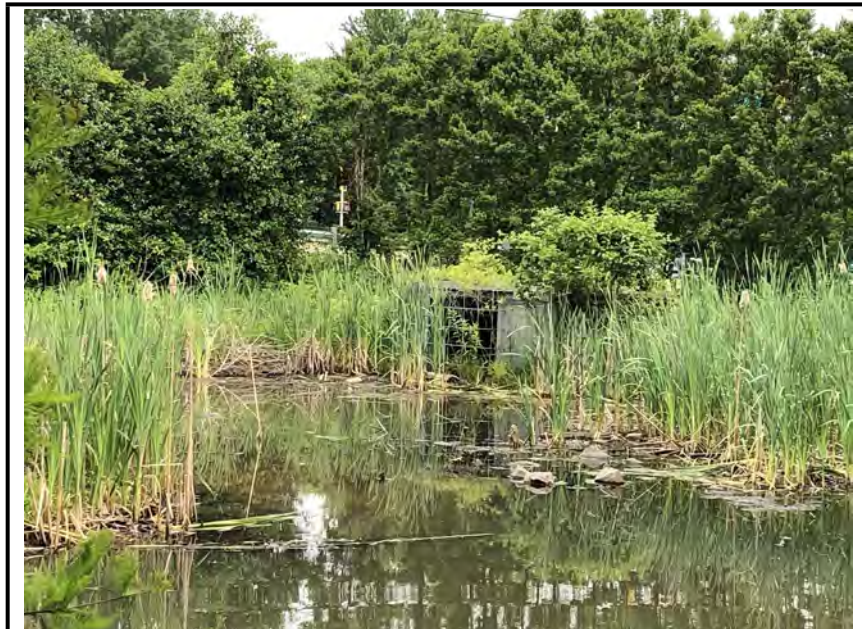
**Photo #2:** The overgrown outfall structure.

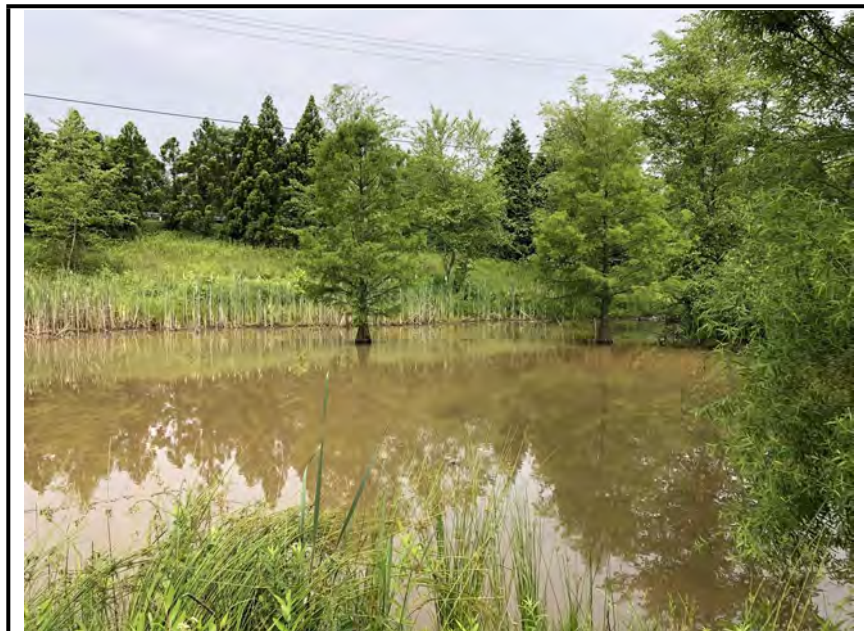
**Photo #4:** Trees and low flow in the forebay.

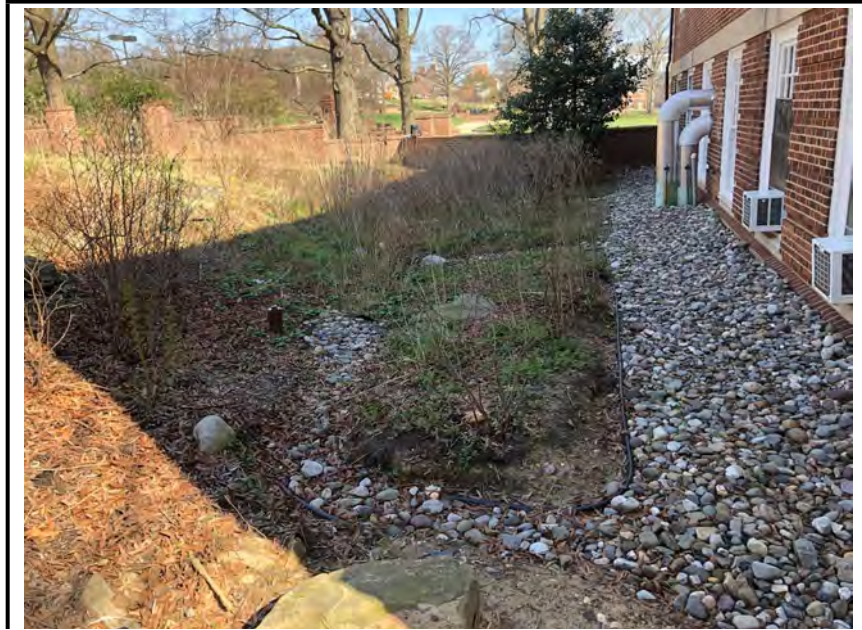
The facility is in overall good condition. Aside from the exposed geotextile, the only other issue is the accumulation of leaf litter on the filter area. Facility appears to be in functional condition.

**Photo #1:** View from base of the facility.

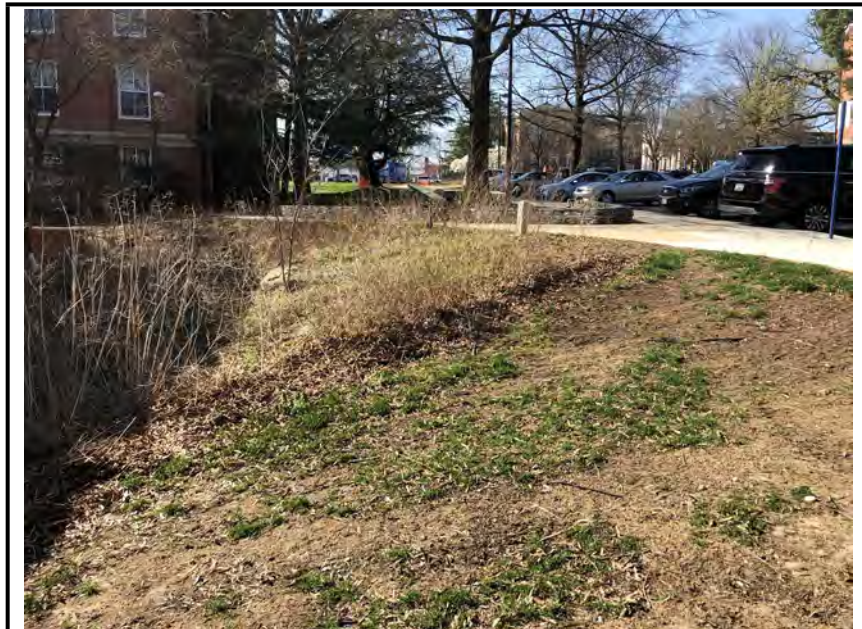
**Photo #2:** Sheet flow entry into the facility.

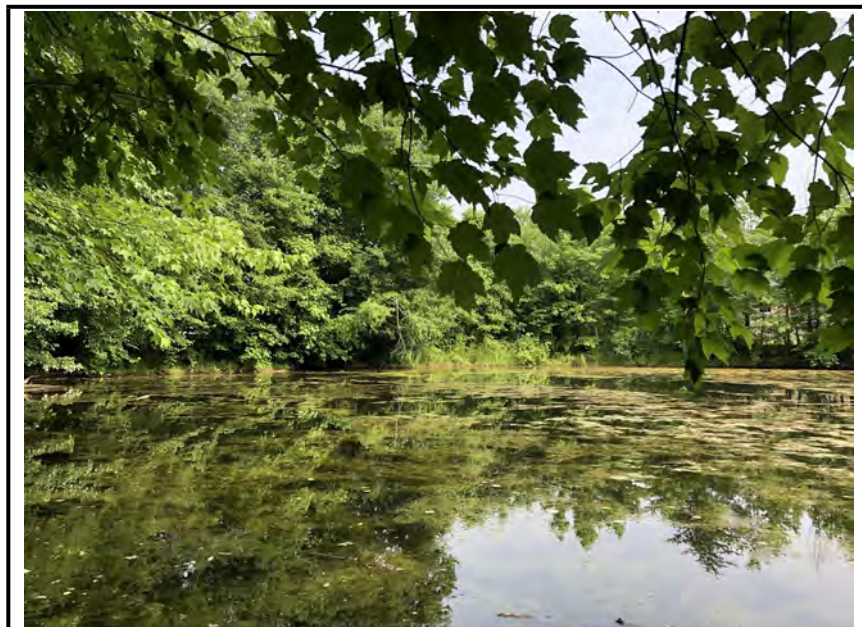
**Photo #2:** View of the water surface.

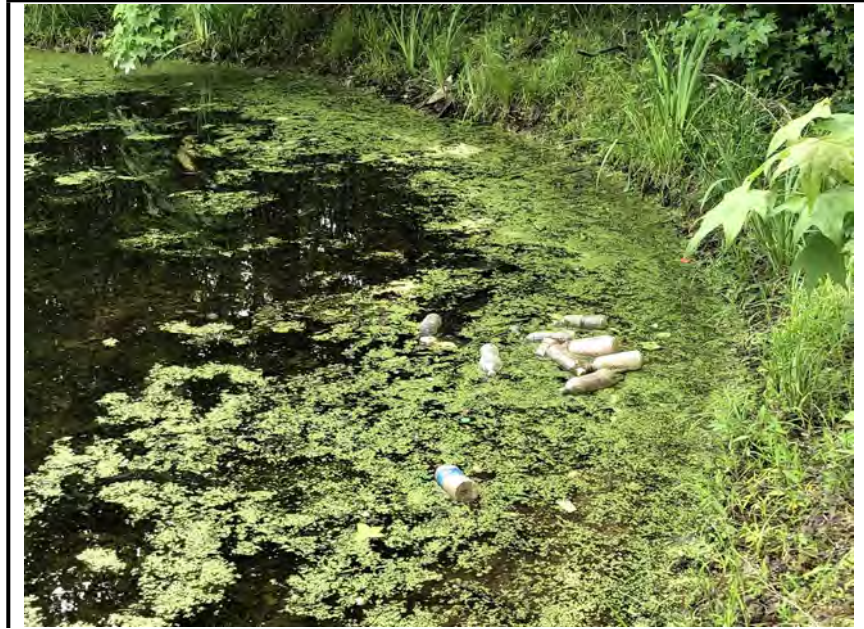
**Photo #3:** Algae and trash on the water surface.

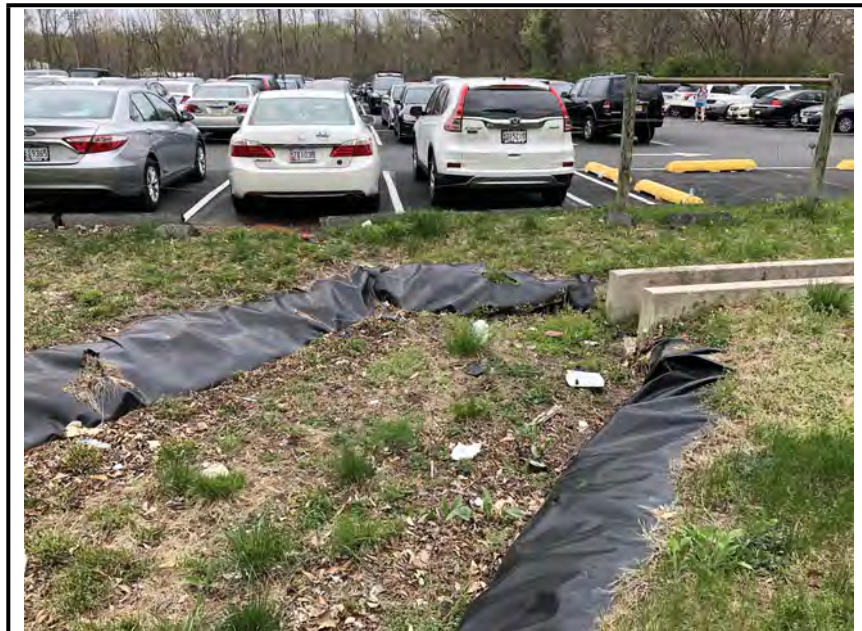
**Photo #4:** The inflow point on SWF 43.

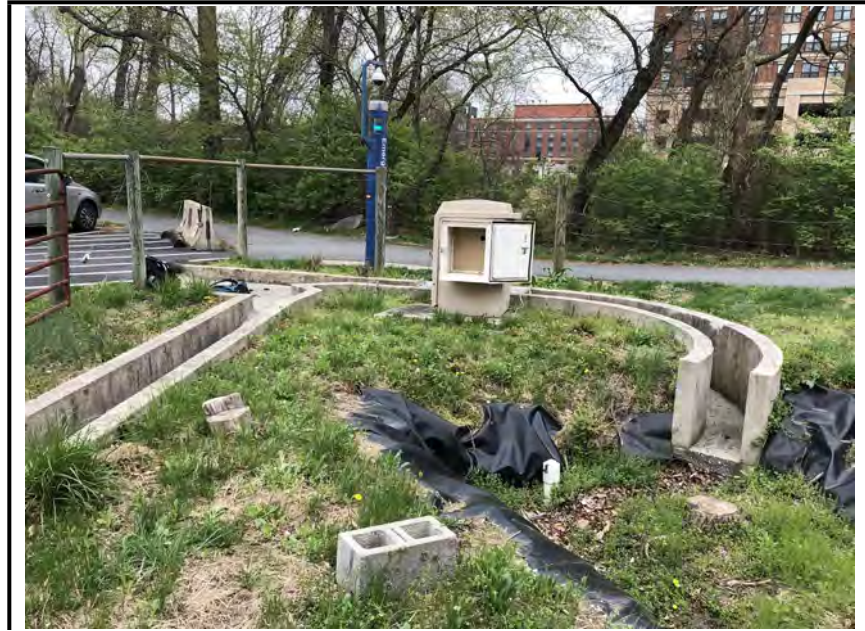
**Photo #5:** The inflow channels of both facilities.
