University of Maryland, College Park  
National Pollutant Discharge Elimination  
System MS4 Phase II  
FY2019 Annual Report  
General Discharge Permit #13-SF-5501

## **Stormwater Treatment Final Report & Recommendations**

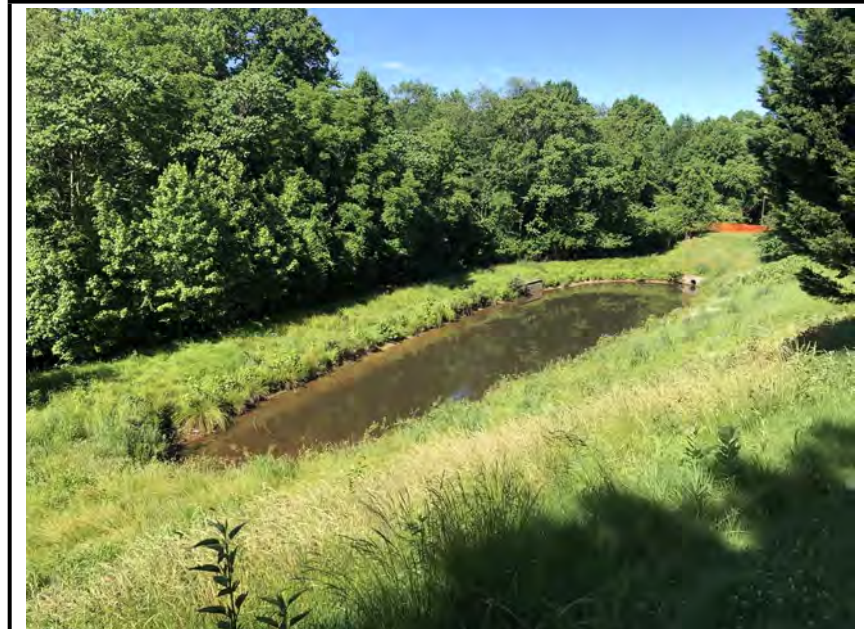
The facility is in fair condition. The water quality is cloudy, but the facility appears to be functional.

**Photo #1:** View into the facility.

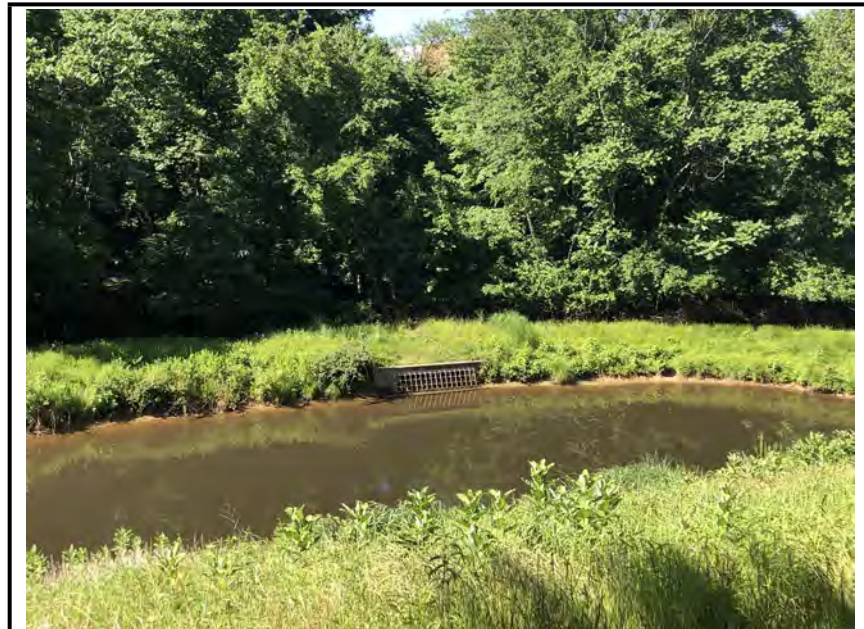
**Photo #2:** The grated outfall structure.

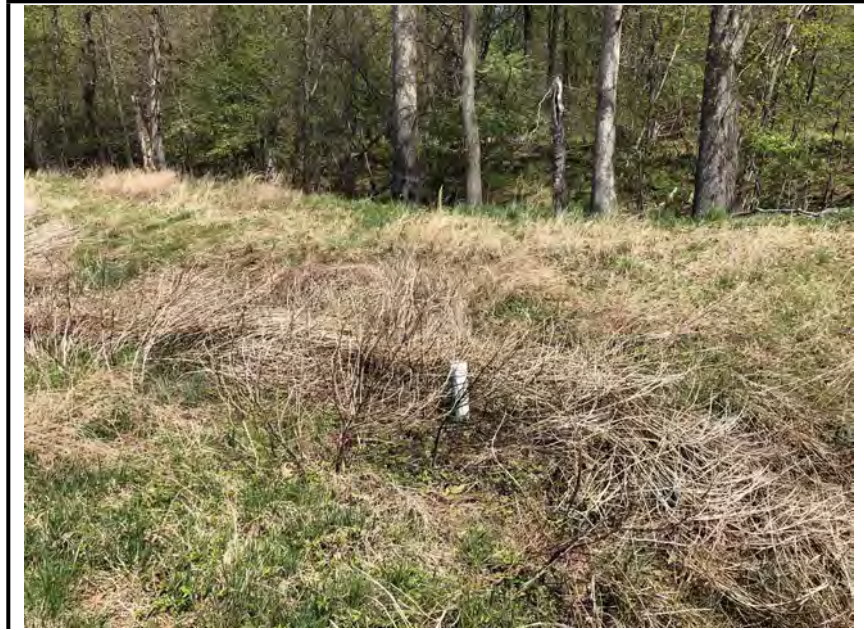
**Photo #3:** Vegetation in the facility is dominated by brush.

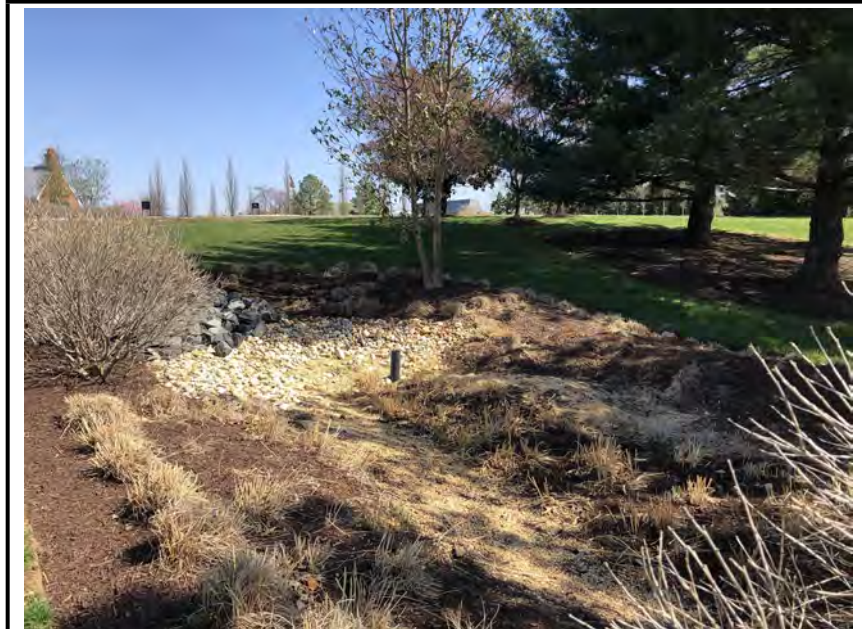
**Photo #1:** View into the facility.

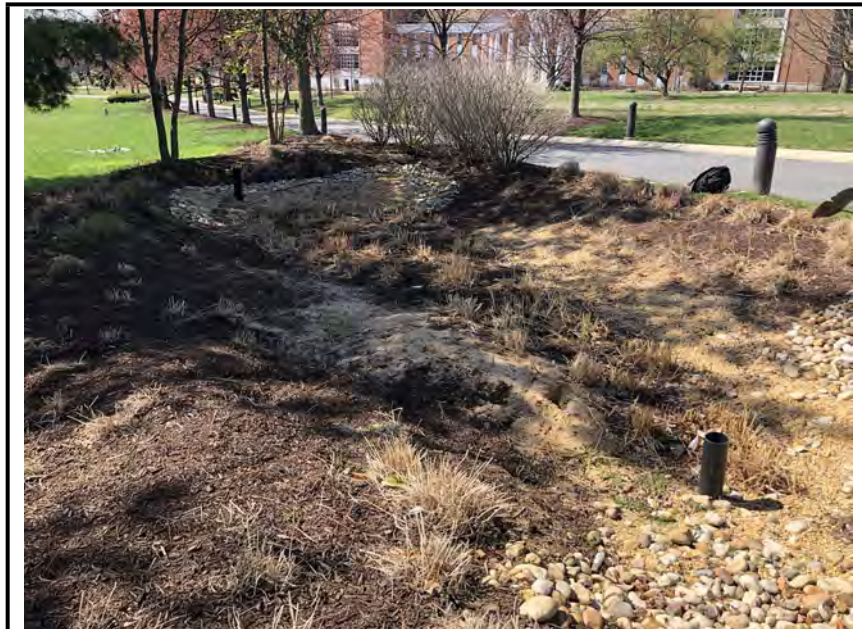
This facility is in good condition. There is a pile of sand in the middle of the filter bed, and two of the cleanouts are missing lids, but the facility appears functional.

**Photo #2:** Pile of sand in the middle of the filter bed.

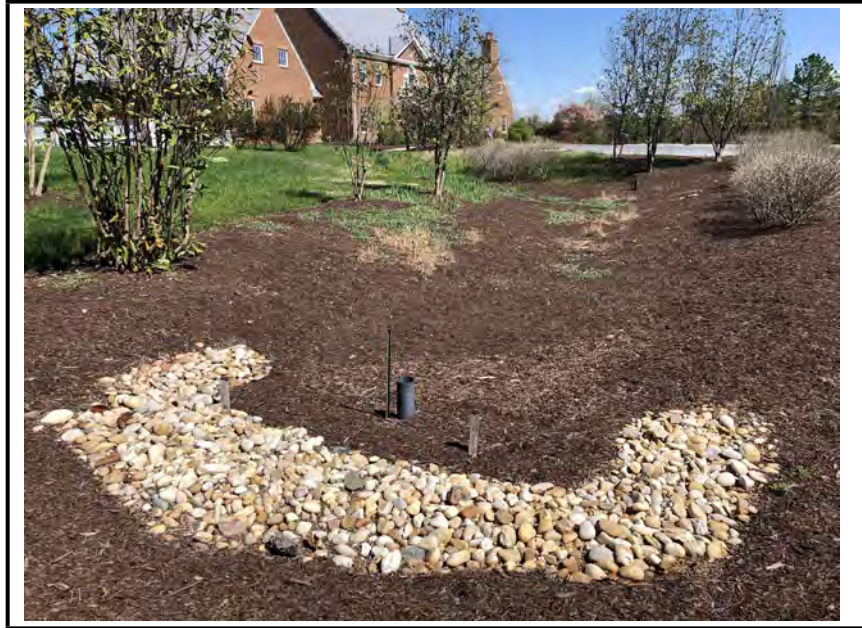
Overall, this facility is in good condition. There is mulch buildup on the filter area which has made the filter area smaller than was designed. The culvert is clogged with leaf debris. The facility appears to be functional, and the landscaping seems maintained.

**Photo #1:** View into bioretention facility.

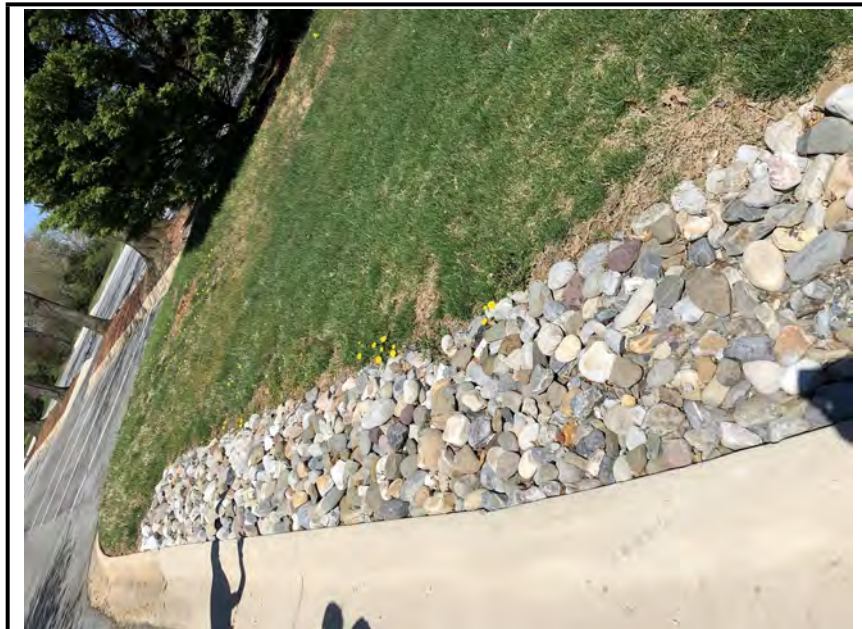
**Photo #2:** The gravel strip into which the underdrain drains.

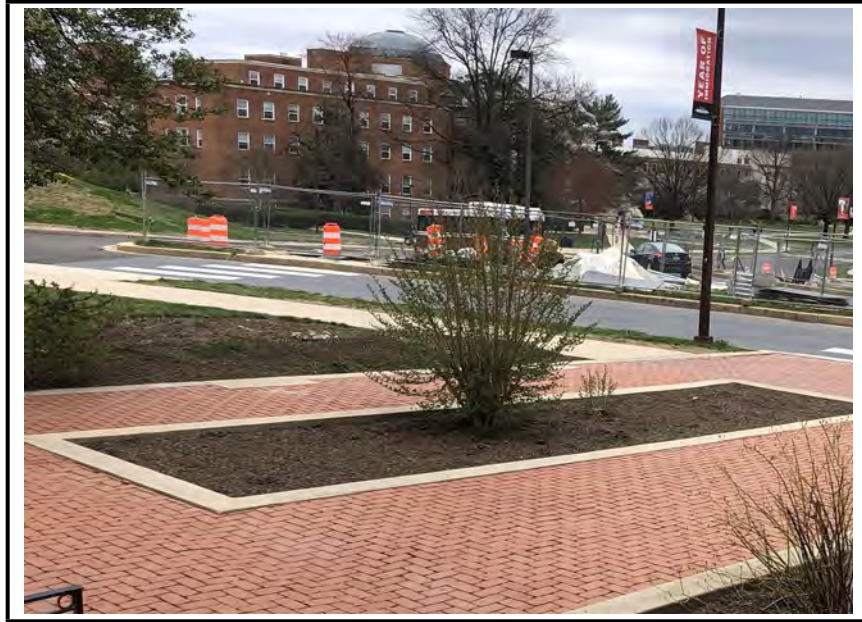
This facility is a shallow, mulch covered rain garden facility with no vegetation except for two bushes and some weeds. At the time of inspection there was no standing water or algae present in the facility, and no noticeable signs of erosion. Aside from the lack of vegetation, this facility appears to be in good condition.

**Photo #1:** Overall view of the rain garden.

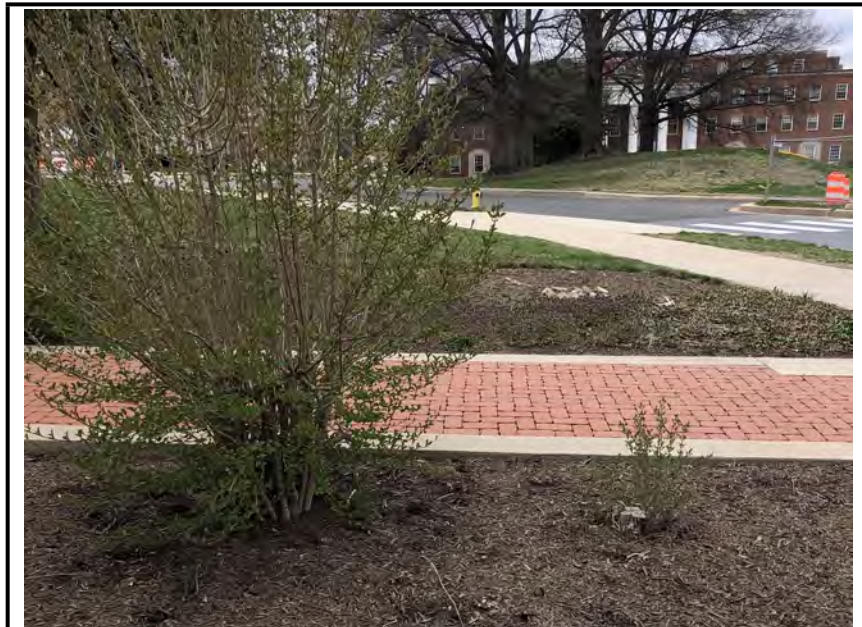
**Photo #2:** Close up view of the vegetation.

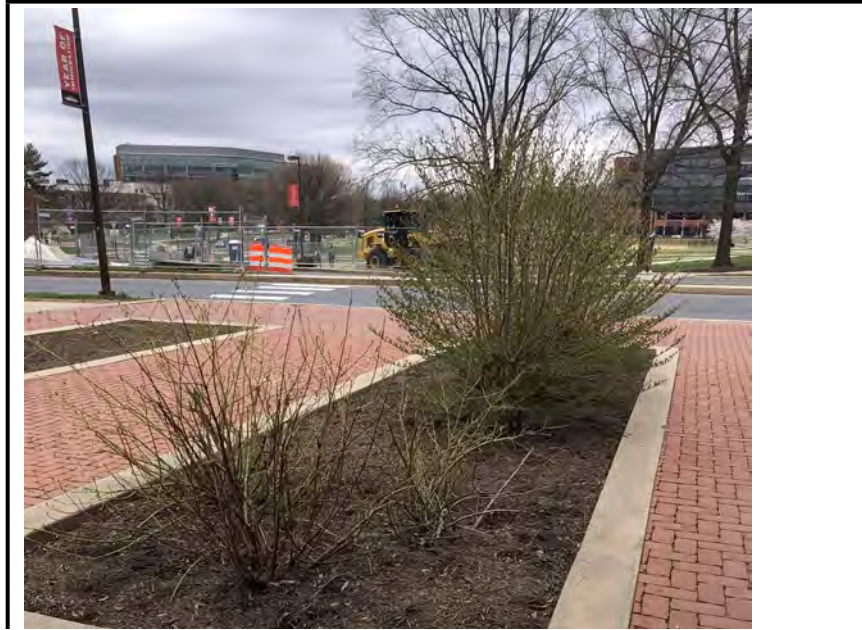
This facility is a shallow, mulch covered rain garden facility with no vegetation except for four bushes and some weeds. At the time of inspection there was no standing water or algae present in the facility, and no noticeable signs of erosion. Aside from the lack of vegetation, this facility appears to be in good condition.

**Photo #1:** View from the right side of the rain garden.

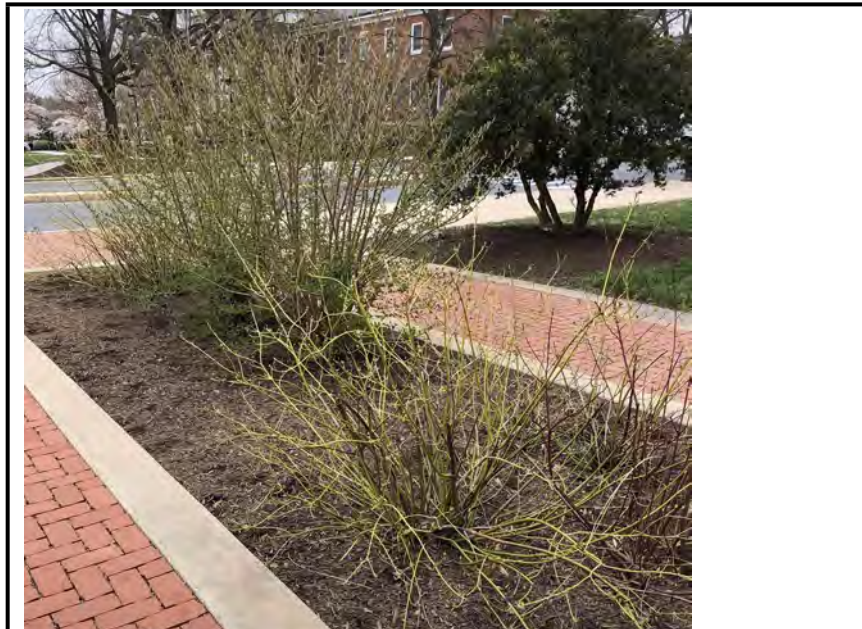
**Photo #2:** View from the left side of the rain garden.

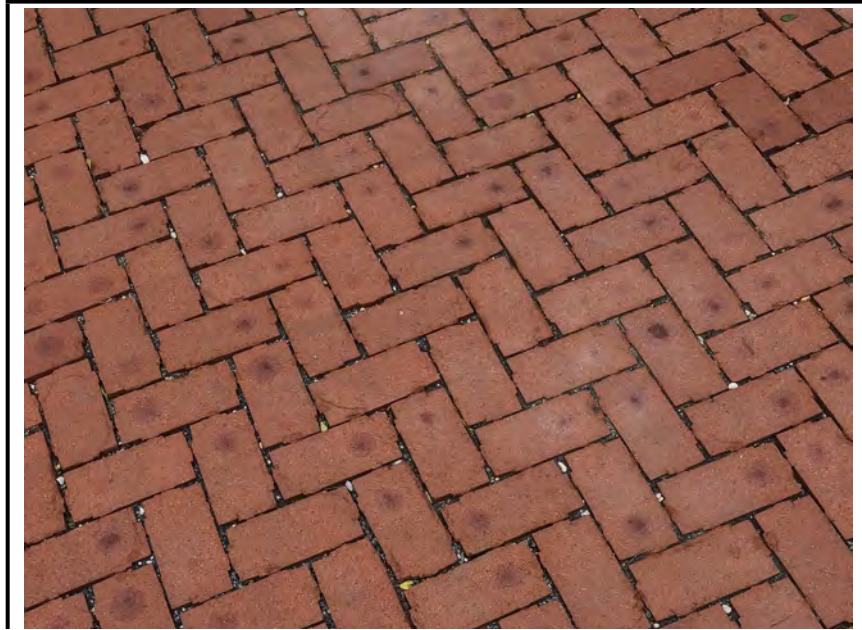
This facility is a permeable, brick patio that is in fair condition. The pavement pores are becoming clogged with debris in some areas, and there are several noticeably sunken areas in its surface. Uneven settling of the bricks may become a safety hazard. The uneven settling also indicates a possible subgrade failure due to poor drainage and infiltration.

**Photo #1:** Semi-clogged pores in pavement.

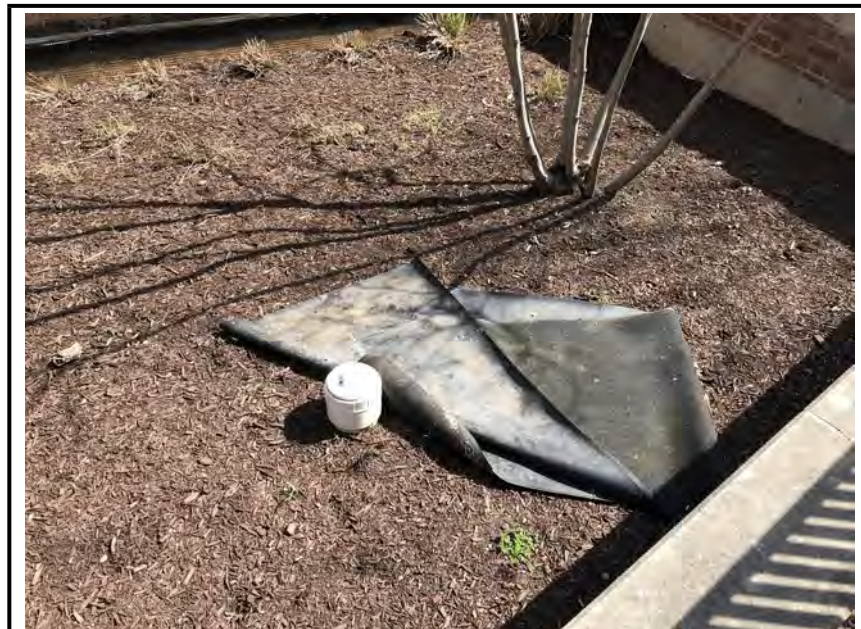
This facility is in good condition. There is mulch buildup near the walls, trash present in the forebays and filter area, and waterproofing loose along the ledge, but the facility appears to be functional. There is a rug in the facility that must be removed.

**Photo #2:** The rug that is inside the facility.

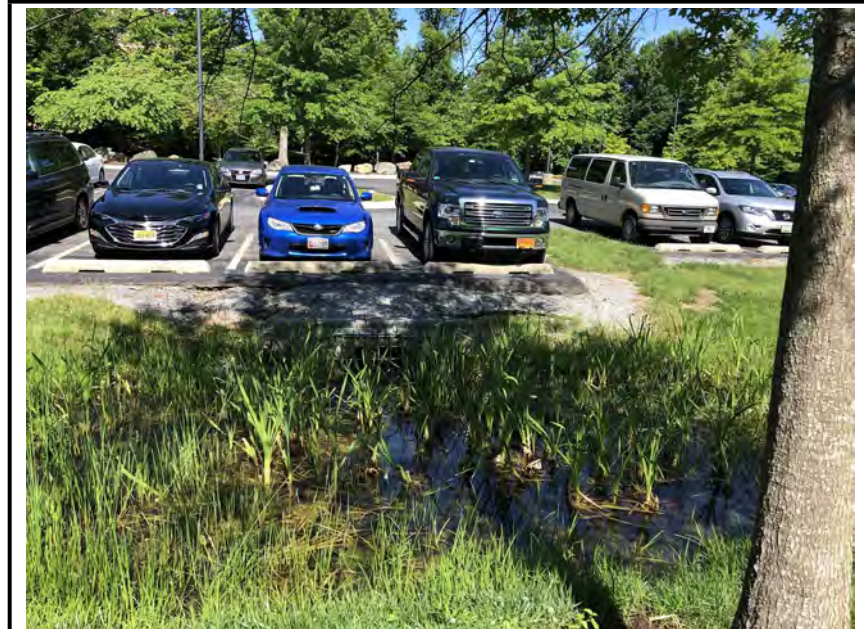
Overall this facility is in fair condition. The grading appears to be compromised as there are concentrated areas of standing water in various points of the swale. These puddles are dominated by young growths of cattails. Additionally, small fish and various types of algae are present.

**Photo #1:** Standing water in the swale.

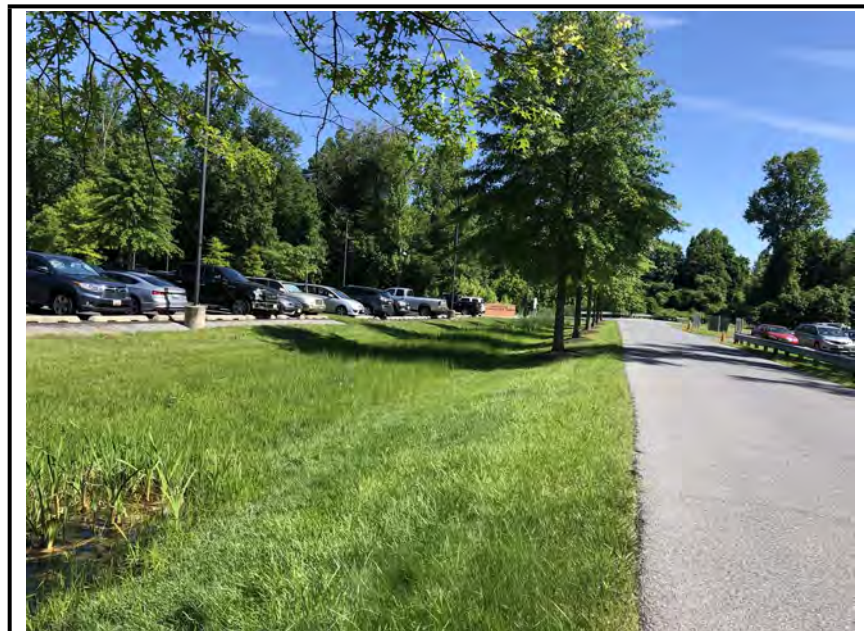
**Photo #2:** View into the facility.

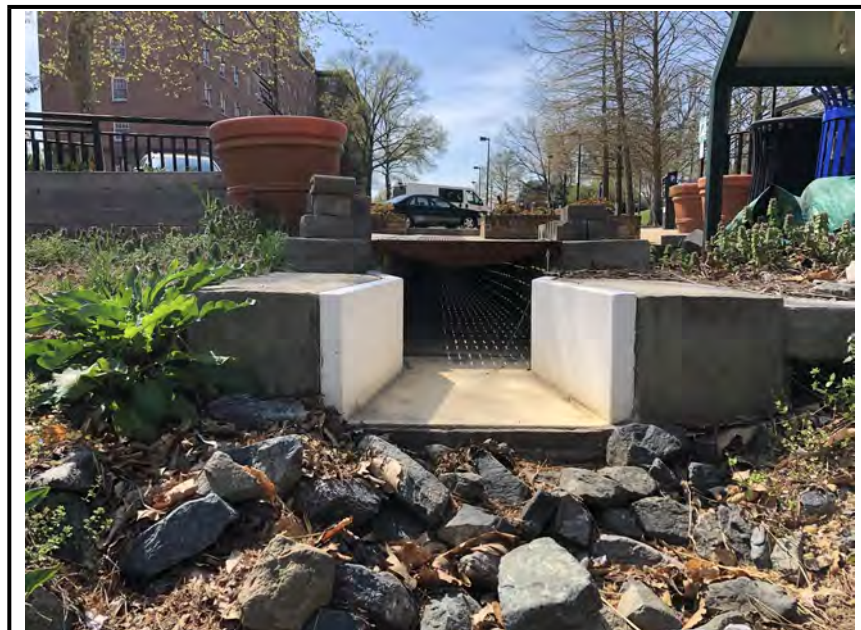
Photo #2: Entry point to facility.

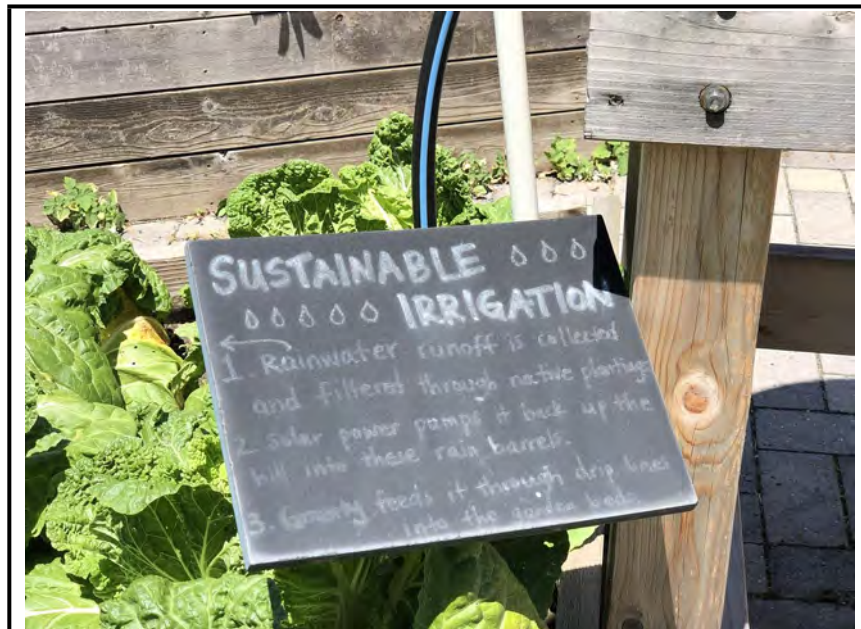
Photo #2: An informational sign explaining the process.

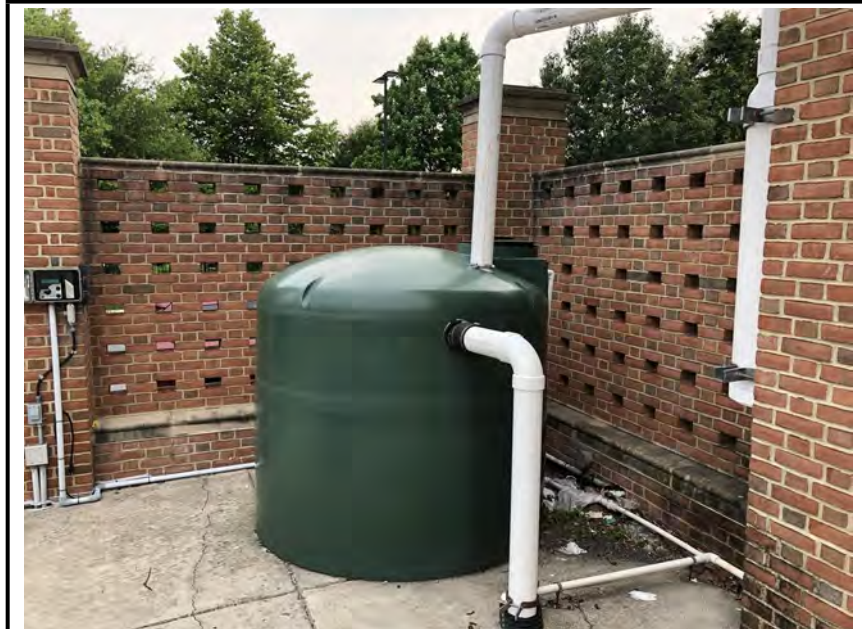
This facility is in fair condition. The seal on the pipe entering the barrel is loose and must be resealed.

**Photo #1:** The rainwater harvesting facility.

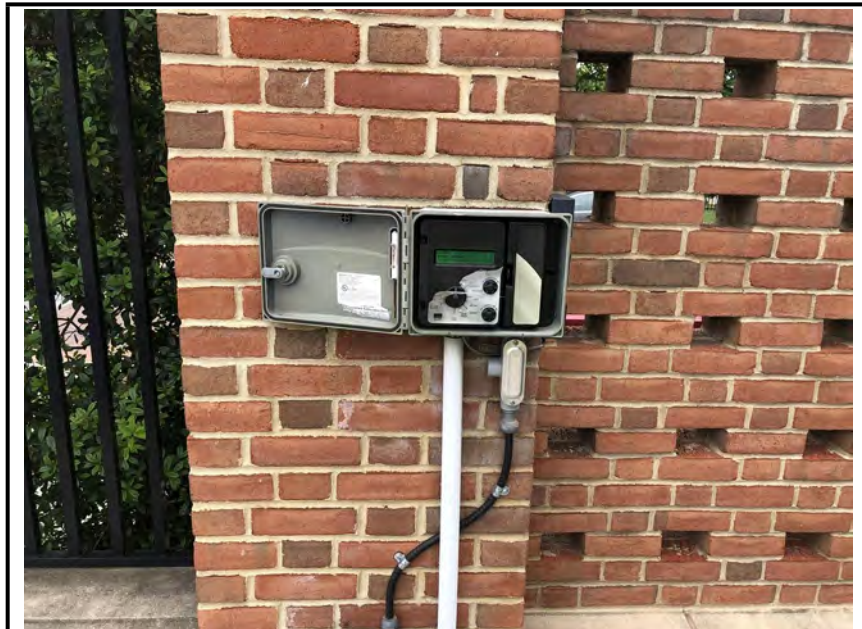
**Photo #2:** The irrigation system control panel.

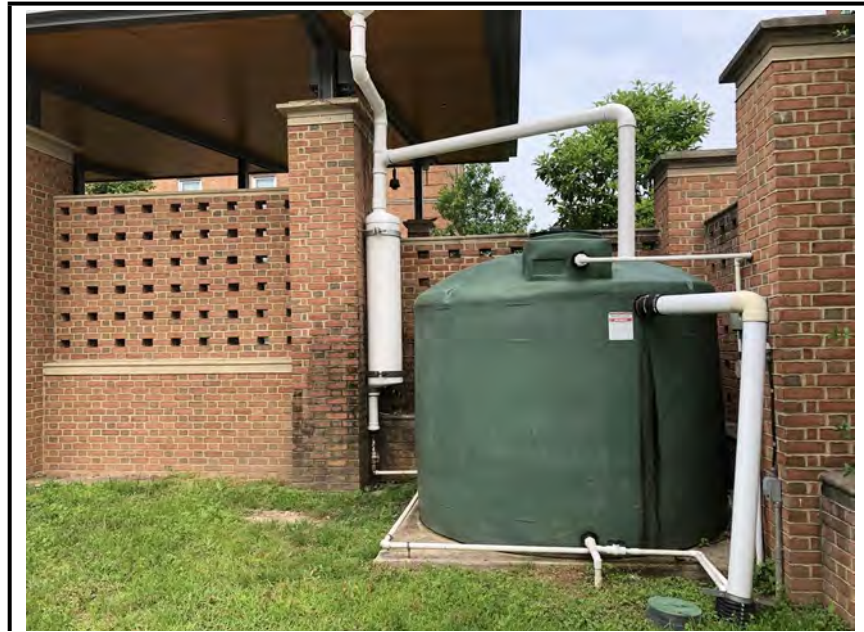
This facility is in fair condition. The seal on the pipe entering the facility is loose, and there is mildew forming on the outside.

Photo #1: The rainwater harvesting facility.

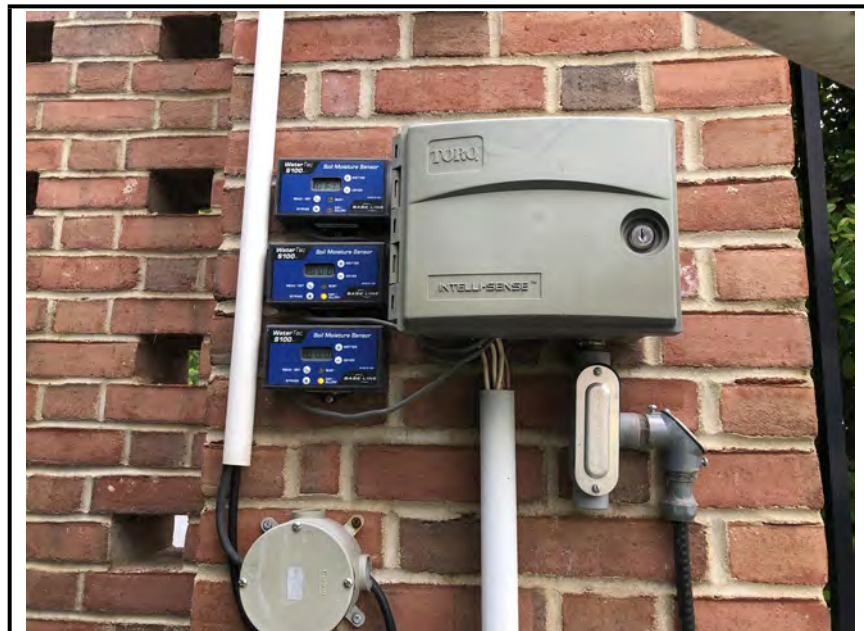
Photo #2: The irrigation control panel.

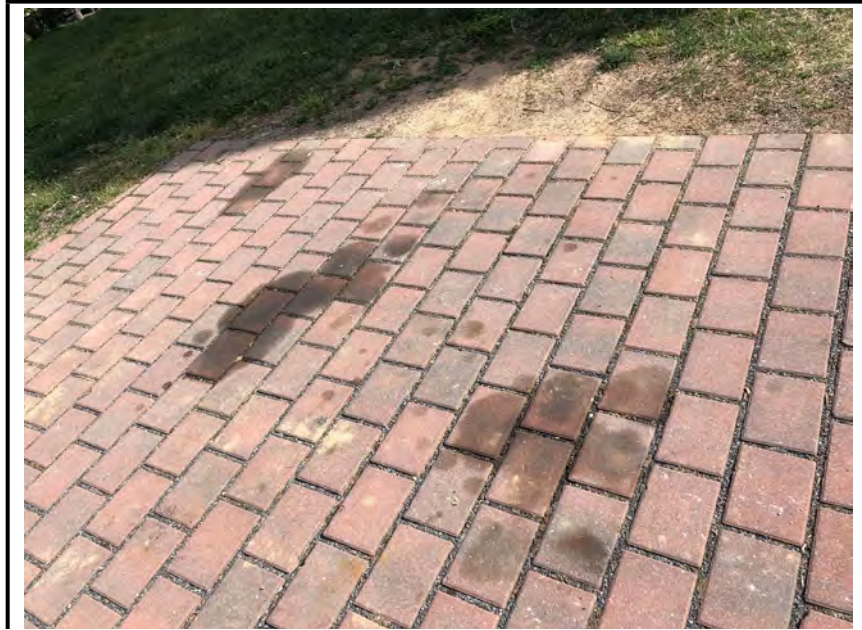
This facility is in poor condition. The pavers are clogged with dirt and have oil stains from golf carts. The golf carts are eroding the grass areas adjacent to the pavers. The pavers have settled unevenly which indicates a possible subgrade failure due to poor drainage and infiltration.

**Photo #1:** Oil spots on the pavers.

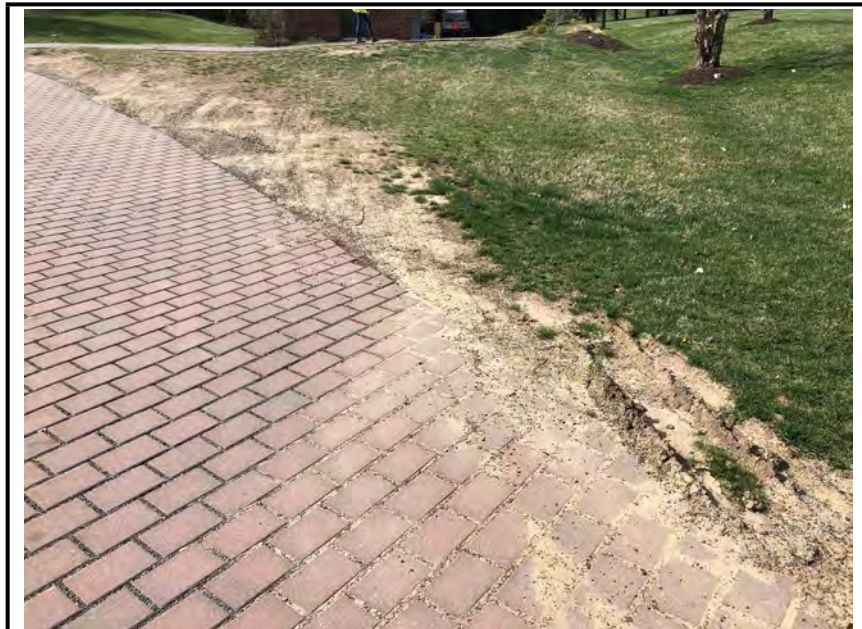
**Photo #2:** Pavers clogged with dirt.

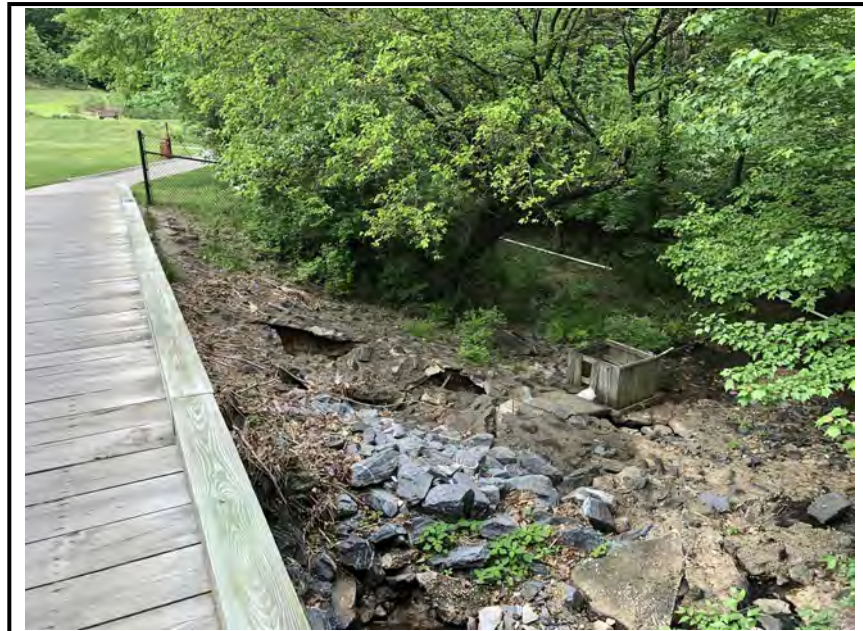
Stormwater exits this facility through a dam, which is in very poor condition. The concrete is crumbling, and the low flow pipe is encased in a broken wooden box. There is considerable debris buildup on the front of dam, as well as errant sand bags lying around.

**Photo #3:** Back of the dam.

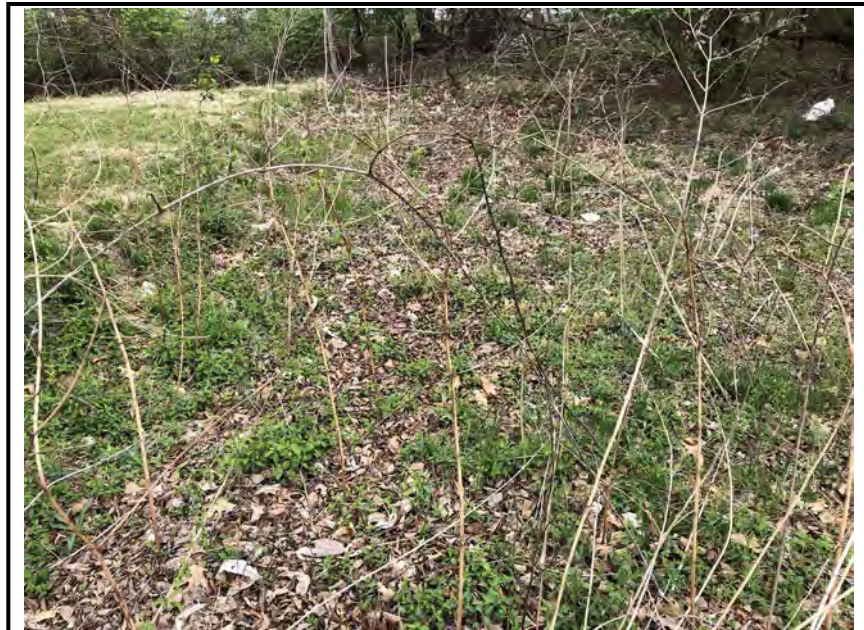
Photo #6: Vegetation inside the filter area.

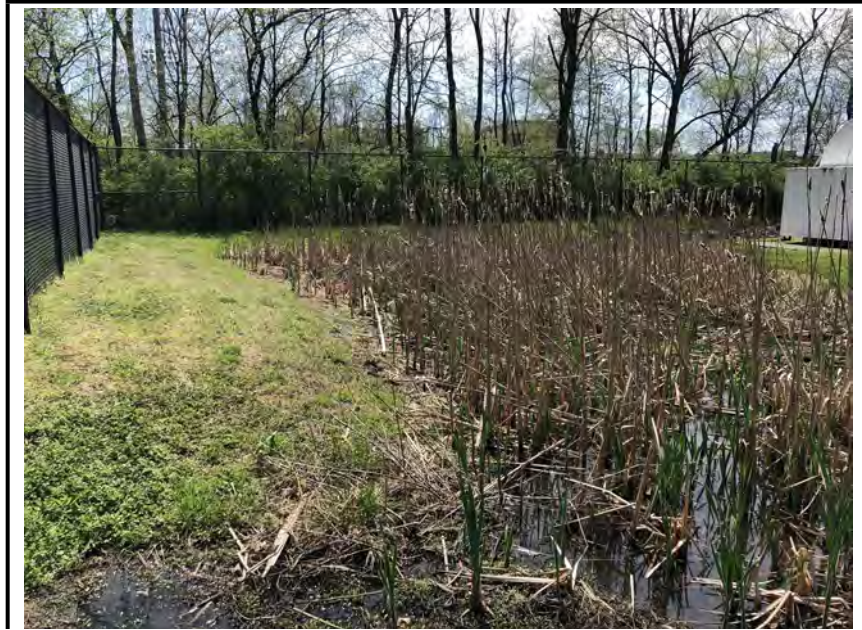
This facility is in poor condition. There is standing water at the inflow and outflow. The design plans do not show a channel outflow. This suggests that water is supposed to leave the facility through infiltration alone but overtime an outlet channel has been eroded. This facility is not functional.

**Photo #1:** View into the facility.

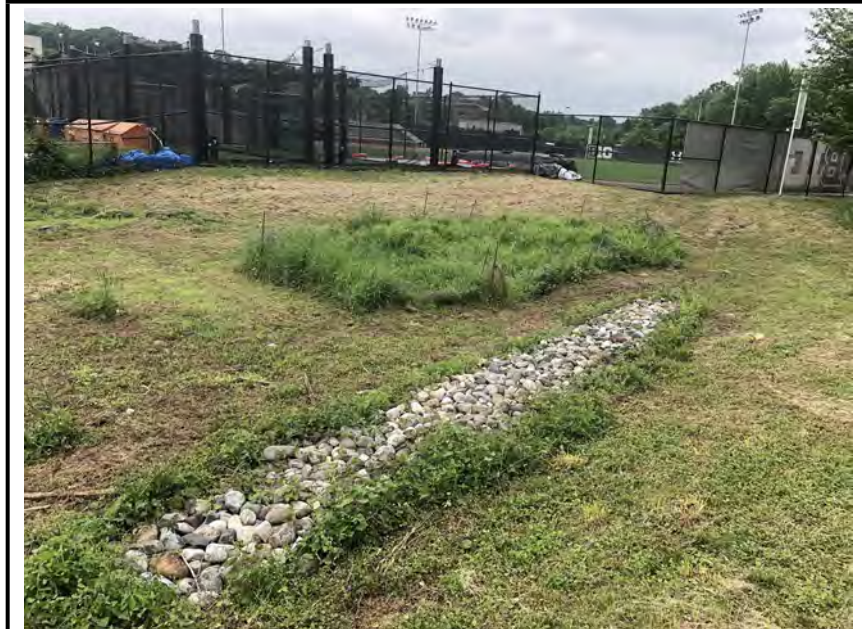
**Photo #1:** A strip of riprap that has no clear purpose.

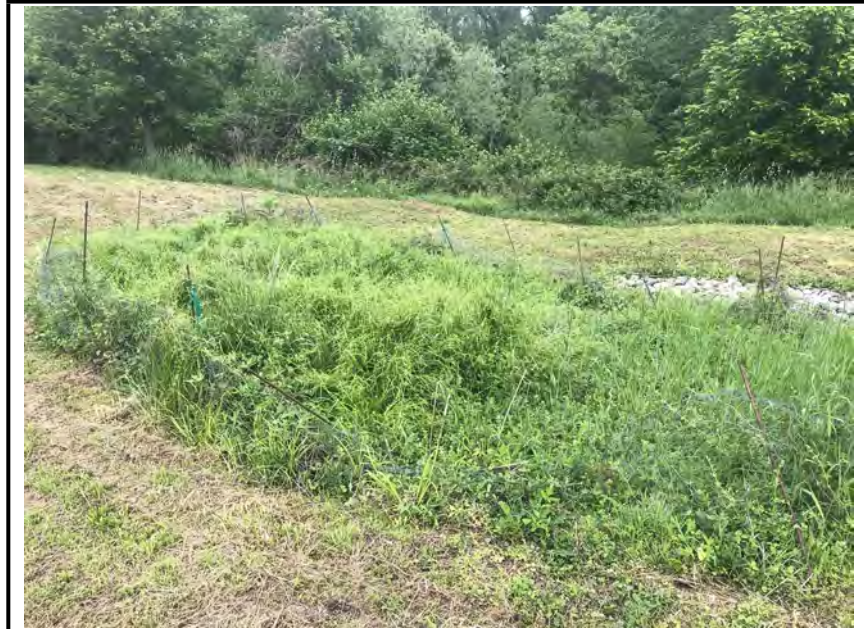
**Photo #3:** Patch of vegetation surrounded by chicken wire.

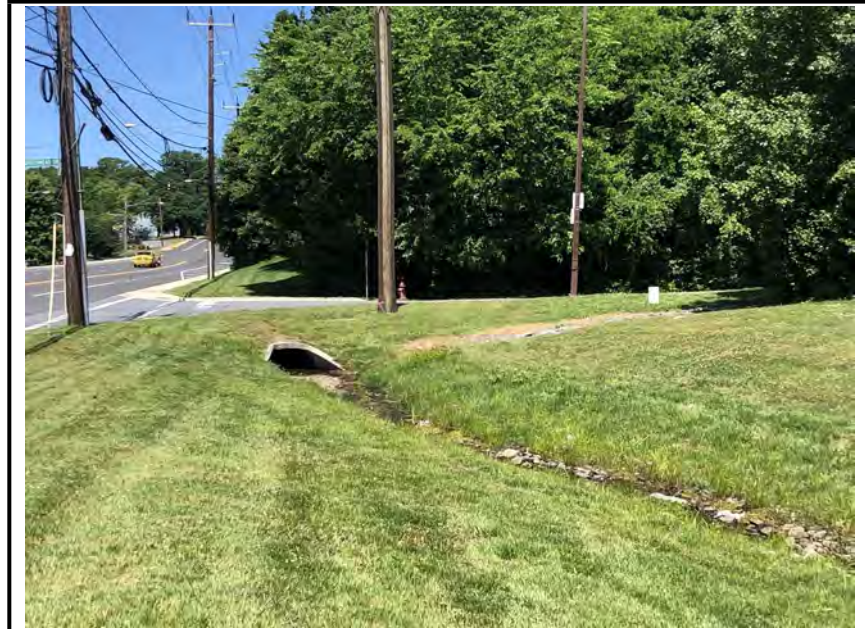
**Photo #3:** The inflow culvert.

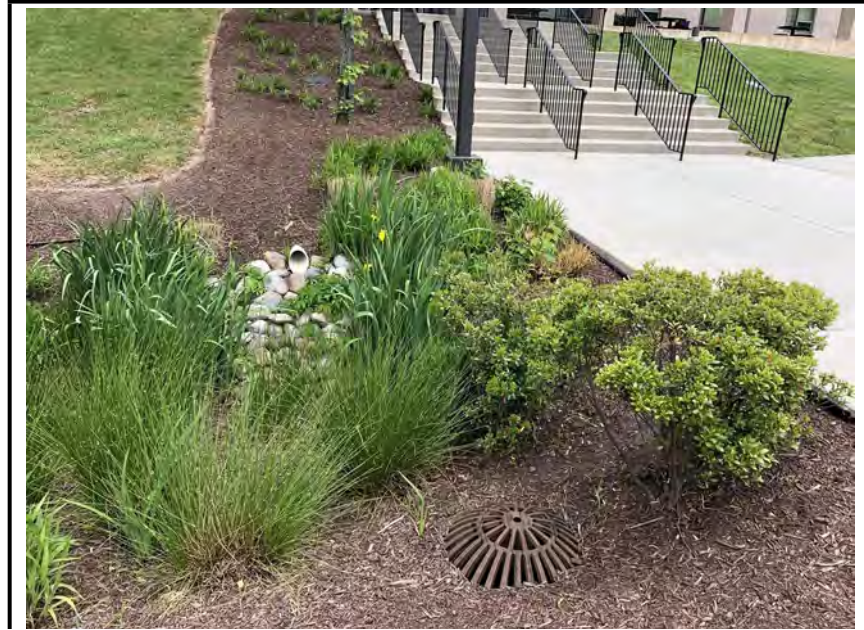
Water exits this facility through an at-grade inlet with a trash rack. The inlet is in good condition, but its low elevation does not provide adequate ponding depth.

**Photo #1:** Outlet structure flush with the mulch elevation.

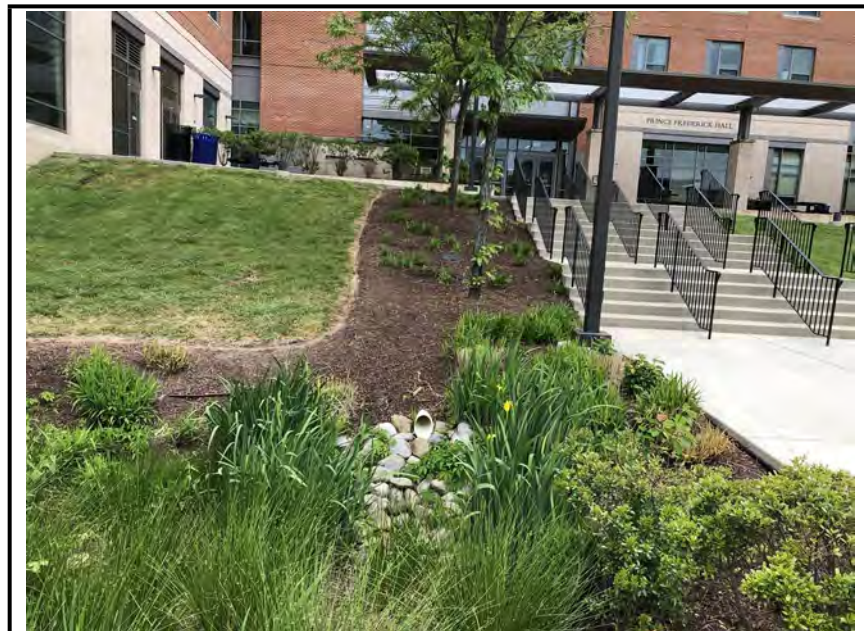
This facility is in good condition. The vegetation is well established and in good condition. The mulch on the steep side slope is eroding.

**Photo #2:** Mulch on the side slope is eroding.

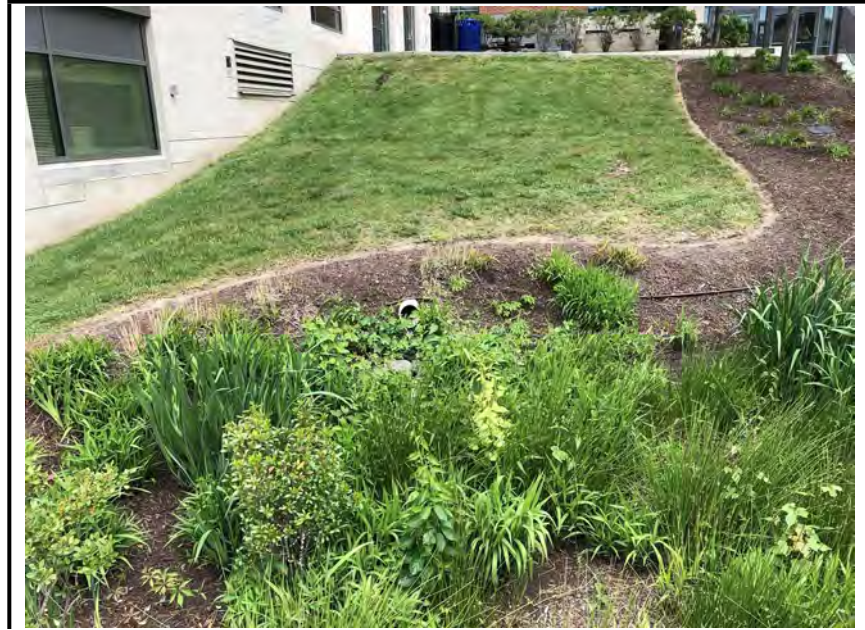
**Photo #3:** The well-established herbaceous vegetation inside the filter area.

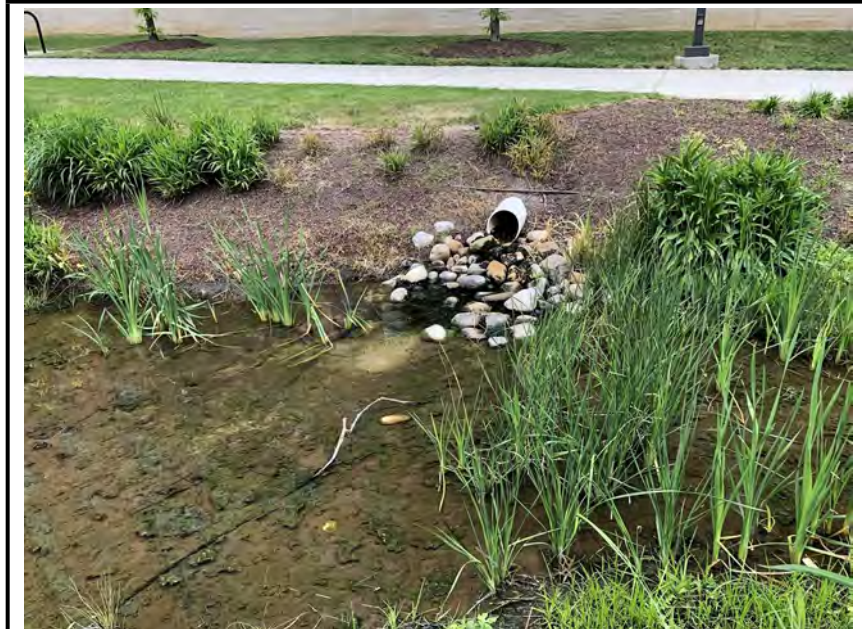
This facility is in poor condition. The side slopes have eroded around the inflow pipes. There is standing water in the center of the filter area, and the facility has high concentrations of algae in the filter area and on the inflow pipes.

**Photo #1:** An eroded and algae-covered inflow pipe.

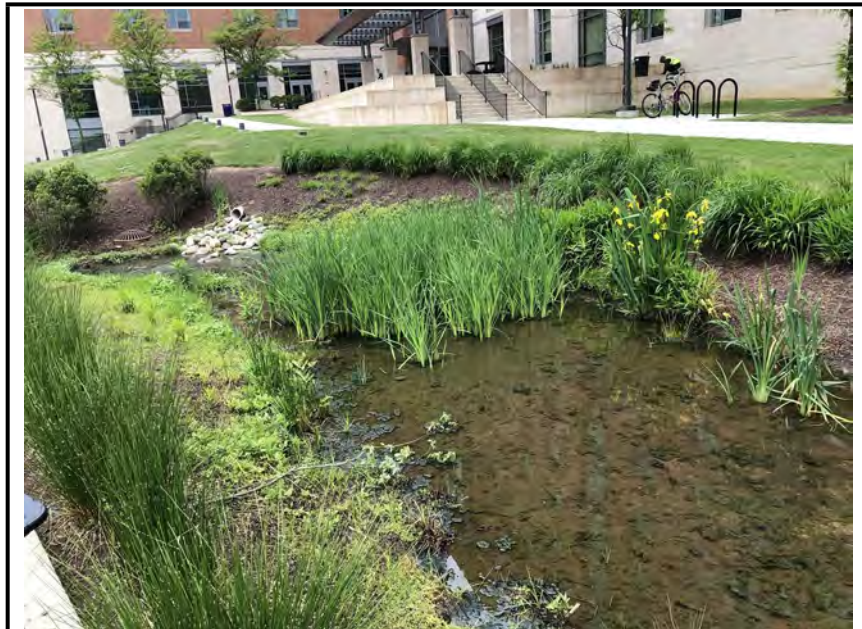
**Photo #2:** Standing water in the center of the filter area.

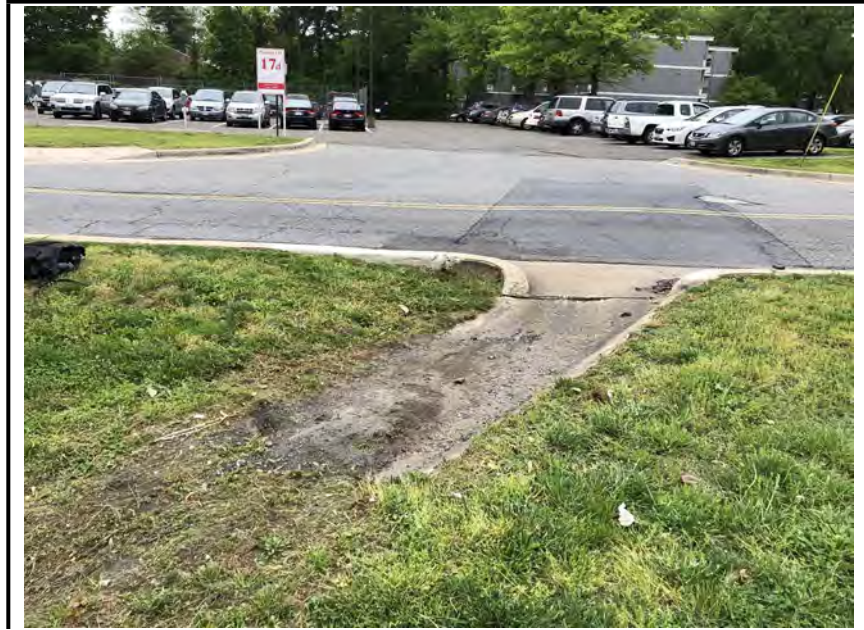
This bioretention facility has a grass surface, with no other plantings. An eroded dirt area is present in the middle of the facility. This facility does not filter runoff as a bioretention because there are no plantings within the filter area. This facility is in poor condition.

Photo #1: Inflow to the facility.

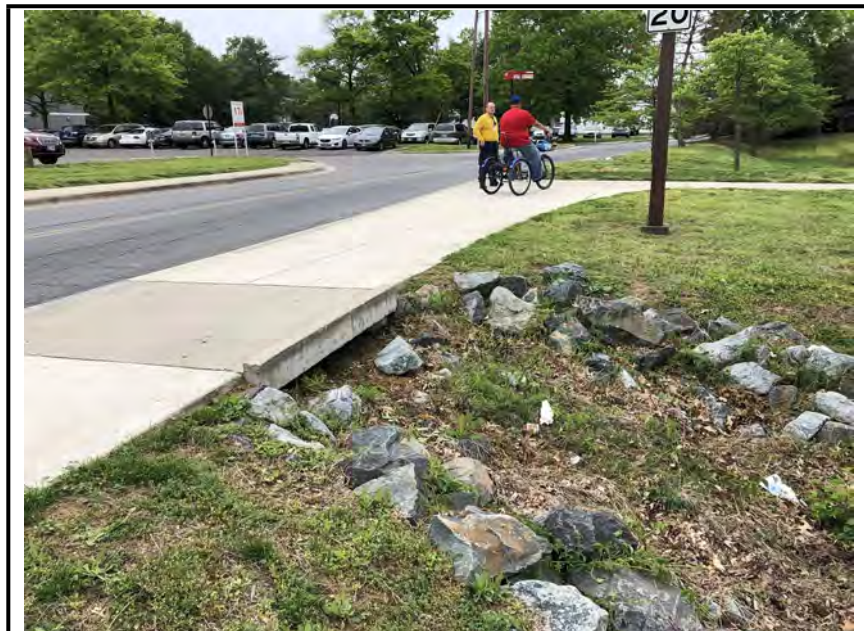
Photo #2: Inflow channel.

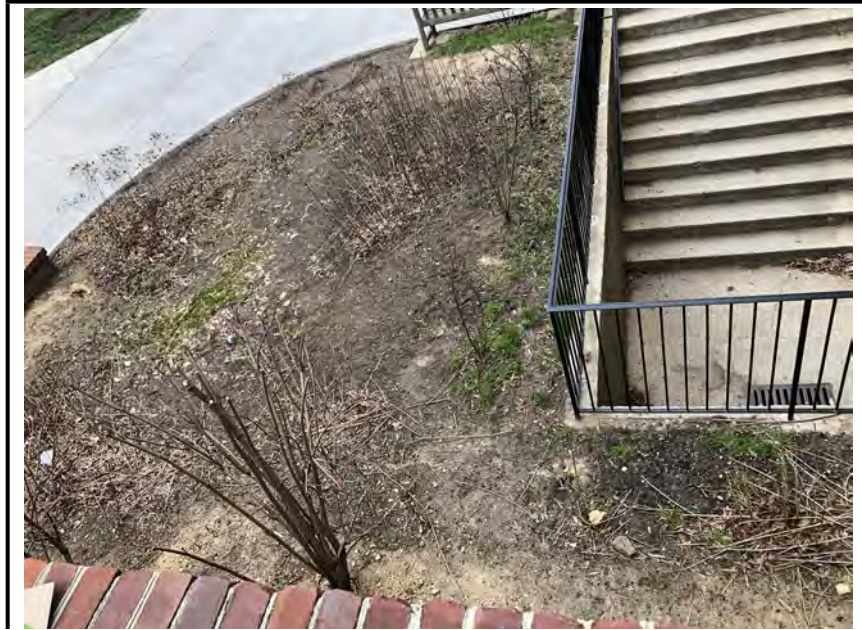
Overall the BMP is in fair condition. Bare spots with no mulch are present in a few areas of the facility. Leaf debris and trash are both present throughout the facility and should be removed.

**Photo #1:** View from above the facility.

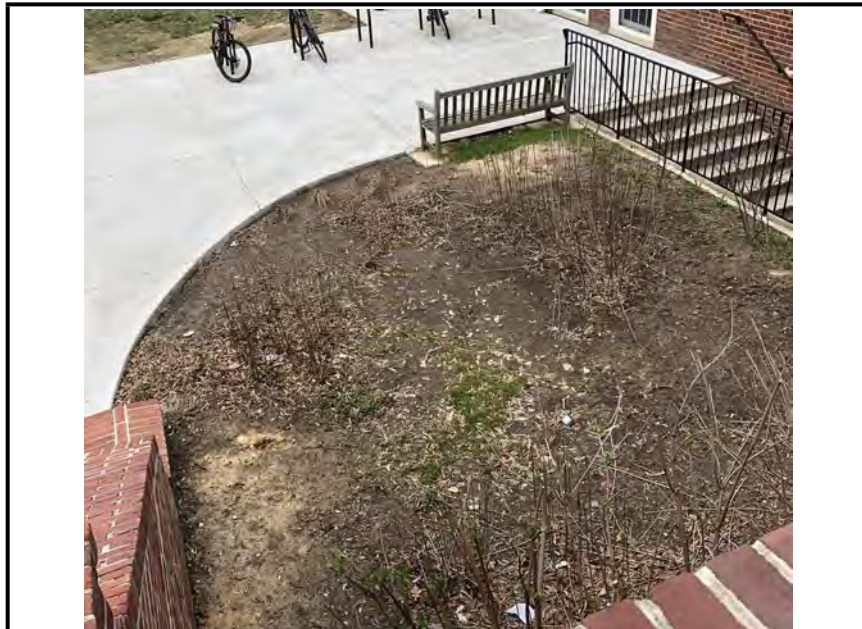
**Photo #2:** The filter area.

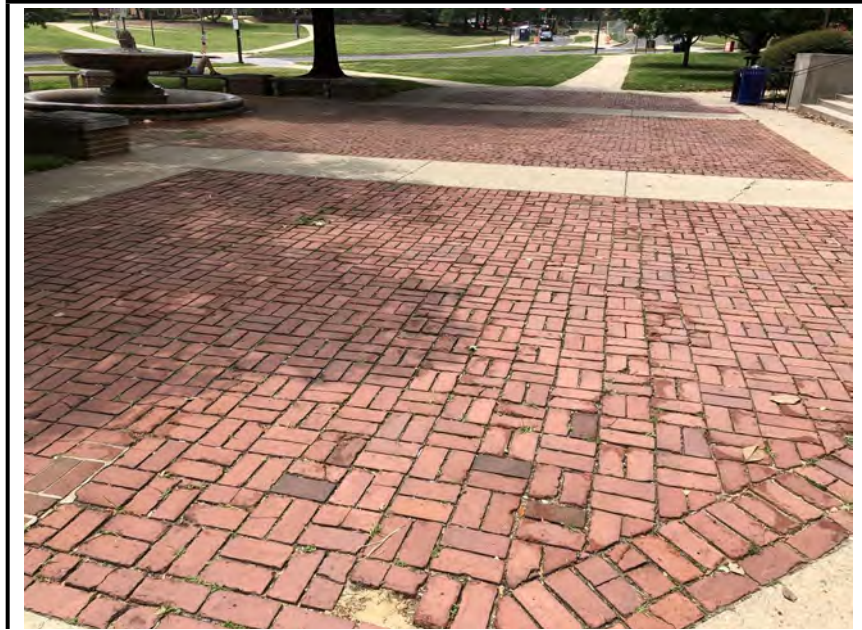
Overall the permeable pavers are in good condition. Grass is growing between a portion of the pavers. A few pavers are missing or cracked. A low spot adjacent to the fountain has collected sand and sediment. The uneven settling of the pavers indicates potential subgrade failure from poor infiltration.

**Photo #1:** Missing brick pavers in pavement surface.
