University of Maryland, College Park  
National Pollutant Discharge Elimination  
System MS4 Phase II  
FY2019 Annual Report  
General Discharge Permit #13-SF-5501

## **Stormwater Treatment Final Report & Recommendations**

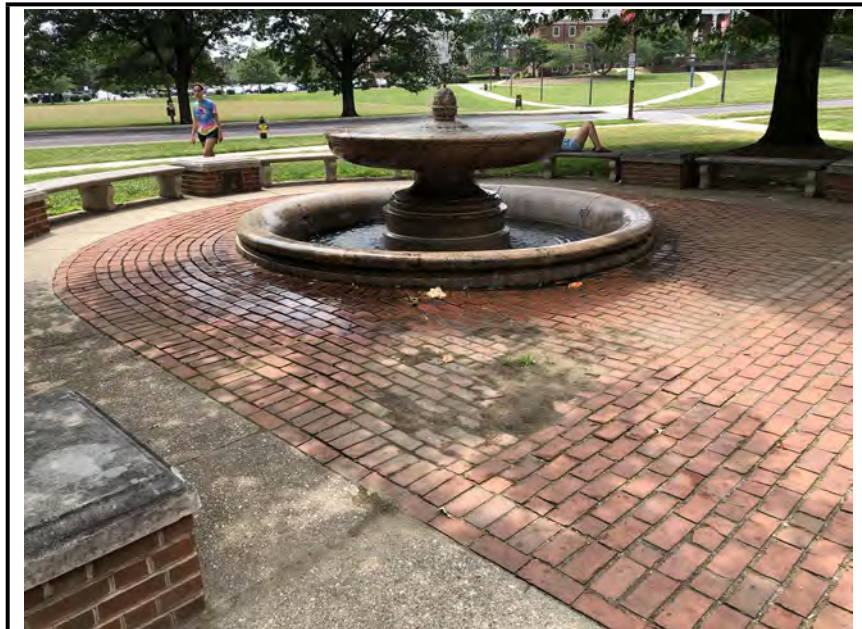
Overall the permeable pavers are in good condition. Grass is growing between a portion of the pavers. A few pavers are missing or cracked. A low spot adjacent to the fountain has collected sand and sediment. The uneven settling of the pavers indicates potential subgrade failure from poor infiltration.

**Photo #2:** Uneven settling of pavers.

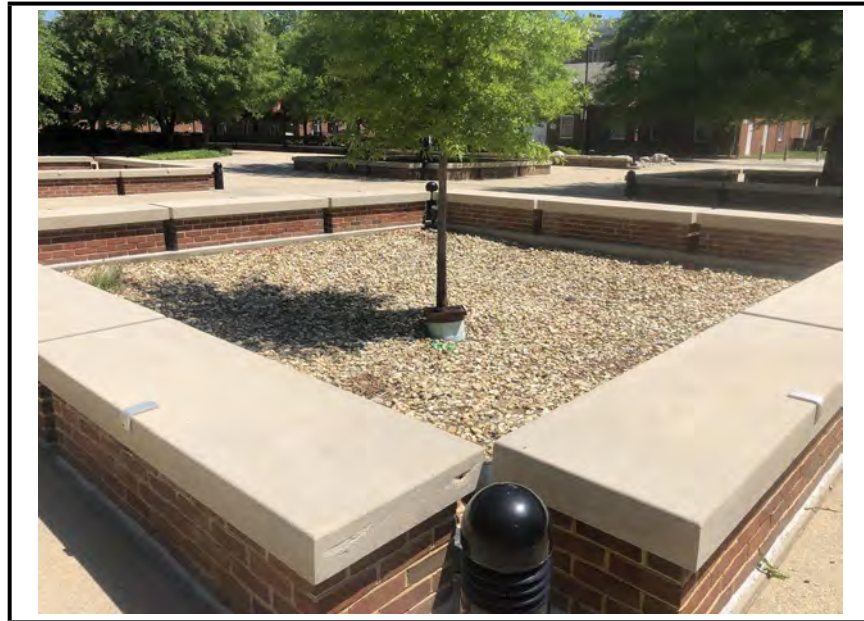
BMP SWF 136 is a shallow, gravel covered micro-bioretenion facility with no vegetation, except for one tree. The facility is 22 feet by 22 feet. At the time of inspection there was no standing water or algae present in the facility. Some erosion is apparent at the curb cut inflow areas. Aside from the lack of vegetation, this facility appears to be in fair condition. No MDE approved drawings were available, however it is assumed that the facility was designed according to Chapter 3 of the MDE Stormwater Manual. It does not meet the vegetation criteria of bioretention facilities. The facility also does not meet the pretreatment requirements of installing

a grass channel, grass filter strip, bottom sand layer, upper sand layer, or washed bank run as aggregate.

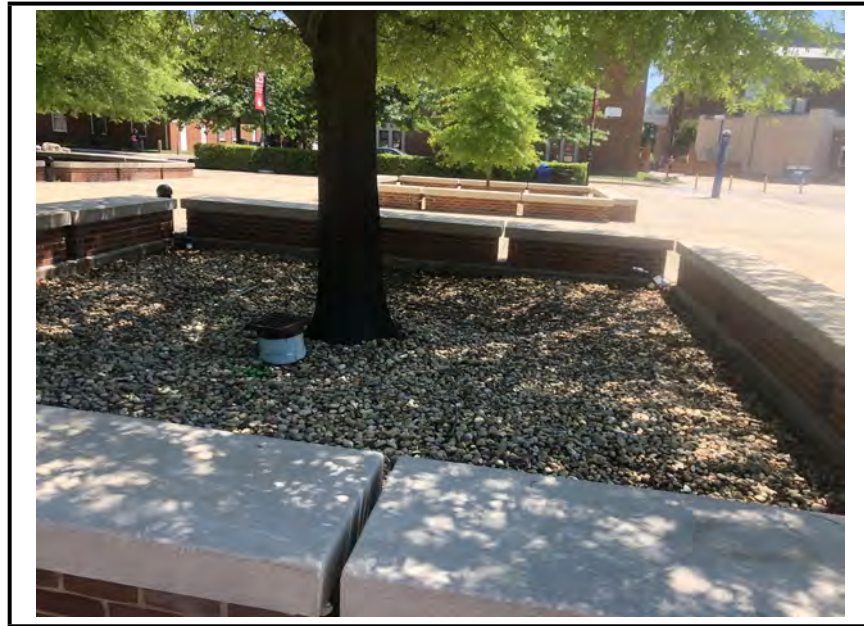
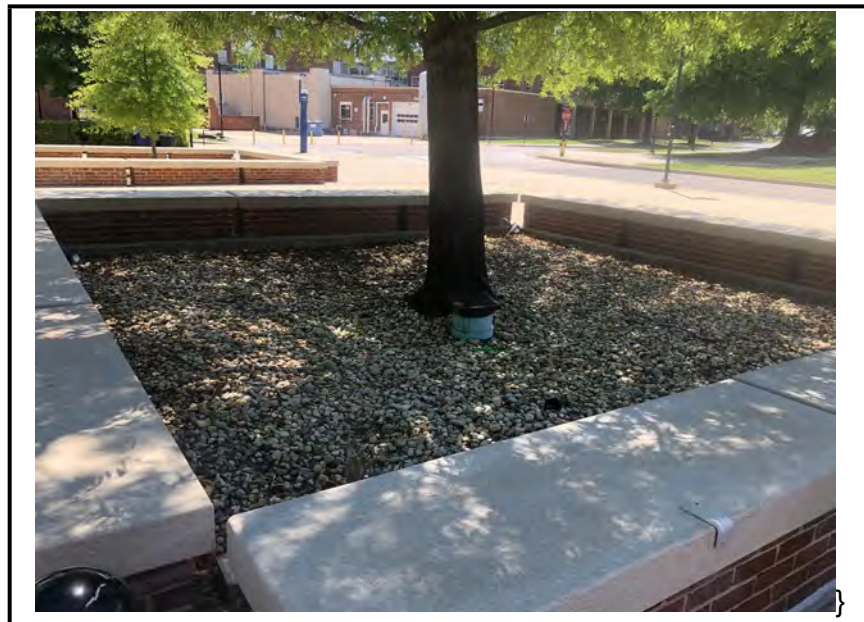
BMP SWF 137 is a shallow, gravel covered micro-bioretenion facility with no vegetation, except for one tree. The facility is 22 feet by 22 feet. At the time of inspection there was no standing water or algae present in the facility. Some erosion is apparent at the curb cut inflow areas. The center surface of the facility is sunken in due to settling over time. Aside from the lack of vegetation, this facility appears to be in fair condition. No MDE approved drawings were available, however it is assumed that the facility was designed according to Chapter 3 of the MDE Stormwater Manual. It does not meet the vegetation criteria of bioretention facilities. The

facility also does not meet the pretreatment requirements of installing a grass channel, grass filter strip, bottom sand layer, upper sand layer, or washed bank run as aggregate.

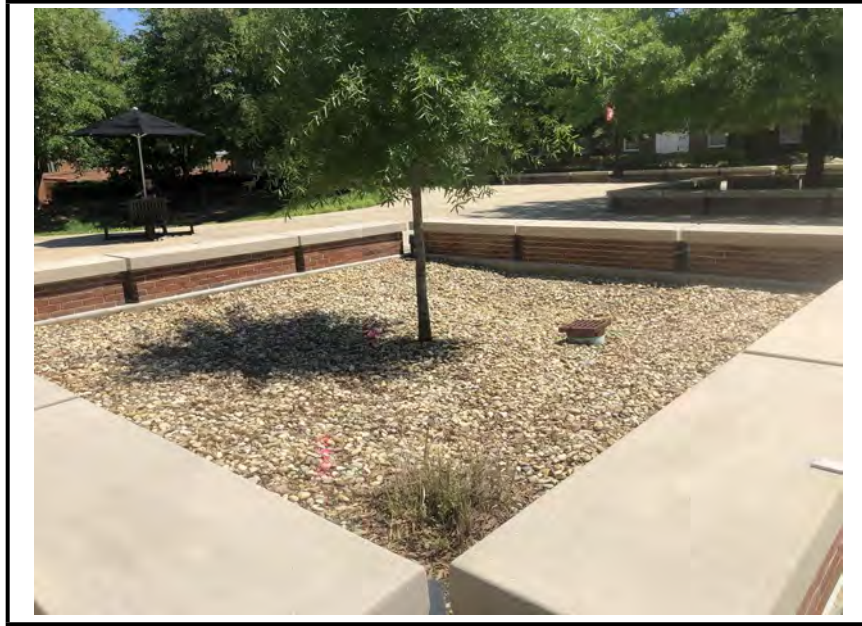
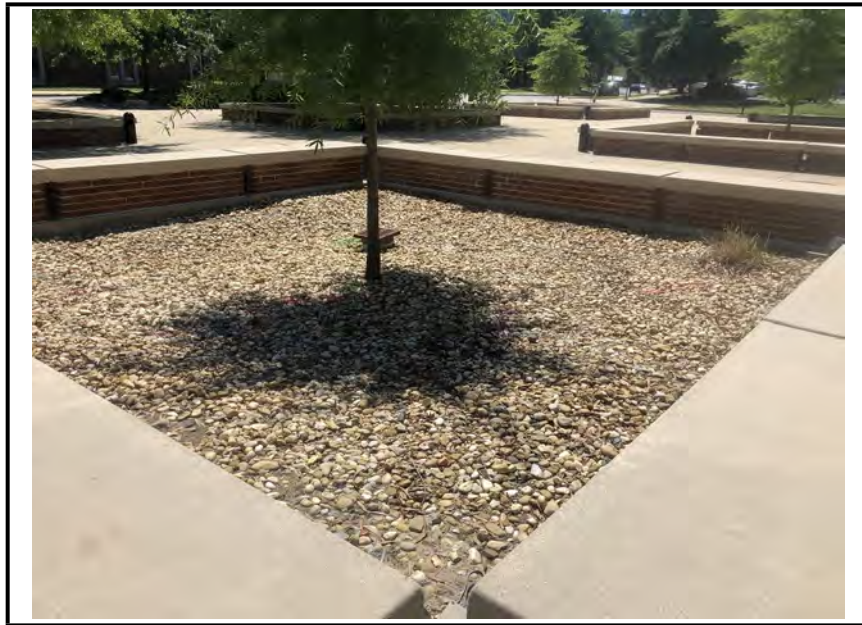
BMP SWF 138 is a shallow, gravel covered micro-bioretention facility with no vegetation, except for one tree. The facility is 22 feet by 22 feet. At the time of inspection there was no standing water or algae present in the facility. Some erosion is apparent at the curb cut inflow areas. Aside from the lack of vegetation, this facility appears to be in fair condition. No MDE approved drawings were available, however it is assumed that the facility was designed according to Chapter 3 of the MDE Stormwater Manual. It does not meet the vegetation criteria of bioretention facilities. The facility also does not meet the pretreatment requirements of installing

a grass channel, grass filter strip, bottom sand layer, upper sand layer, or washed bank run as aggregate.

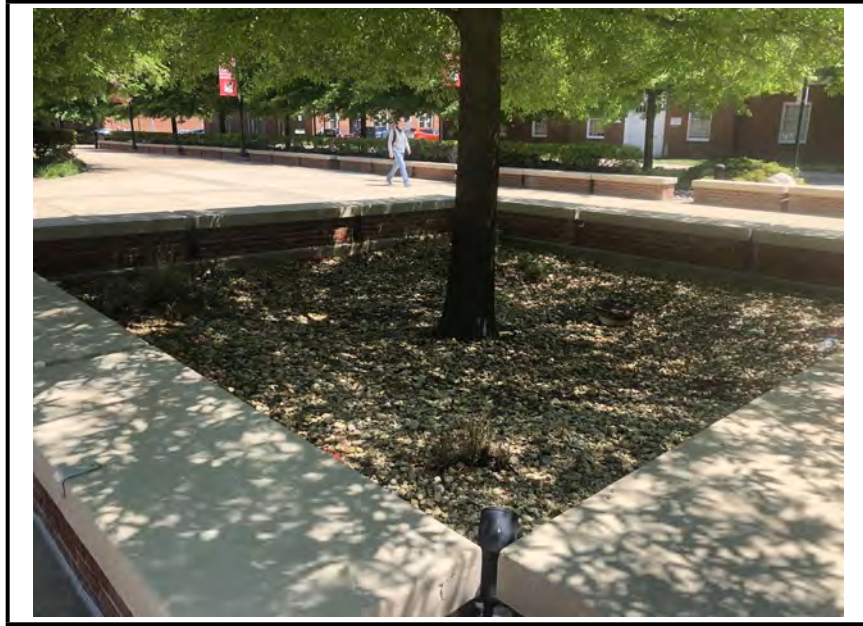
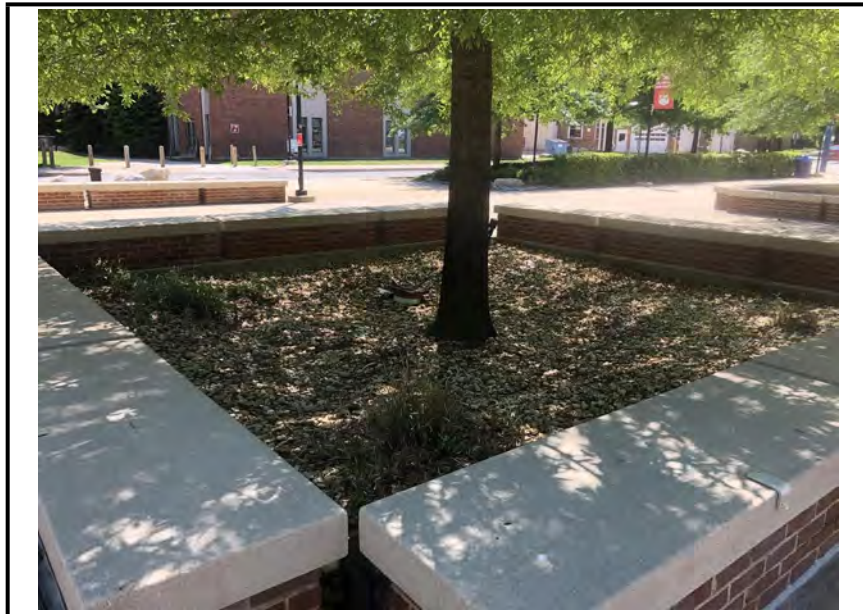
BMP SWF 139 is a shallow, gravel covered micro-bioretention facility with no vegetation, except for one tree. The facility is 22 feet by 22 feet. At the time of inspection there was no standing water or algae present in the facility. Some erosion is apparent at the curb cut inflow areas. The center surface of the facility is sunken in due to settling over time. Aside from the lack of vegetation, this facility appears to be in fair condition. No MDE approved drawings were available, however it is assumed that the facility was designed according to Chapter 3 of the MDE Stormwater Manual. It does not meet the vegetation criteria of bioretention facilities. The

facility also does not meet the pretreatment requirements of installing a grass channel, grass filter strip, bottom sand layer, upper sand layer, or washed bank run as aggregate.

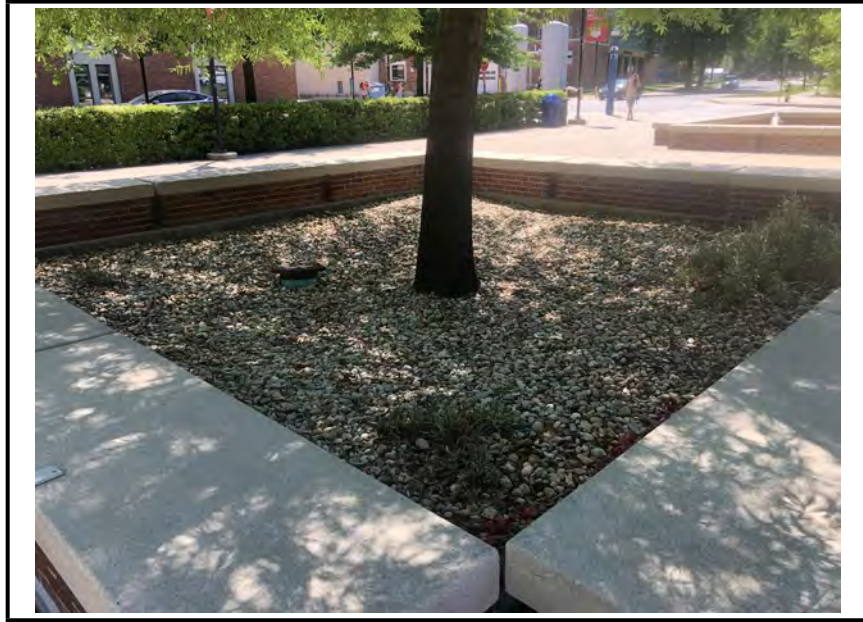
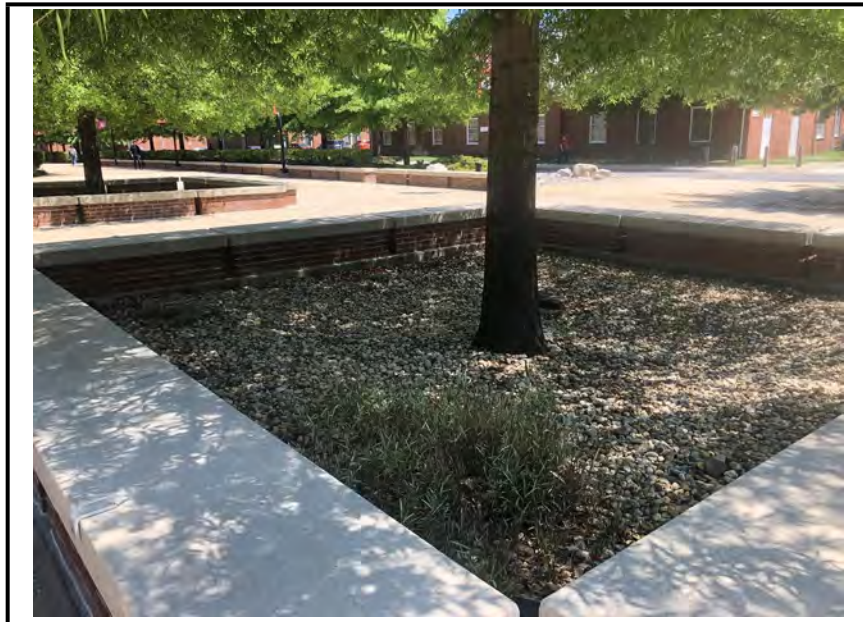
BMP SWF 140 is a shallow, gravel covered micro-bioretenion facility with no vegetation, except for one tree. The facility is 22 feet by 22 feet. At the time of inspection there was no standing water or algae present in the facility. Some erosion is apparent at the curb cut inflow areas. The center surface of the facility is sunken in due to settling over time. Aside from the lack of vegetation, this facility appears to be in fair condition. No MDE approved drawings were available, however it is assumed that the facility was designed according to Chapter 3 of the MDE Stormwater Manual. It does not meet the vegetation criteria of bioretention facilities. The

facility also does not meet the pretreatment requirements of installing a grass channel, grass filter strip, bottom sand layer, upper sand layer, or washed bank run as aggregate.

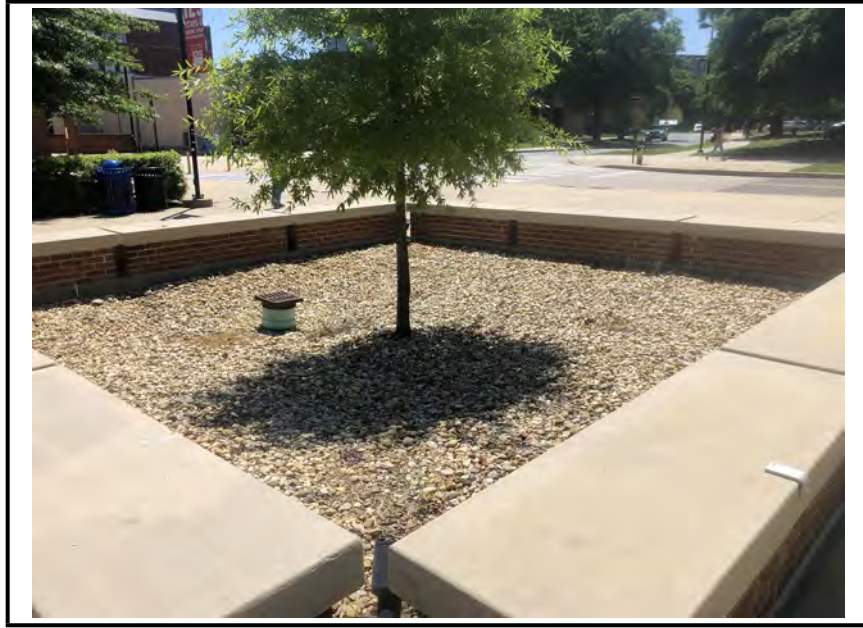
BMP SWF 141 is a shallow, gravel covered micro-bioretenion facility with no vegetation, except for one tree. The facility is 22 feet by 22 feet. At the time of inspection there was no standing water or algae present in the facility. Some erosion is apparent at the curb cut inflow areas. The center surface of the facility is sunken in due to settling over time. Aside from the lack of vegetation, this facility appears to be in fair condition. No MDE approved drawings were available, however it is assumed that the facility was designed according to Chapter 3 of the MDE Stormwater Manual. It does not meet the vegetation criteria of bioretention facilities. The

facility also does not meet the pretreatment requirements of installing a grass channel, grass filter strip, bottom sand layer, upper sand layer, or washed bank run as aggregate.

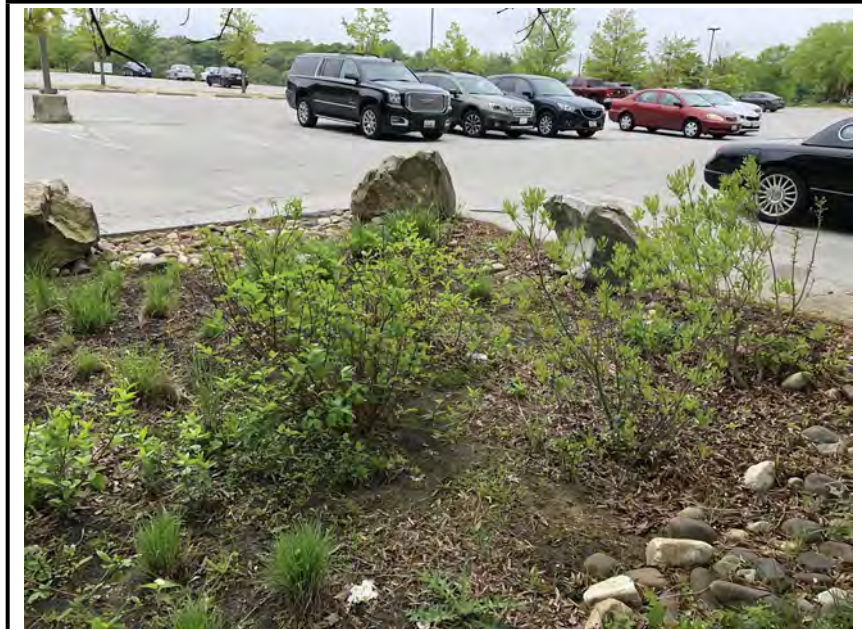
The rain garden filter area is designed to be 1018 square feet. The drainage area to the facility is 50,700 square feet, including 15,881 square feet of impervious area. 48,000 square feet is treated within the facility. No mulch is present within the facility. Grasses and herbaceous plants are present throughout the filter area. No defined filter bed and ponding area is visible. The facility is in poor condition.

Photo #1: Vegetation within the facility.

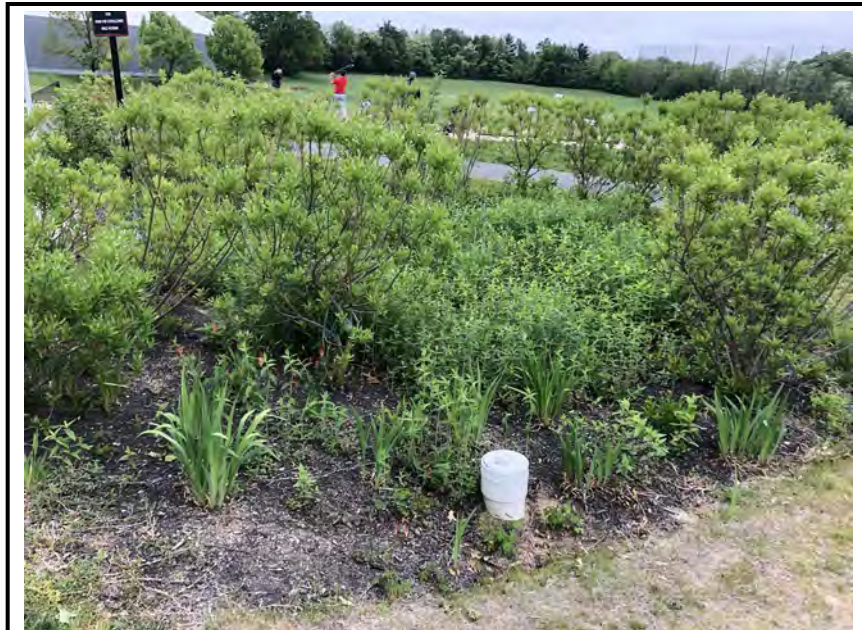
The rain garden filter area is designed to be 630 square feet. The drainage area to the facility is 5,400 square feet, including 3,325 square feet of impervious area. 9,828 square feet is treated within the facility. The vegetation within the rain garden is healthy. There are stones creating a walking path from the parking lot to the putting green through the facility area. Since the stones are raised higher than the filter area, this could be fractioning the total filter area, and creating less ponding volume.

**Photo #1:** Vegetation within the facility.

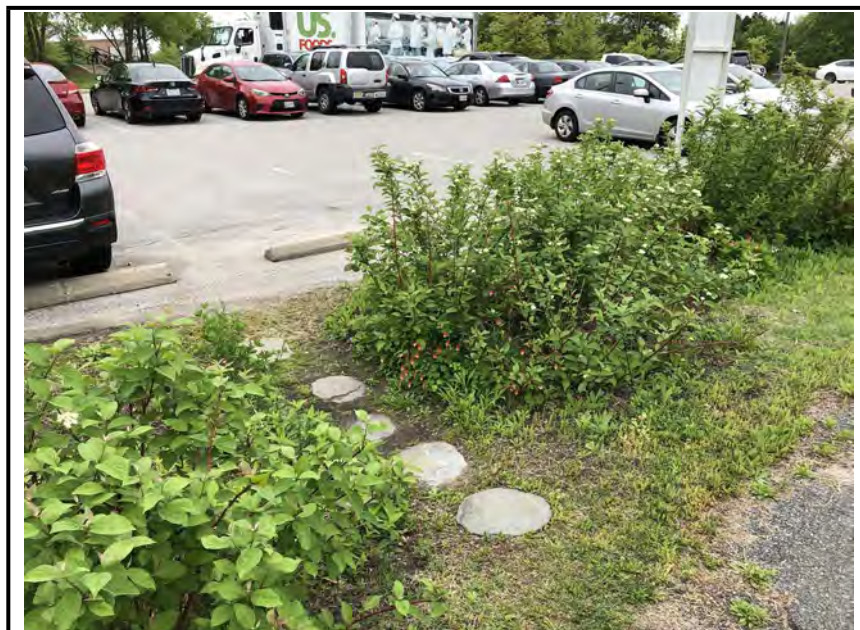
**Photo #2:** Pathway that bisects the filter area.

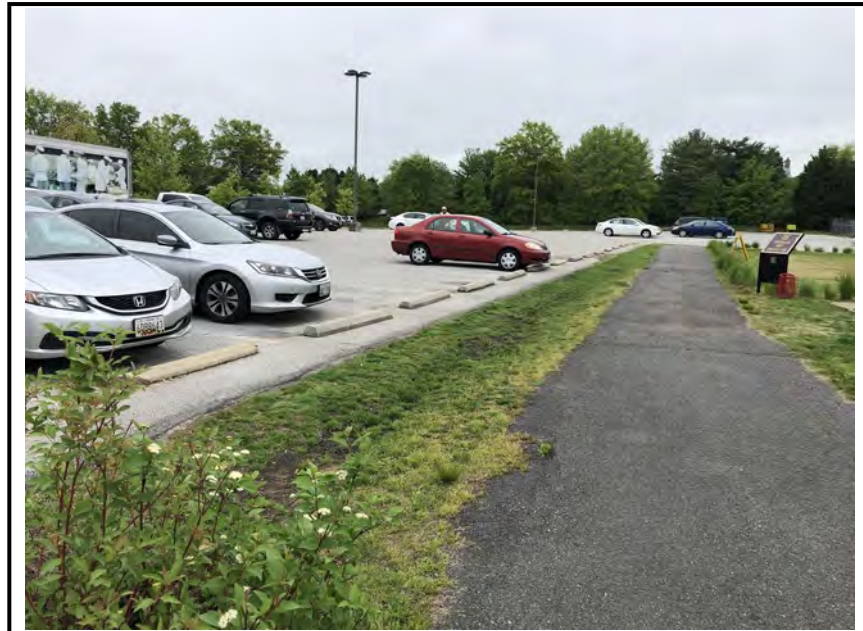
**Photo #3:** Grass area of the facility.

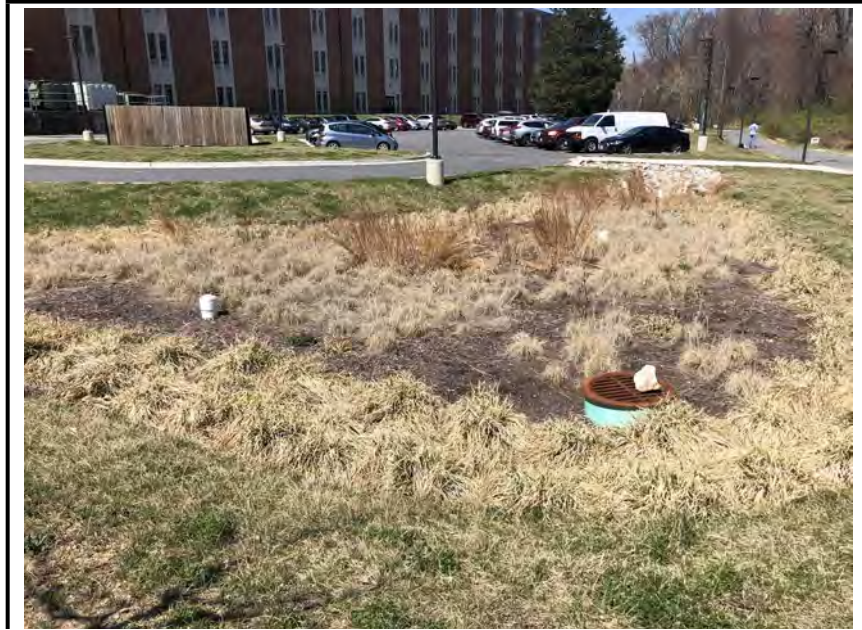
The bioretention facility is in overall good condition. The total drainage area of the facility is 25,448 square feet, including 16,263 square feet of impervious area. The ponding depth is designed to be 6 inches, with 2 feet of media depth. The total designed ESDv provided is 1,723 cubic feet, and a  $P_E$  of 1.3 inches is designed. There are grasses and vegetation covering much of the filter area. Some trash is present within the facility.

Photo #1: View into the facility.

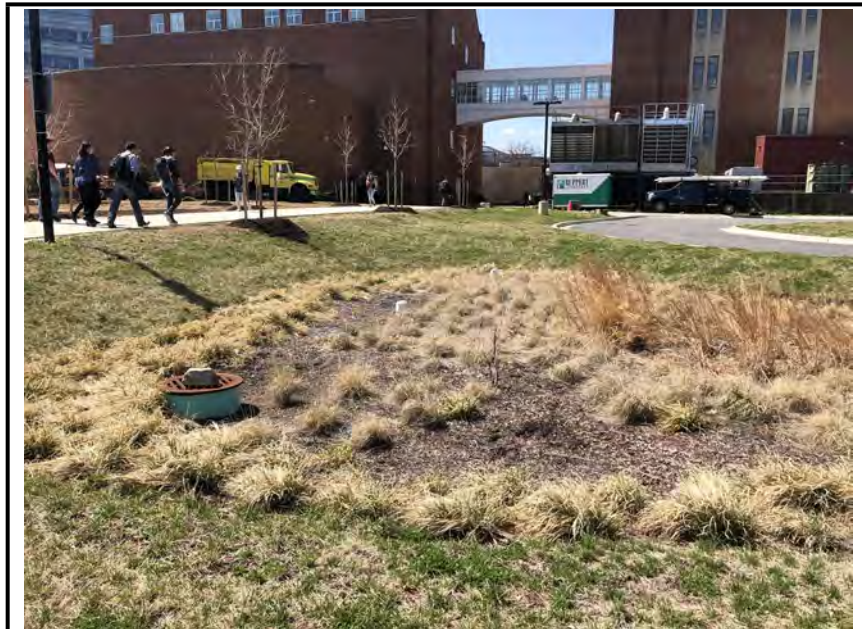
Photo #2: View into the facility.

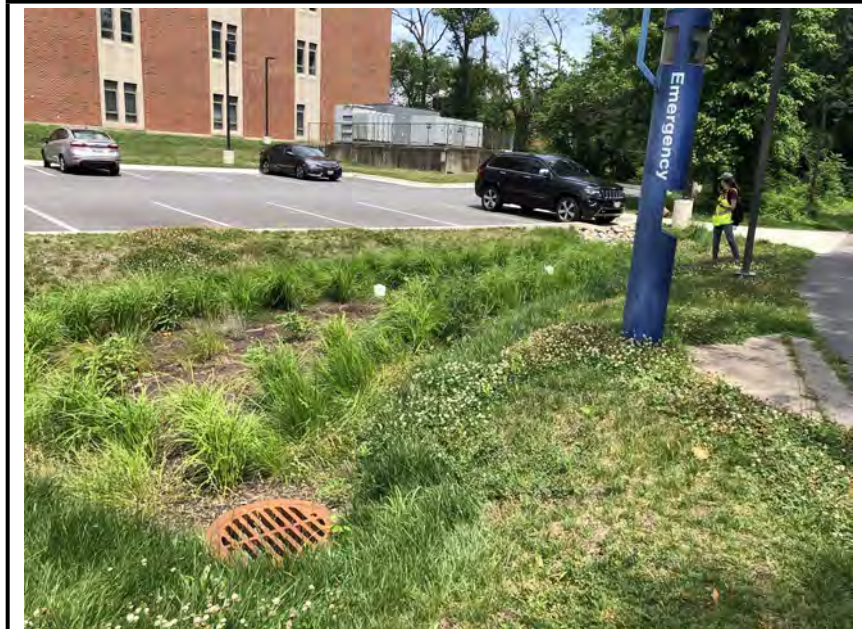
The bioretention facility is in overall good condition. The total drainage area of the facility is 14,925 square feet, including 9,477 square feet of impervious area. The ponding depth is designed to be 6 inches, with 2 feet of media depth. The total designed ESDv provided is 1,005 cubic feet, and a  $P_E$  of 1.3 inches is designed. There are grasses and vegetation covering much of the filter area.

Photo #1: View into the facility.

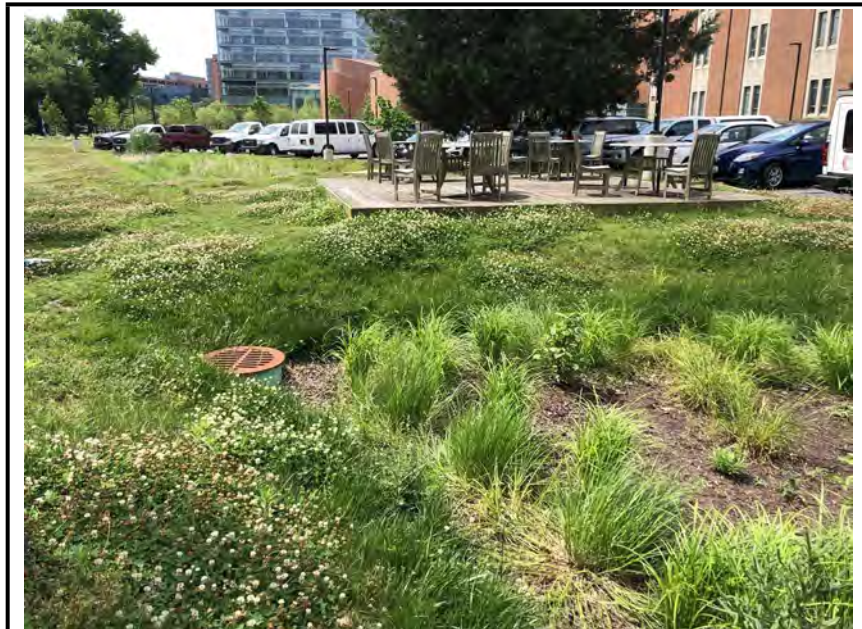
Photo #2: View into the facility.

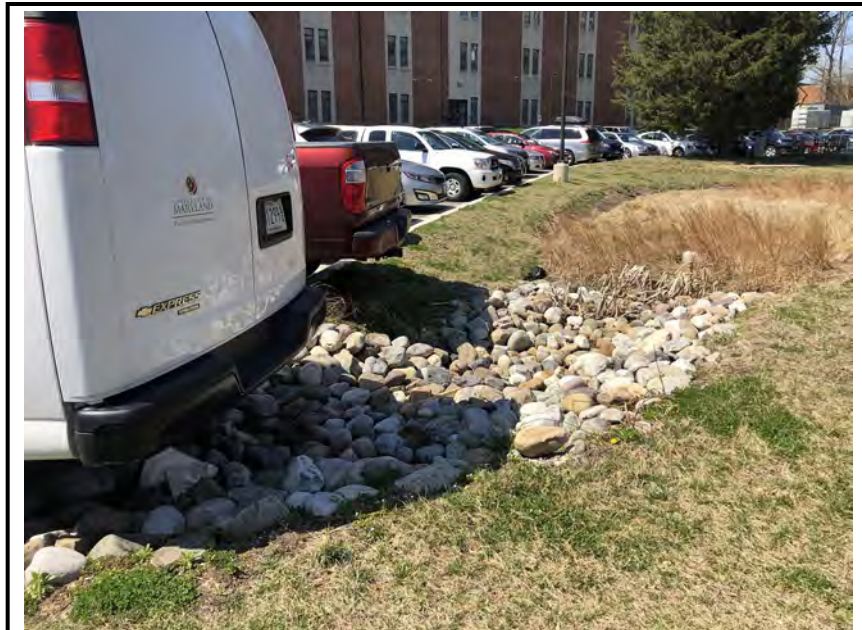
**Photo #1:** Inflow channel that leads to the facility.

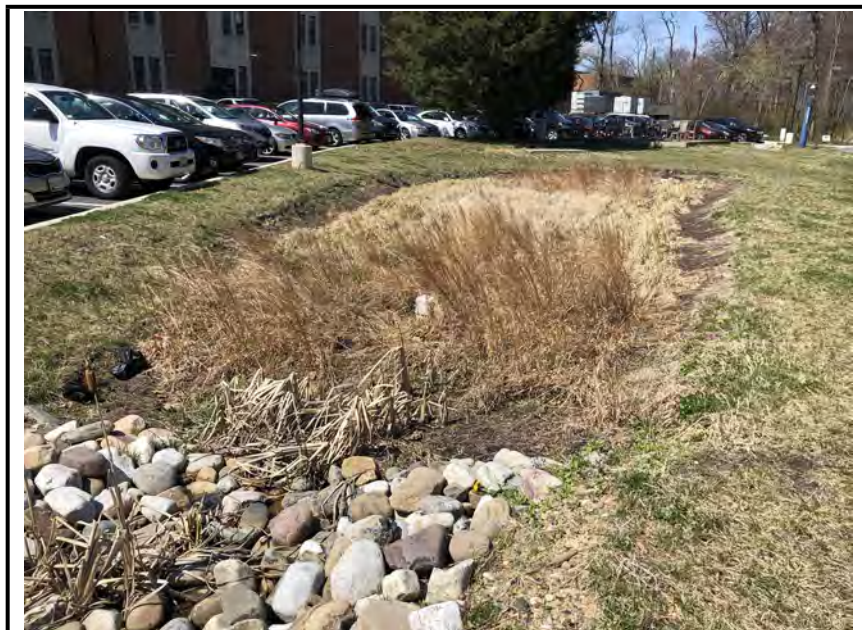
The bioretention facility is in overall good condition. The total drainage area of the facility is 23,781 square feet, including 17,396 square feet of impervious area. The ponding depth is designed to be 6 inches, with 2 feet of media depth. The total designed ESDv provided is 1,263 cubic feet, and a  $P_E$  of 0.9 inches is designed. There are grasses and vegetation covering much of the filter area. Some trash is present within the facility.

**Photo #2:** Vegetation within the facility.

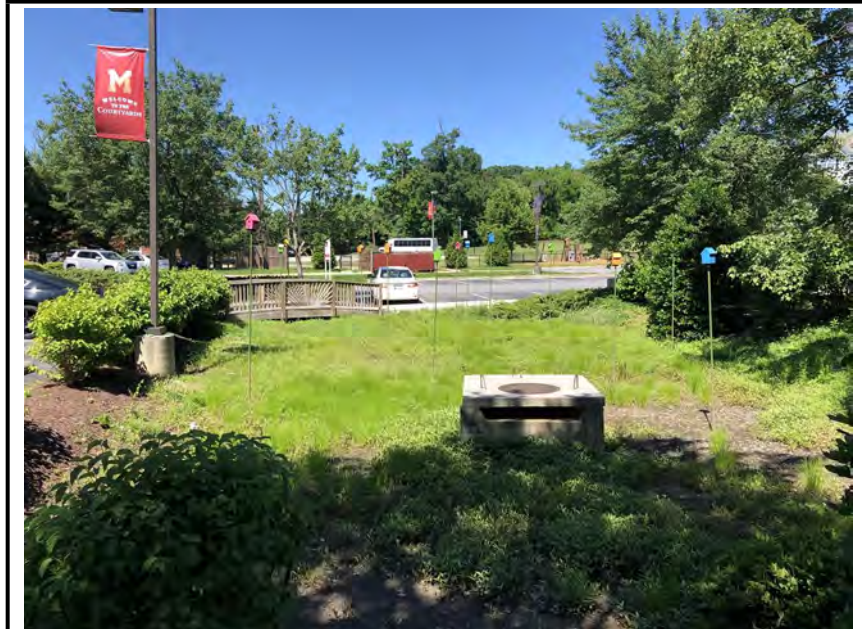
The facility has grasses and herbaceous plants throughout the treatment area, and several bushes and trees along the edges. A muck layer is present throughout the entire bottom of the facility as a result of deposited leaves and sediment. Birdhouses on poles are installed throughout the facility. The facility is in fair condition.

**Photo #1:** View into the facility.

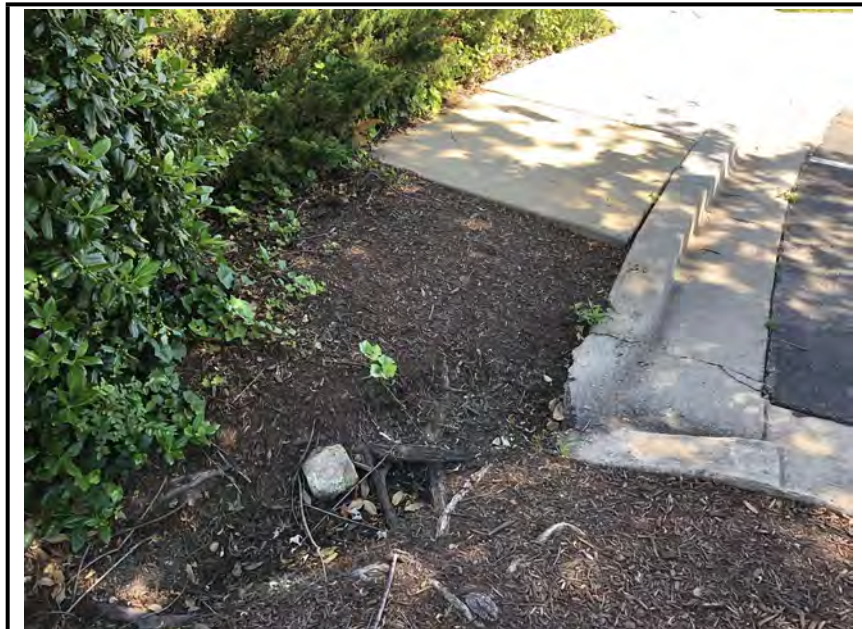
**Photo #2:** Erosion at curb cut.

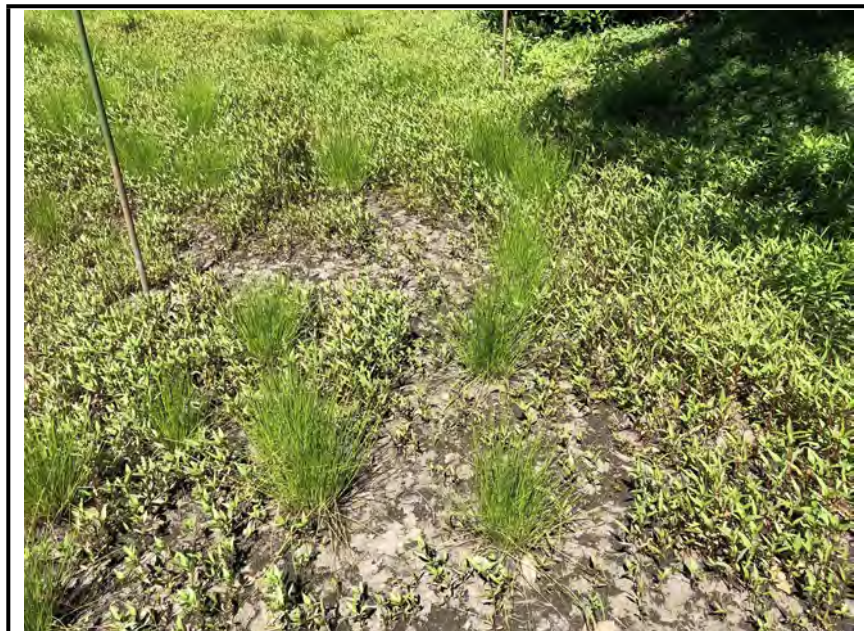
Photo #4: Vegetation in the facility.

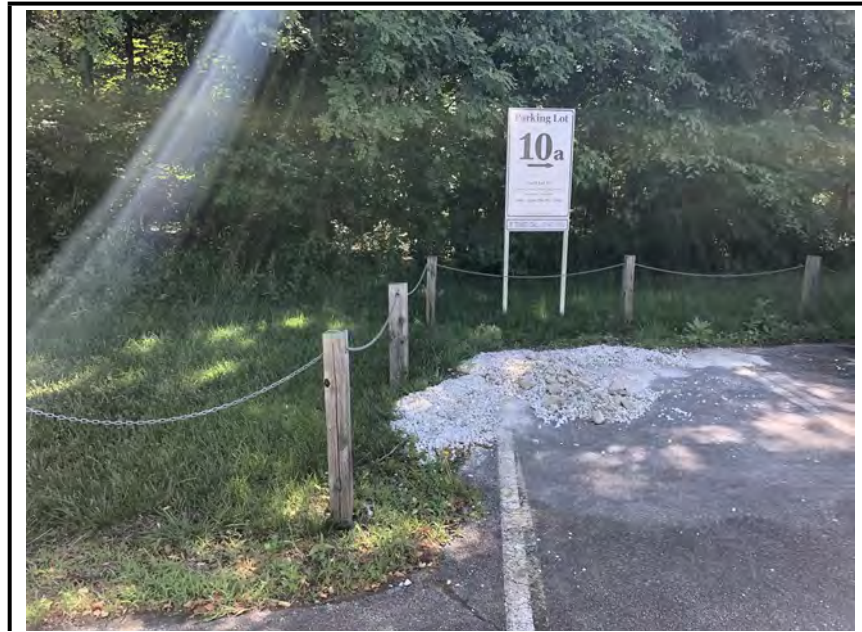
This BMP is sheet flow to a grass area and is a non-structural practice. The grass adjacent to the parking lot is in good condition. There is a gravel pile located in the corner of the parking lot that could carry gravel and sediment into the grass area. A trailer was also parked on the edge of the parking lot on the day of inspection. This impedes runoff from getting to the grass area. The facility is in fair condition.

**Photo #1:** Gravel that is blocking the non-structural practice.

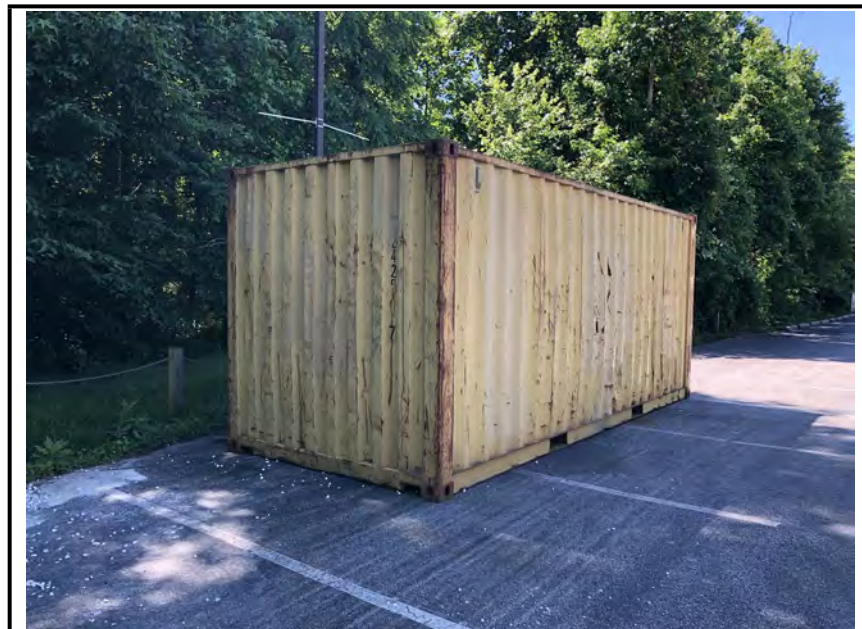
**Photo #2:** Trailer that is blocking the non-structural practice.

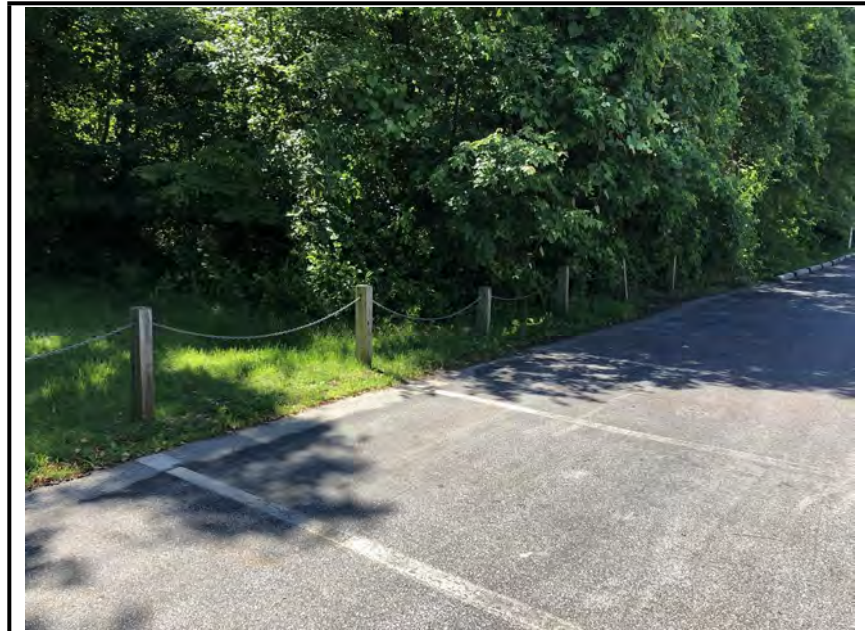
Photo #3: View of the non-structural practice.

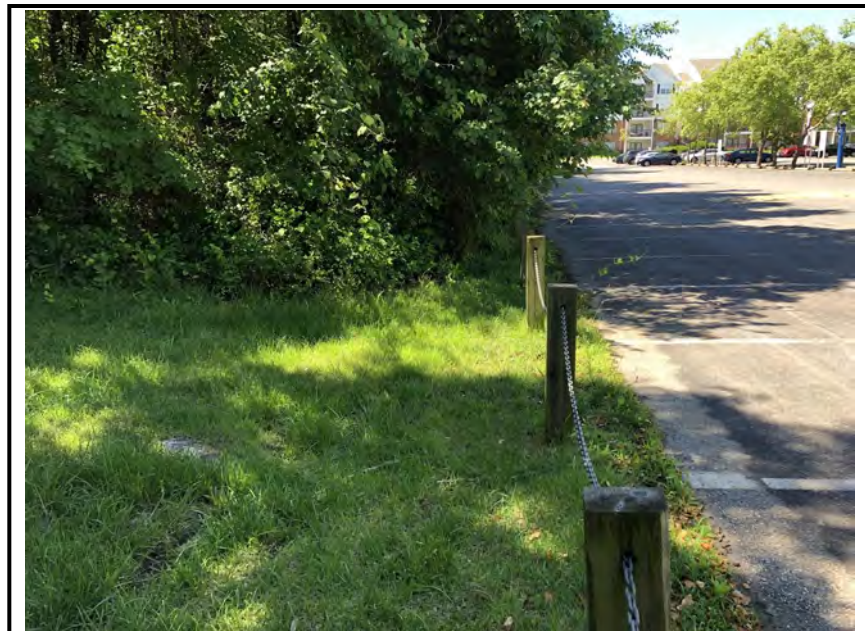
Photo #4: Grass area behind the parking lot.

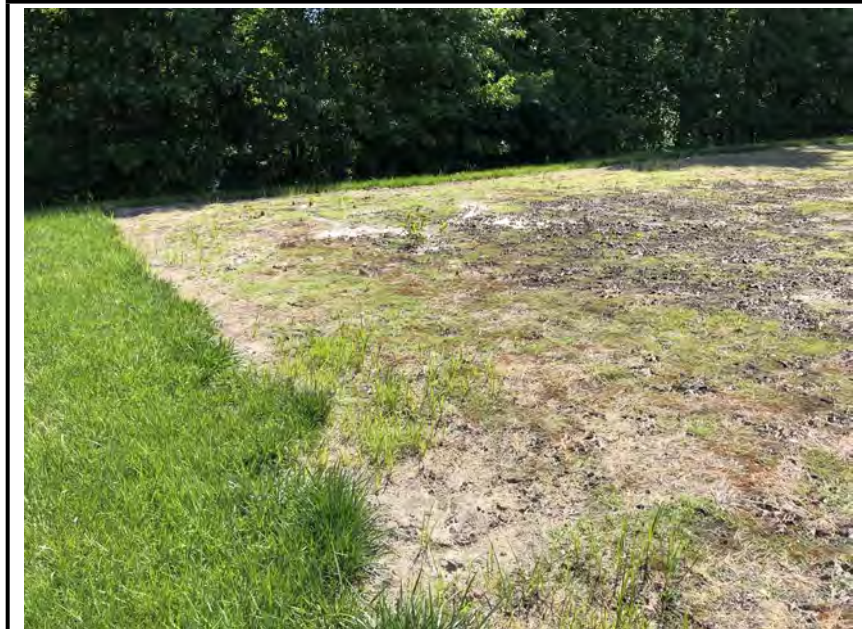
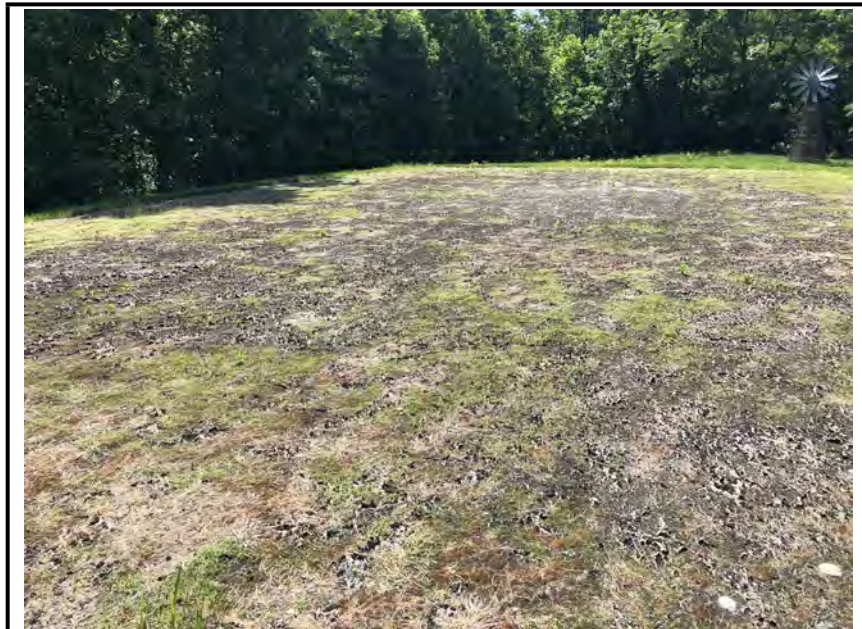
This BMP is sheet flow to a conservation area and is a non-structural practice. The impervious area that was intended to be treated looks to be removed because a rectangular sand area remains. More information and plans are needed to understand the status of this facility. If impervious area was removed, credit could be attributed to this area.

**Photo #1:** View of the removed non-structural practice.

**Photo #2:** View of the removed non-structural practice.

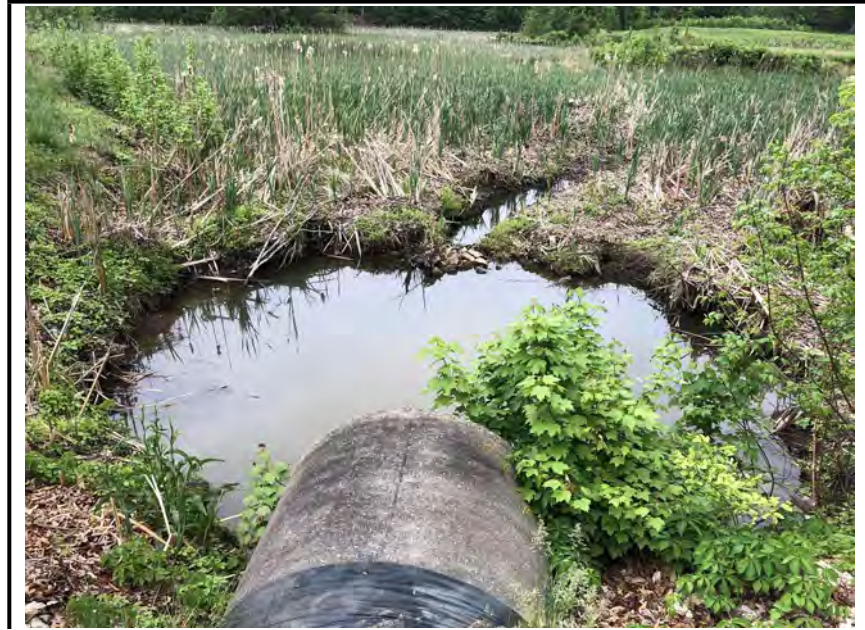
**Photo #3:** Small ponded area at inflow pipe.

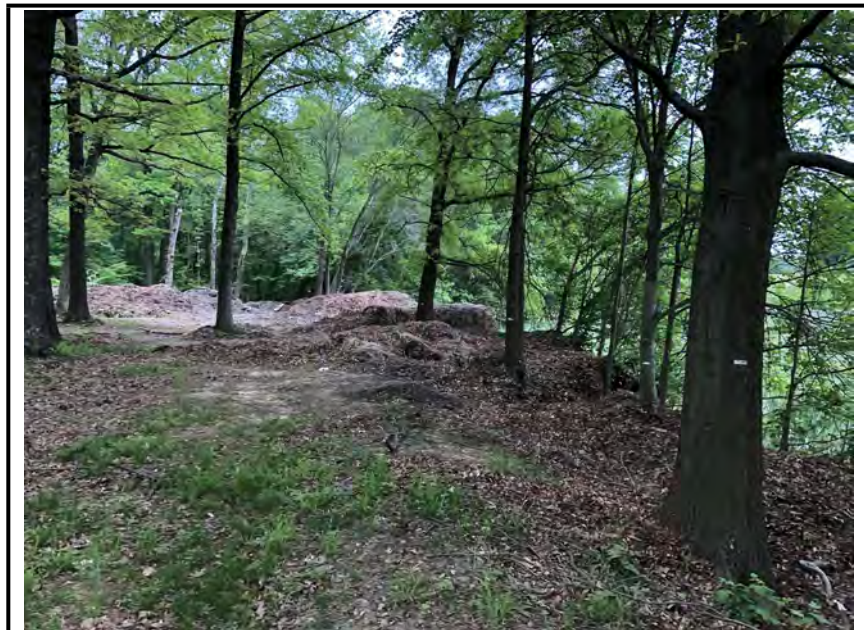
northern edge of the pond, there are several large piles of leaves that have been dumped extremely close to the edge of the facility. This leaf debris could be entering the facility area

Photo #6: Leaf piles adjacent to pond edge.

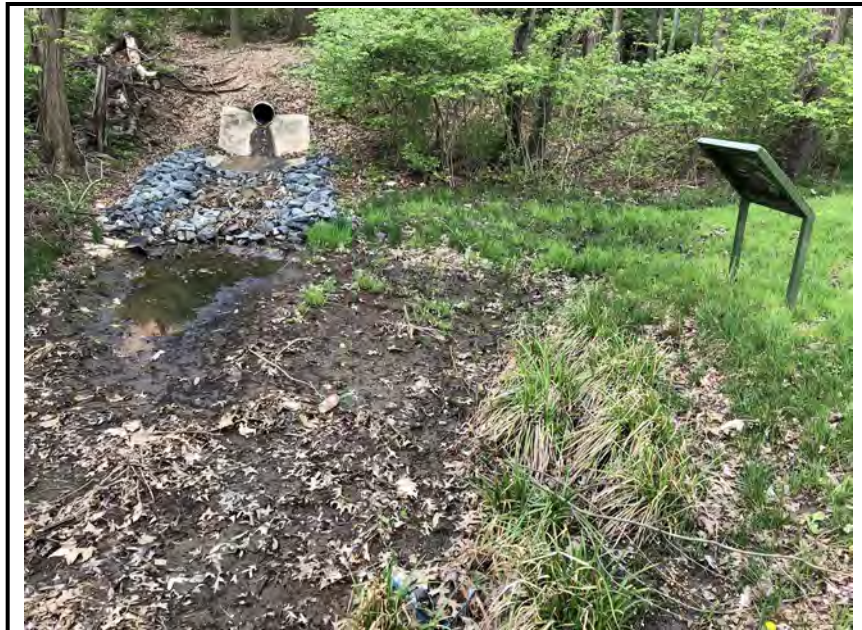
The facility receives runoff through a culvert discharging to a concrete channel, then a rip rap channel. The rip rap channel is filled with sediment and leaves that have discharged from the culvert. An area of standing water is present after the rip rap channel, due to a low spot caused by erosion.

Photo #1: Inflow and facility area.

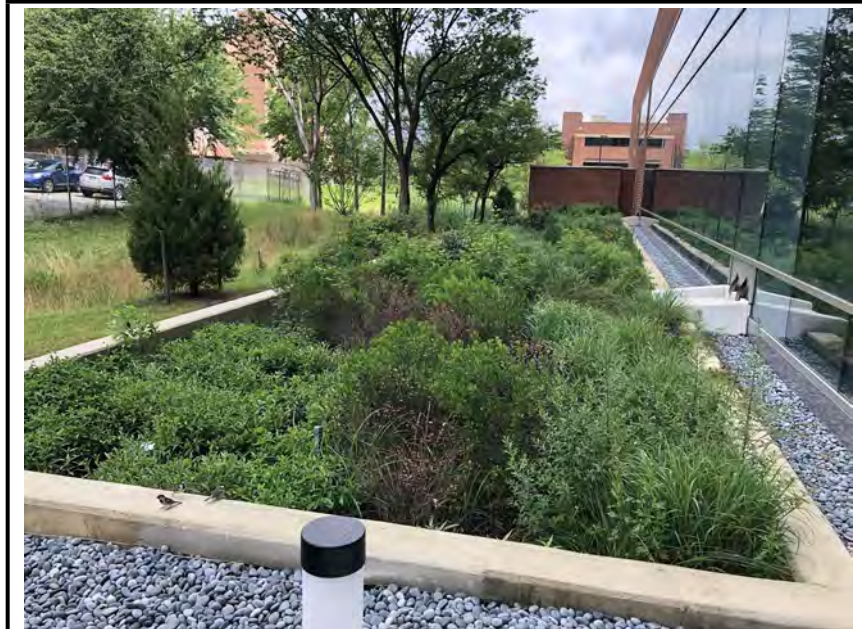
This facility is in fair condition. The facility has trash and weeds present throughout the BMP area. An irrigation hose system is installed throughout the facility. Additional water filtering through the facility from the irrigation system could contribute to more flow than the runoff that the facility was designed to treat and cause erosion.

**Photo #1:** View into the facility.

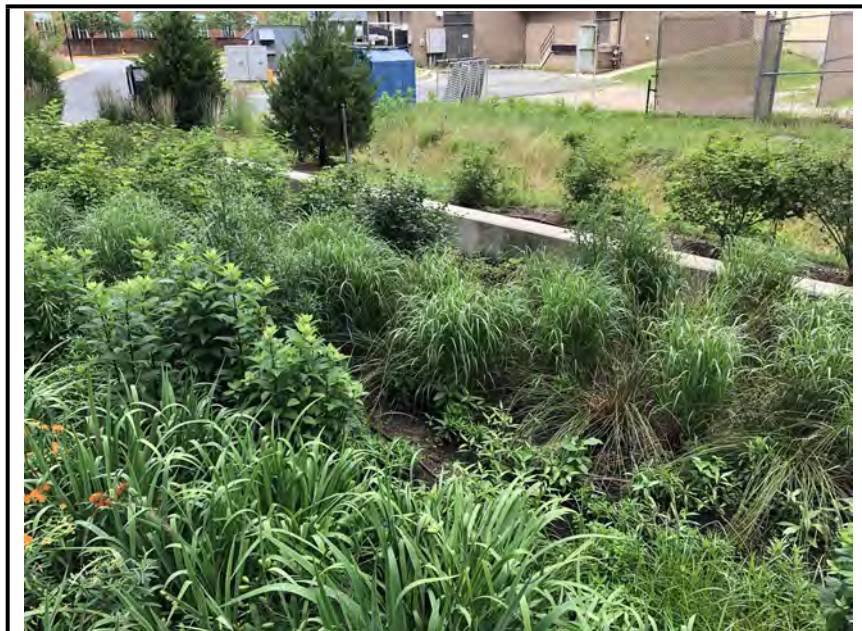
**Photo #2:** Vegetation within the facility with the irrigation lines exposed.

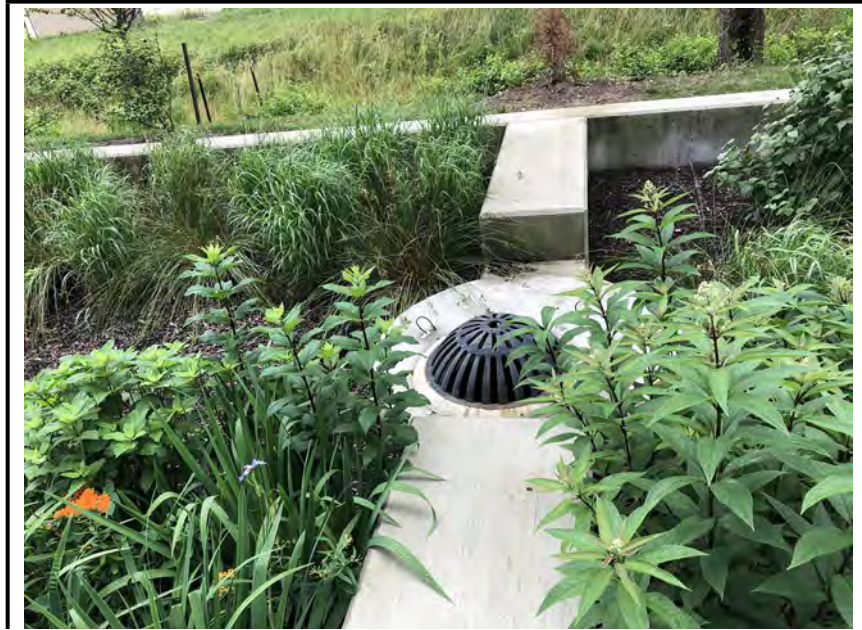
The facility outflow is through infiltration, an underdrain, and an overflow riser. The riser had 6 inches of standing water at the time of inspection.

**Photo #1:** The riser outlet structure shared with CH-1
