University of Maryland, College Park  
National Pollutant Discharge Elimination  
System MS4 Phase II  
FY2019 Annual Report  
General Discharge Permit #13-SF-5501

## **Stormwater Treatment Final Report & Recommendations**

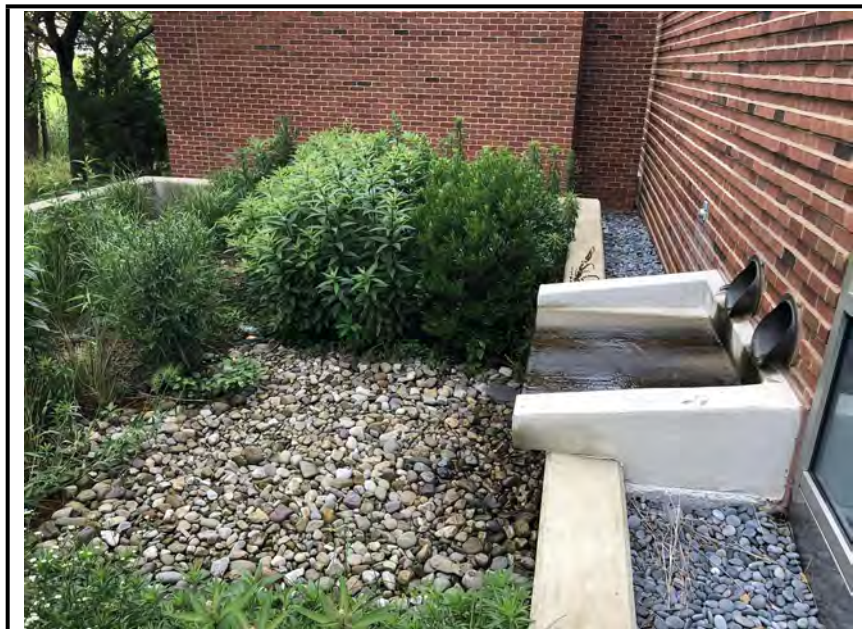
**Photo #2:** Two inflow pipes and the trench drain that lead into the facility.
